The repair of Arctic structures damaged by thaumasite

John A. Bickley

John A. Bickley Associates Ltd, Consulting Engineers, 27 Summerhill Avenue, Toronto, Canada M4T 1A9

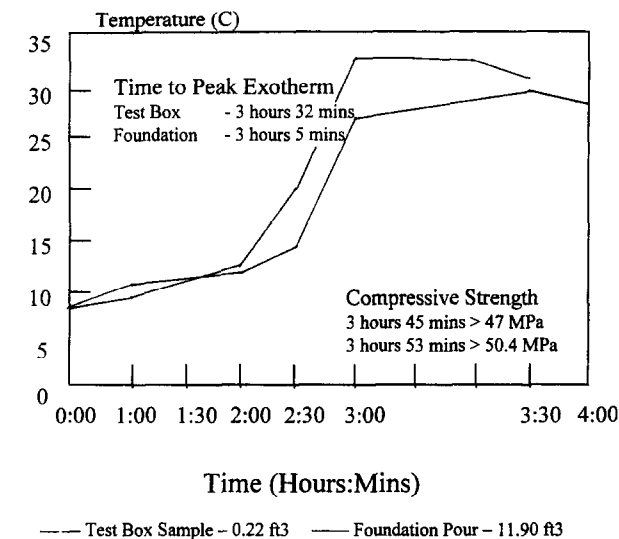
Fig. 7. Curing characteristics of resin concrete.

In the event Mr Ray Crowne of Cappar Ltd. controlled the measurement, mixing and placing of each batch and the removal of all defective material. He also carried out various ad hoc physical tests to confirm the satisfactory exothermic reaction and hardening of each batch. A typical plot of the exothermic reaction is shown as Fig. 7.
