Restoration of Hanshin Expressway after Kobe/Awaji Earthquake – challenge of 623 days before opening

Hidenao Hayashi *, Tamotsu Marui, Nobuhiko Taniguchi, Shigeru Kayano

Hanshin Expressway Public Corporation, 4-1-3 Kyutaro-machi Chuo-ku, Osaka, Japan

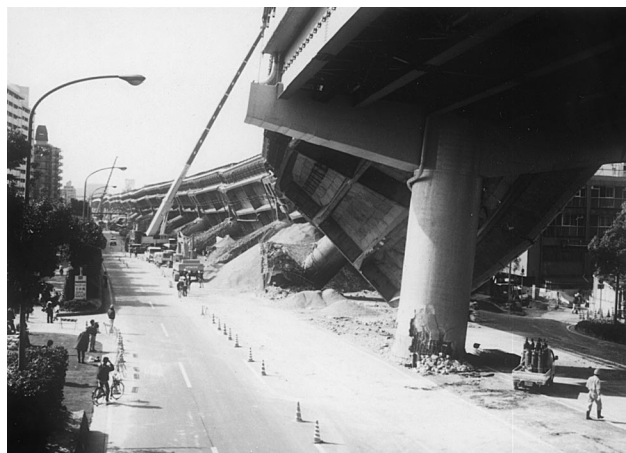
Kobe/Awaji Earthquake in 1995 struck the Kobe City and Awaji Island severely, and Hanshin Expressway Route 3 was also suffered a significant damage during the earthquake. One 635-meter elevated section was toppled in Higashi–Nada ward (see Fig. 1), and four other sections along Route 3 were collapsed. An emergency inspection was done immediately after the earthquake. It was found that 604 of the 1106 piers and 551 of the 1304 elevated sections were distressed in the 27.7 km stretch between Mukogawa and Tsukimiyama in Hyogo Prefecture as shown in the map of Fig. 2. Damaged structures were ranked on a scale between As, A, B, C, and D, according to the criteria specified in the Handbook of Earthquake Countermeasures for Roads (see Figs. 3–5).

Fig. 1. Toppled columns at Fukae Section.

Fukae Section is located in Higashi-Nada ward, eastern part of Kobe City. There had been concrete bridges with mushroom-shaped piers ('pilz' type) and they were toppled during the earthquake as shown in Fig. 1.

The structures above ground level were removed totally within ten days after the earthquake to keep the safety of National Highway Route 43 running under the Hanshin Expressway Route 3.

The superstructures of toppled 18 spans were rebuilt as two 9-span continuous steel box girder bridges. The representative cross section is shown in Fig. 9. Seismic

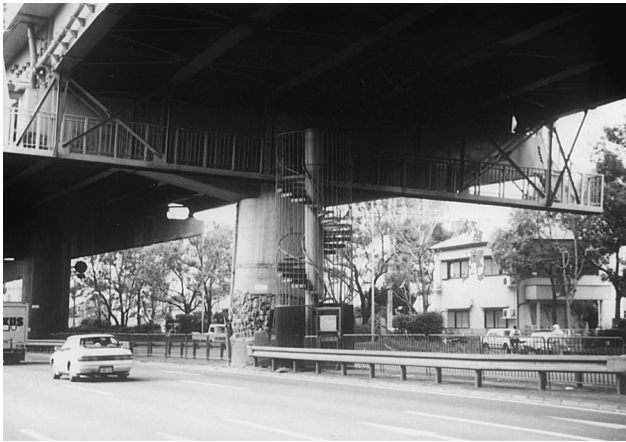
15% of the 943 concrete piers were judged As or A that means functional damage, and 35% were judged B or C meaning relatively light damage. Besides, the number of severely affected steel piers were relatively low at 11, buckling or cracking around accessholes and

Fig 3. Damaged RC pier (ranked A).

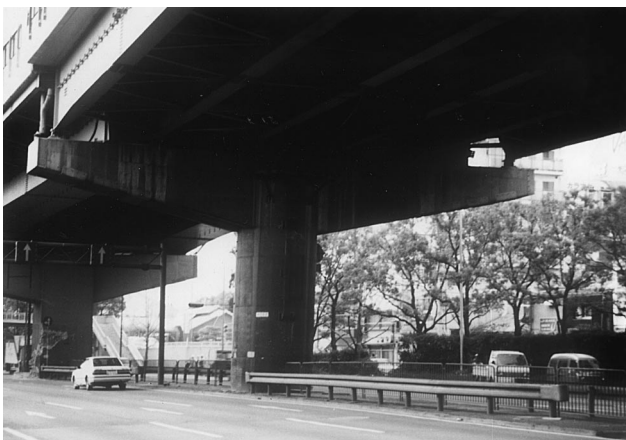
Fig 4. Damaged RC pier (ranked B).

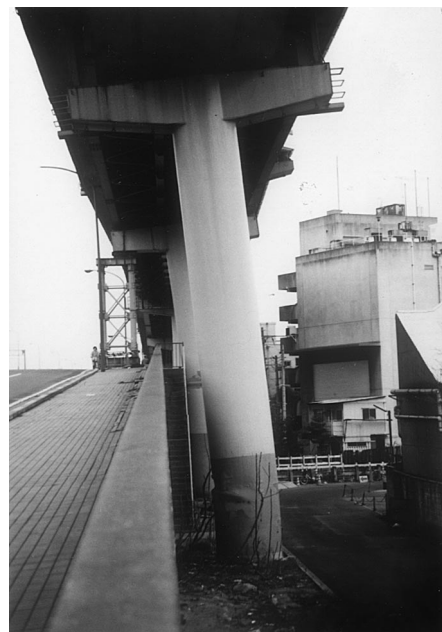
peeling of coatings on welds were observed in about 80% of steel piers.

Fig 5. Damaged steel pier.

Steel piers were removed and rebuilt when columns had been substantially buckled or cracks were observed around the circumference. Where repair work by replacing partial segments was judged possible, the superstructure was removed temporary, damage sections were cut out, and new segments were installed in their place. There are several measures to increase the lateral force bearing capacity of steel piers such as adding rib plates to the interior of a pier or filling concrete inside a pier. In the restoration of Route 3, the latter measure was employed according to the Restoration Specifications.

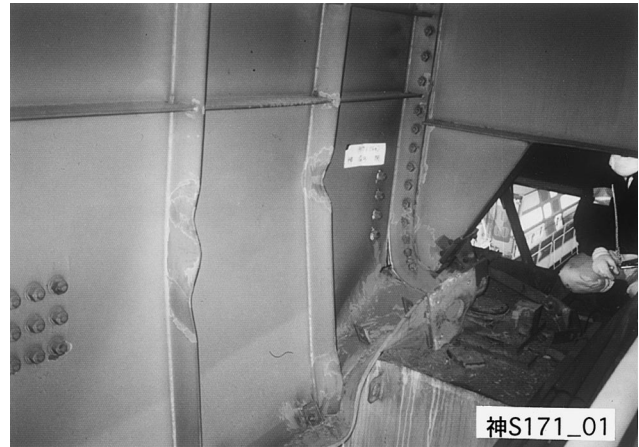
On steel girder bridges, many buckling damages were found at the end of the main girder where end cross-beams had knee braces (see Fig. 6). It was considered that they were due to less transverse stiffness of grid, so that a full-web structure was employed for the end cross beam to reinforce the transverse stiffness of superstructure.

Fig 6. Buckling of main girder.

Most of the survived steel girders were repaired. Basically the buckled members were replaced with new members. When the damage was relatively light, buckled members were heated or welded as they were. And repaired girders were connected to each other as much as possible not to fall down with the structure as shown in Fig. 7. The continuation of girders is also effective for the environment by reducing the noise from expansion joints. When the girders could not be connected, seismic restrainers or displacement stoppers were installed to prevent the bridges from falling down (see Fig. 8).
