Case studies of concrete deterioration in a marine environment in Portugal

António Costa ^{*}, Júlio Appleton

Departamento de Engenharia Civil, Instituto Superior Técnico, Technical University of Lisbon, Av. Rovisco Pais, 1049 001 Lisboa, Portugal

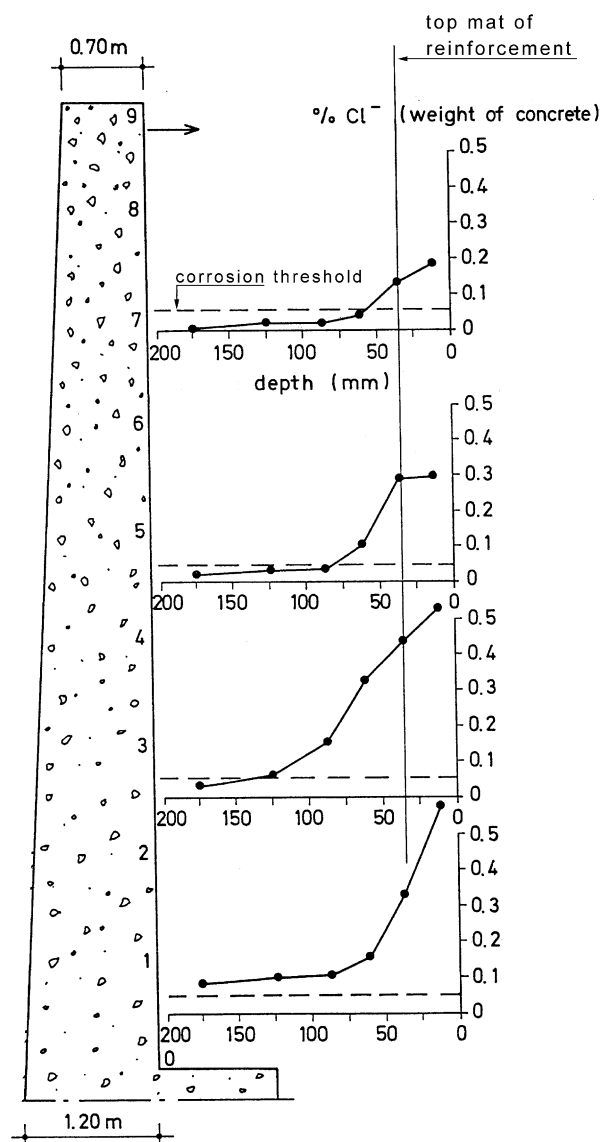
Fig. 2. Chloride profiles measured on the internal surface of dock 20 walls (1980); measurements in m.

The deterioration process developed along the years extending to several parts of the docks. The deterioration rates depended mainly on the exposure conditions of each zone. The worst situation was observed on the internal side of the walls of dock 20. After 5 years of exposure, the concrete was deeply contaminated by chlorides at the reinforcement level as shown in Fig. 2. After 10 years of exposure, a general delamination and spalling of the cover concrete occurred, up to the level reached by the salt water when the dock was filled as shown in Fig. 3.

The extremely high deterioration rate observed in the internal walls can be explained by the exposure conditions and the poor concrete quality. Regarding the ingress of chlorides into concrete, different physical mechanisms may be distinguished: permeation, capillary absorption and diffusion. Permeation and absorption are very fast transport mechanisms while diffusion is much slower. As a result of the wet and long dry cycles of the internal walls of the dock and the high capillary porosity of the concrete, the absorption process was the dominant transport mechanism. So, after the first cycles of dock filling the reinforcement was depassivated. The

high chloride concentration, the low resistivity of the concrete, and the easy access of oxygen to the reinforcement during the dry periods led to a high corrosion rate which caused the early spalling of the concrete cover.

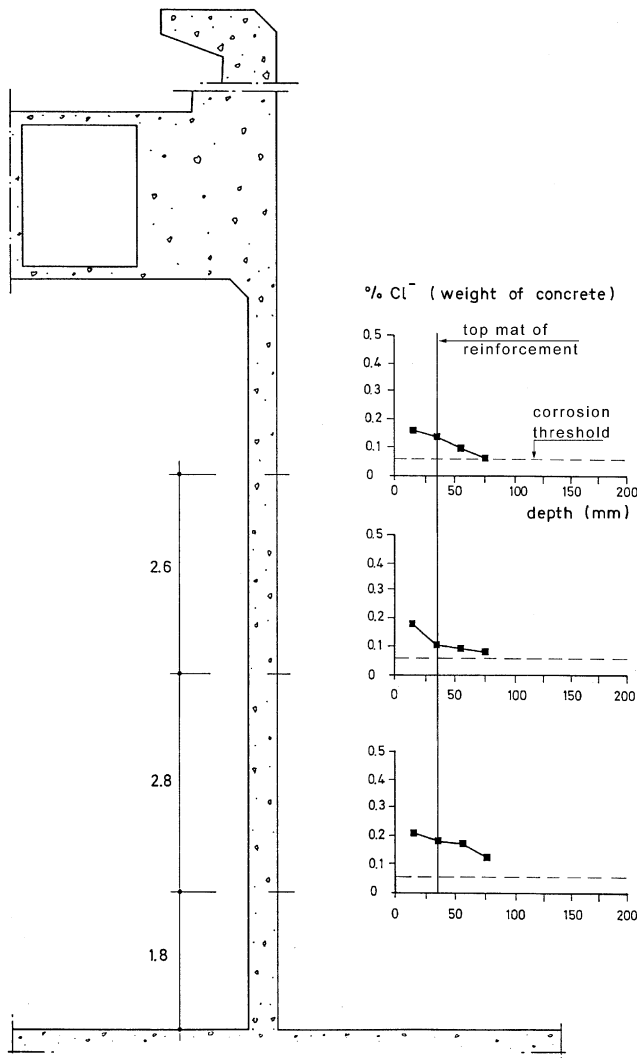
Fig. 4. Chloride profiles measured on the lower part of dock 21 walls (1991).

At the lower zone, the wall is subject to frequent wetting cycles (about 48 h twice a month). The concrete at that area usually presents a high saturation level caused by this high filling rate and by the permeation of water from the reverse side of the wall. Under these conditions the dominant transport mechanism of chlorides is diffusion. Fig. 4 presents the chloride profiles in the lower part of the walls measured after 16 years of exposure, showing high concentration but much less than that observed in dock 20 after 5 years of exposure.

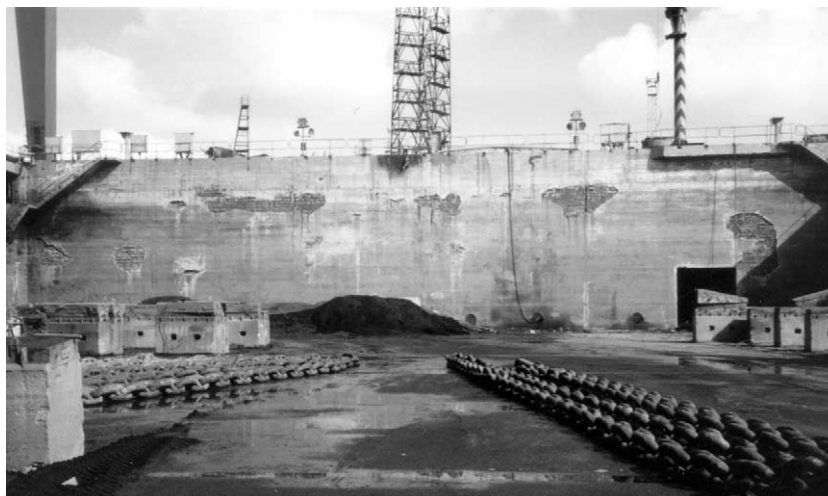
Fig. 5. Deterioration of the northern wall of dock 22 (1999).

In dock 22, a similar deterioration process was observed on the internal surfaces of the walls. Due to the saturation of the concrete in the lower parts of the walls, the corrosion rate is controlled by the cathodic process due to the limited access of oxygen to the reinforcement. This explains the much less concrete spalling in these zones. It has also been observed that the northern wall of the dock 22 showed a deterioration level higher than that on the east and west walls, as shown in Fig. 5. This fact is also due to the exposure conditions. Exposure to the sun of the northern wall is fairly higher than that of the other walls. Therefore, it is exposed to higher temperatures, which lead to a quicker drying of the concrete and to a higher access of oxygen to the reinforcement. It is also known that the temperature increases the corrosion rate significantly. Thus, these two factors together led to a higher deterioration level of that wall.

Macro corrosion cells, i.e., corrosion cells with well-separated anodes and cathodes, were observed on these walls, as shown in Fig. 6. This phenomenon is characteristic of chloride-induced corrosion and is due to the high conductivity of the concrete caused by water and chlorides in the pore structure. The measured values of concrete resistivity ranged usually from 1.5 to 3.0 kΩ cm. The anodic zones in these macrocells increased in time, giving rise to the type of deterioration observed in Fig. 5. This process can lead to very high

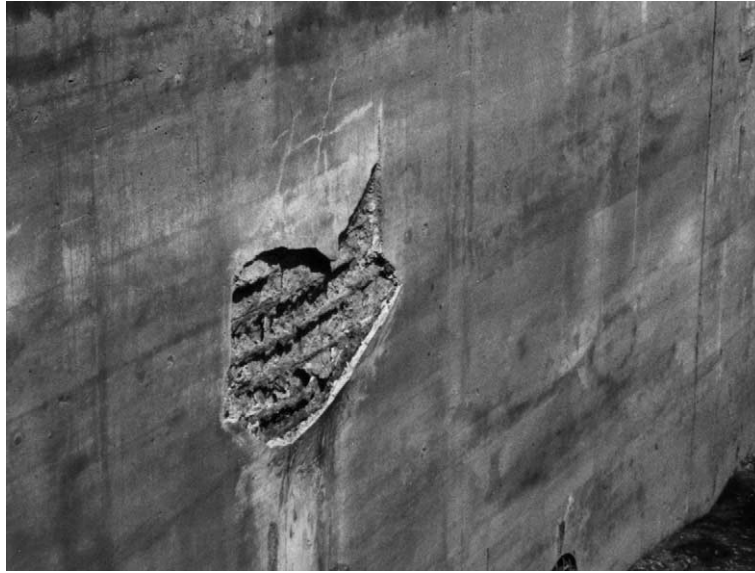
Fig. 6. Macro corrosion cell in dock 22 walls.

corrosion rates when the cathodic areas are much larger than the anodic ones. The corrosion rate was measured through the loss of section of the bars in several anodic zones of the walls. Values of 200–400 $\mu\text{m}/\text{year}$ were frequently obtained and in some cases values in excess of 600 $\mu\text{m}/\text{year}$ were measured. These high values are similar to those obtained in several studies [3–6] where the corrosion rates were measured both in situ and in laboratory tests on elements exposed to chloride-contaminated environments.

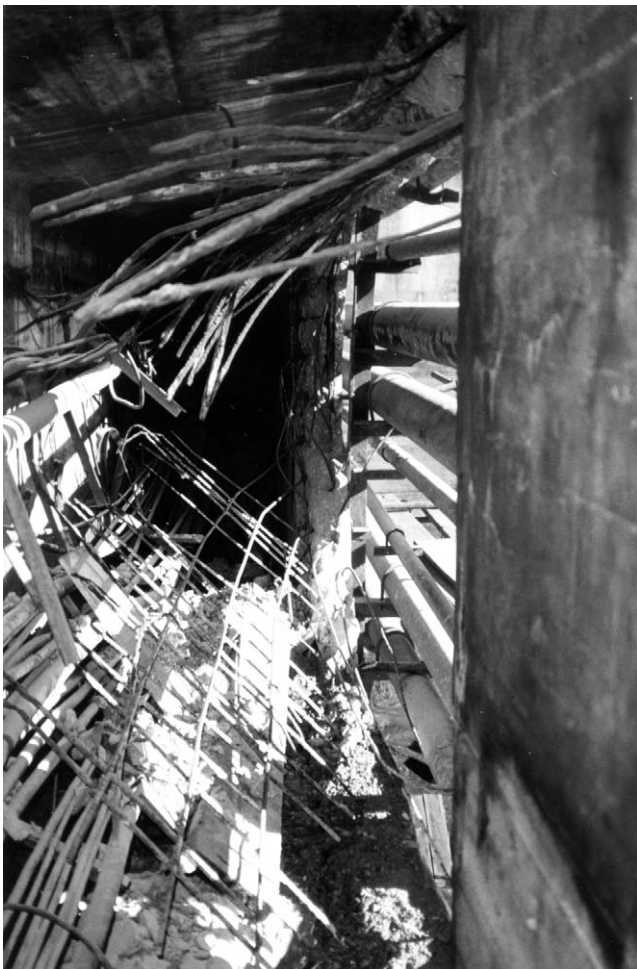
Fig. 7. Failure of the gallery wall in dock 21.

In dock 21, an accident occurred due to a failure of a structural element, deeply affected by reinforcement corrosion, as shown in Fig. 7. A wall of a technical gallery collapsed under water pressure when the dock was completely filled and a ship was manoeuvring. This almost caused the emptying of the dock and severe damage to the ship. The collapse of the wall was mainly caused by the loss of bond between the bars and concrete due to the splitting of the concrete cover. This accident shows the significance of reinforcement corrosion on structural safety.

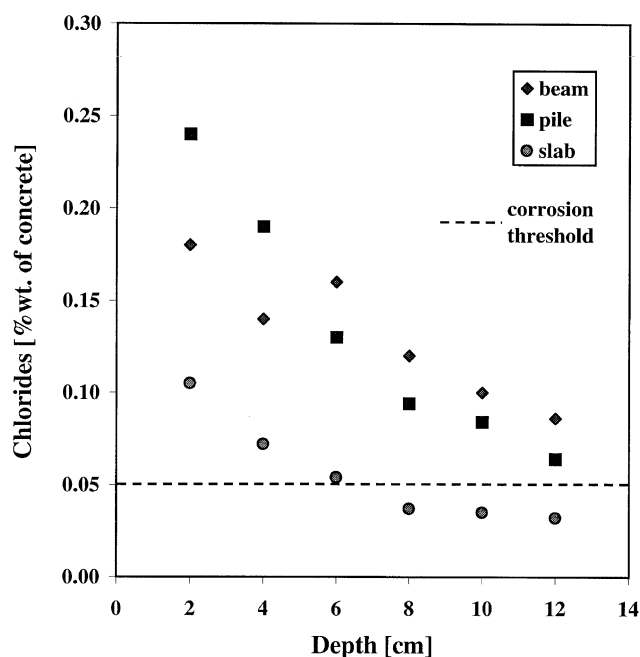
Fig. 9. Typical chloride profiles in different structural elements of the wharves.

The tests performed during the in-depth inspection showed that the concrete was heavily contaminated by chlorides to a depth far beyond the reinforcement in almost all the structural elements of the wharves, as shown in Fig. 9.

In the beams the chloride content at the level of the prestressed tendons is generally in excess of 0.1% by weight of concrete, while in the slabs it is lower (less than 0.05%) except in a critical zone below the crane rails, where the cover of the tendons is about 5 cm due to the execution of gutters in the slab to put in the rails.

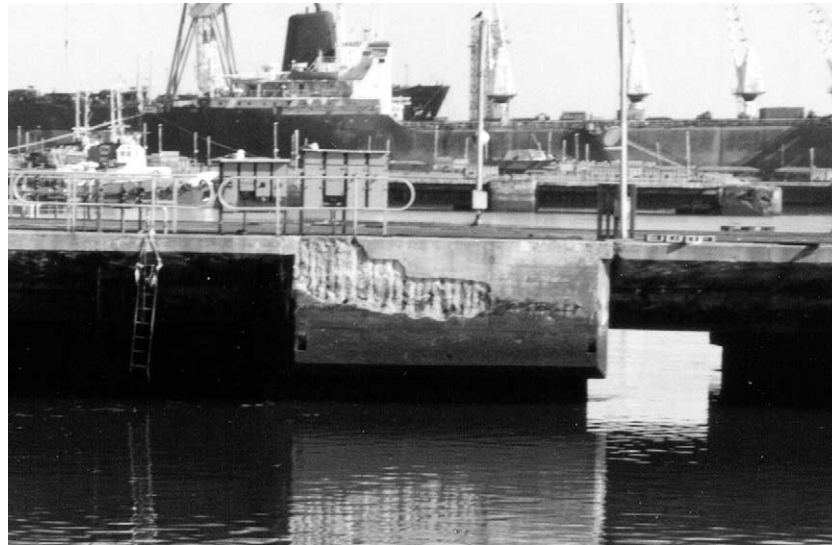
Fig. 10. Typical deterioration observed in the splash and tidal zones.

Two main different degrees of deterioration were observed in the wharves. The upper part exposed to the splash and spray zones presented large areas with spalled and delaminated concrete due to reinforcement corrosion. The lower part exposed to the tidal zone presented a much lower degree of deterioration. In this zone only small delaminated areas were observed. Fig. 10 illustrates the difference of the deterioration conditions between the splash and tidal zones.

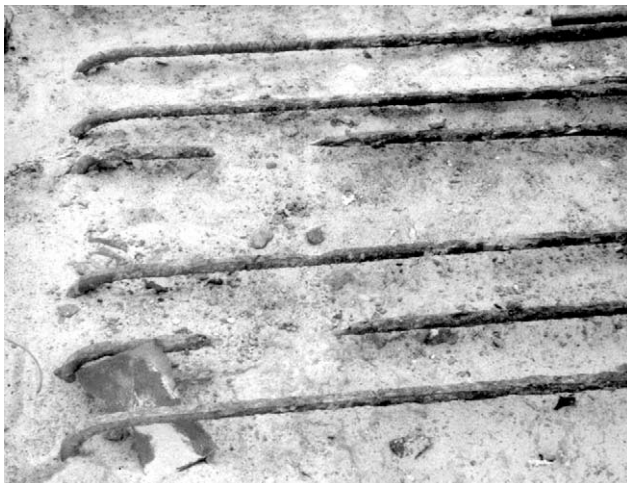
Fig. 11. Bars with 25 mm diameter totally corroded.

A substantial loss of the cross-section of the bars was observed in the deck of the wharves. In some zones, 25 mm diameter bars were totally corroded after 24 years of exposure, as shown in Fig. 11. This accounts for a corrosion rate in excess of 500 $\mu\text{m}/\text{year}$, assuming uniform corrosion around the bars. The extremely high corrosion rates developed in the deck bars can be explained by the macrocell chloride-induced corrosion mechanism with large cathodic areas and small anodic zones as discussed before.

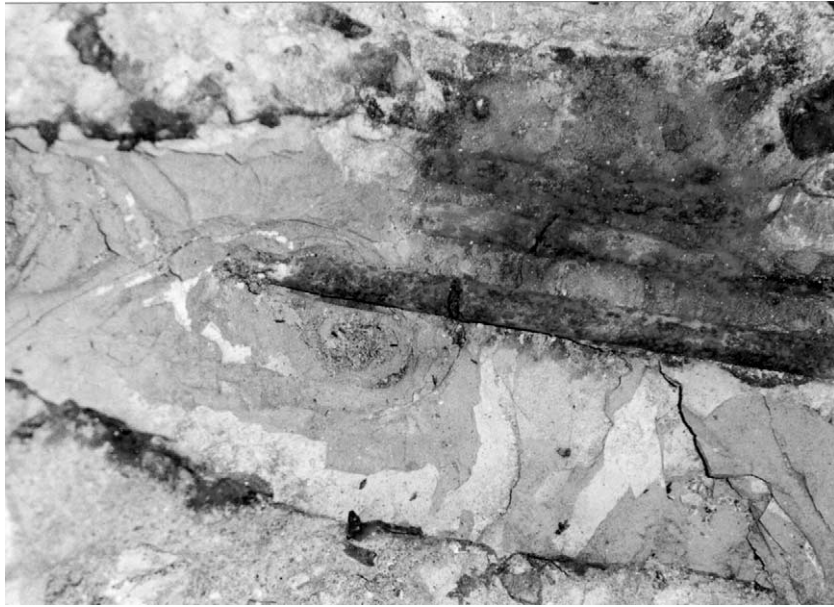
Fig. 12. Stress corrosion cracking of the prestressed wires.

In one of the wharves a very critical deterioration case was detected. The prestressed tendons of the deck slab located below the gutters that contain the crane rails showed a deep corroded condition. The steel ducts were almost all destroyed by corrosion and in many cases it seems that stress corrosion cracking of the wires had occurred, as shown in Fig. 12. This type of corrosion causes the brittle failure of the prestressing steel without significant loss of cross-section. Sudden failure of the structural elements may occur since there is no visible warning of tendons deterioration. Several cases of bridge collapse due to this type of corrosion process are reported [12].

The extreme deterioration condition of the prestressing tendons was caused by a very aggressive microenvironment engendered in the rail gutters associated to poor materials and workmanship. The lack of drainage of the gutters led to the accumulation of salt water during long periods on the concrete surface. The water evaporation leaves behind the salts which lead to growing chloride concentrations. These conditions caused a high penetration rate of chlorides into concrete and led to the early development of the corrosion mechanism on the tendons.

The repair methodology adopted for the wharves was in general the same as used for the dock except in the case of the deck slab with deeply deteriorated tendons. Here it was necessary to strengthen this structural element. The strengthening consists of a 20 cm thick cast-in-place high-quality concrete overlay (water/cement ratio = 0.30; cement content = 400 kg/m³; microsilica

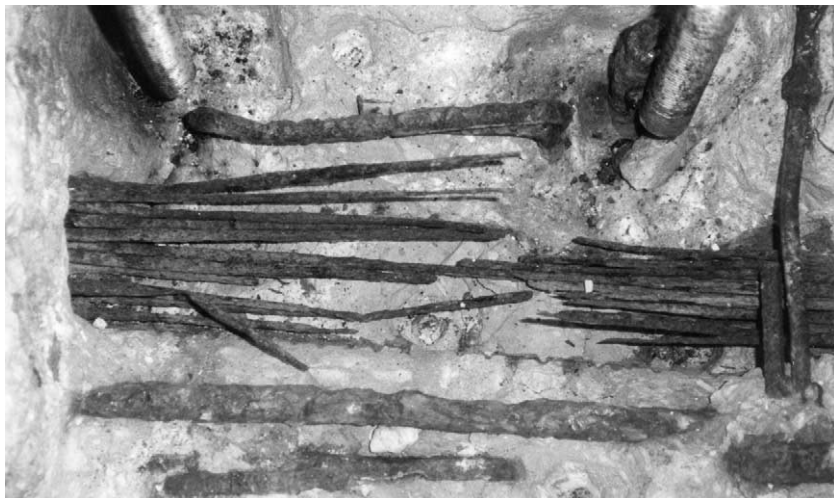
Fig. 13. Corrosion of prestressing steel in un-grouted ducts.

In some cases, ducts were left totally un-grouted due to poor workmanship. In these situations the prestressed wires are not protected by the alkaline environment of

the grout and a drastic degradation condition was found, as shown in Fig. 13.

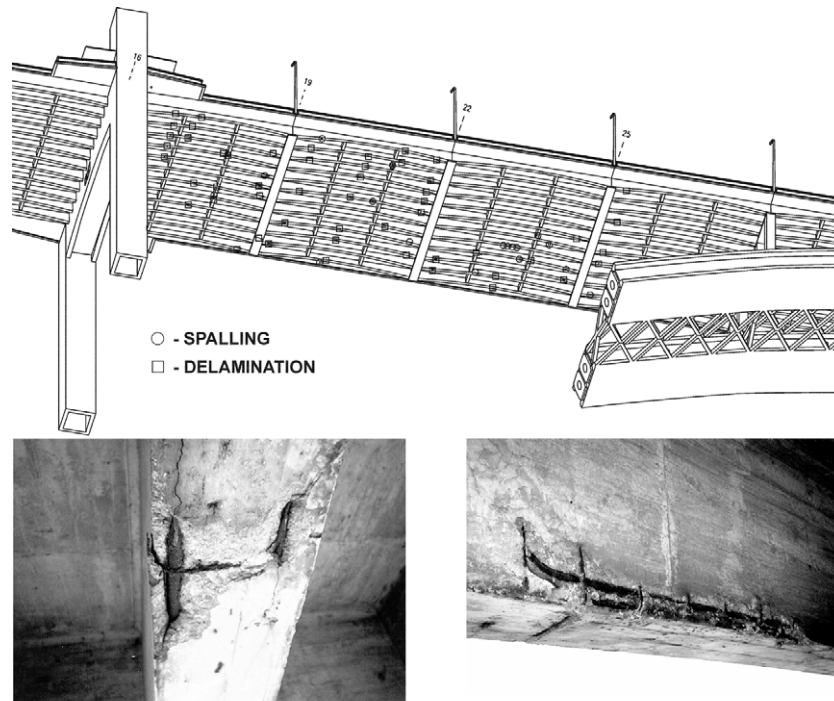
Fig. 14. Typical deterioration observed along the deck.

Concrete spalling in a construction joint and in a low cover zone.

The main find of the investigation was significant delamination and spalling of concrete occurring in the deck beams mainly over the arch. Fig. 14 shows the recorded information of the typical concrete deterioration observed in the inspection of the deck. Higher incidence of deterioration was observed in the downstream faces and lower corners of the beams.

The main cause of the concrete deterioration of the bridge was poor execution quality since the concrete quality was very good. Poorly made construction joints and honeycombing were frequently observed and the thickness of concrete cover presented a high scatter. The inspection showed that there was a significant area of the beams with a concrete cover thickness less than 2 cm.

The repair strategy adopted for this bridge was local patch repair with cement mortar followed by an application of a protective coating. The basic principles behind this repair methodology are the following: stopping the anodic process where the reinforcement is corroding; application of a surface barrier to control the ingress of further aggressive substances and also to limit the moisture content of the concrete. This last aim of the surface protection is very important since it is impossible in practice to assure that all the contaminated concrete is removed in a patch repair methodology. A surface protection impermeable to water and permeable to water vapour allows concrete to dry out raising its resistivity and controlling in this way the electrolytic conduction process of the corrosion mechanism.

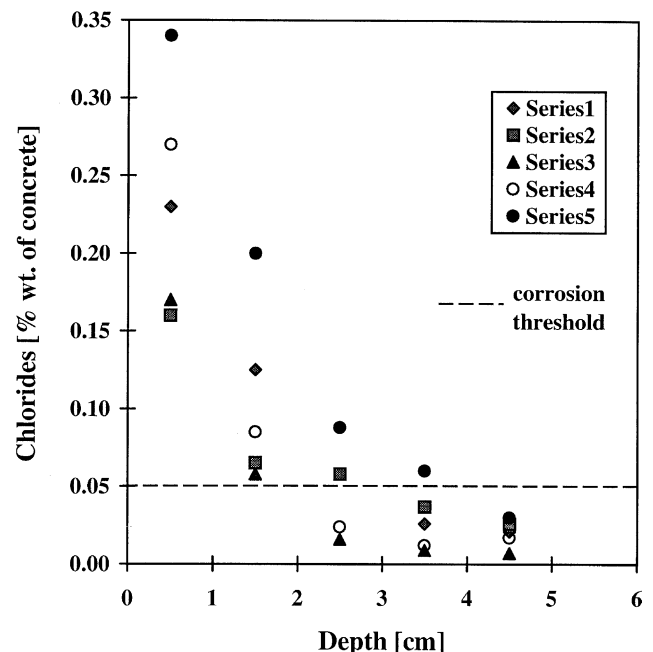
Fig. 15. Chloride profiles in zones with defects.

Carbonation measurements did not exceed 5 mm depth, even in the areas of deficient concrete placing. Chloride penetration was in general small except in areas with defects where values up to 0.06% by weight of concrete were observed at 3.5 cm depth, as summarised

in Fig. 15. Chloride-induced corrosion was thus the cause of deterioration in these areas.
