# Evidence of thaumasite formation in Southern California concrete

S. Sahu <sup>\*</sup>, S. Badger, N. Thaulow

*R.J. Lee Group Inc., 350 Hochberg Road, Monroeville, PA 15146, USA*

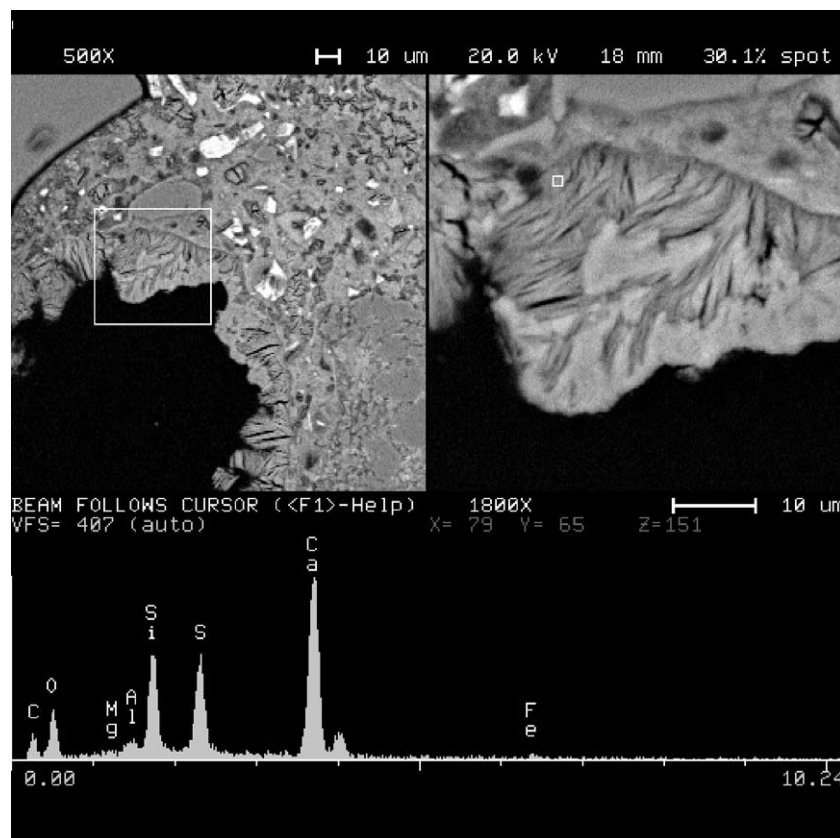
Fig. 1. BSE image showing thaumasite deposits in association with gypsum.

Sulfate attack was diagnosed in most of the cores analyzed. Thaumasite was identified only in few cores obtained from garage slabs. This concrete did not contain ground carbonaceous (limestone, dolomite) material as filler or as aggregates. Severe carbonation was observed at the bottom as well as at the top of the concrete. The depth of carbonation was measured to a 20–30 mm thickness. Though carbonation was observed at the top and bottom of the concrete, thaumasite deposits were observed only in the bottom portion of the cores. A backscattered electron (BSE) image of thaumasite deposits in an entrapped air void is shown in Fig. 1. Thaumasite is associated with gypsum as a lining. The deposits are just above the bottom carbonation zone of the core. Fig. 2 shows a BSE image of thaumasite deposits in another entrapped air void in the same core. The entire deposit in the air void is thaumasite. The other deposits in the air voids in the left image are

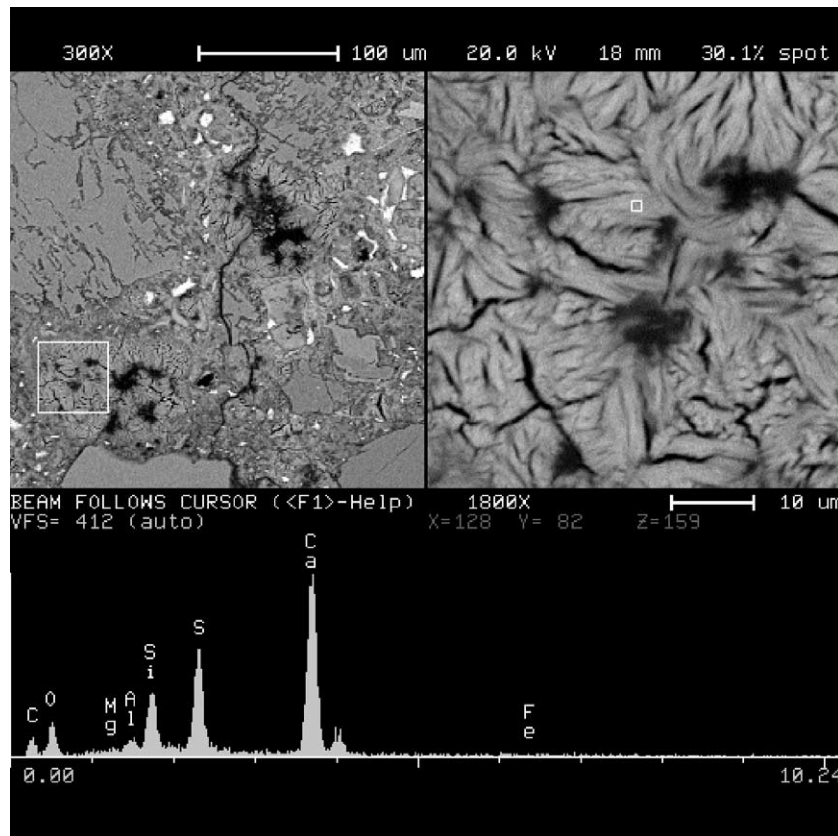
Fig. 2. BSE image of thaumasite deposits in an entrapped air void.

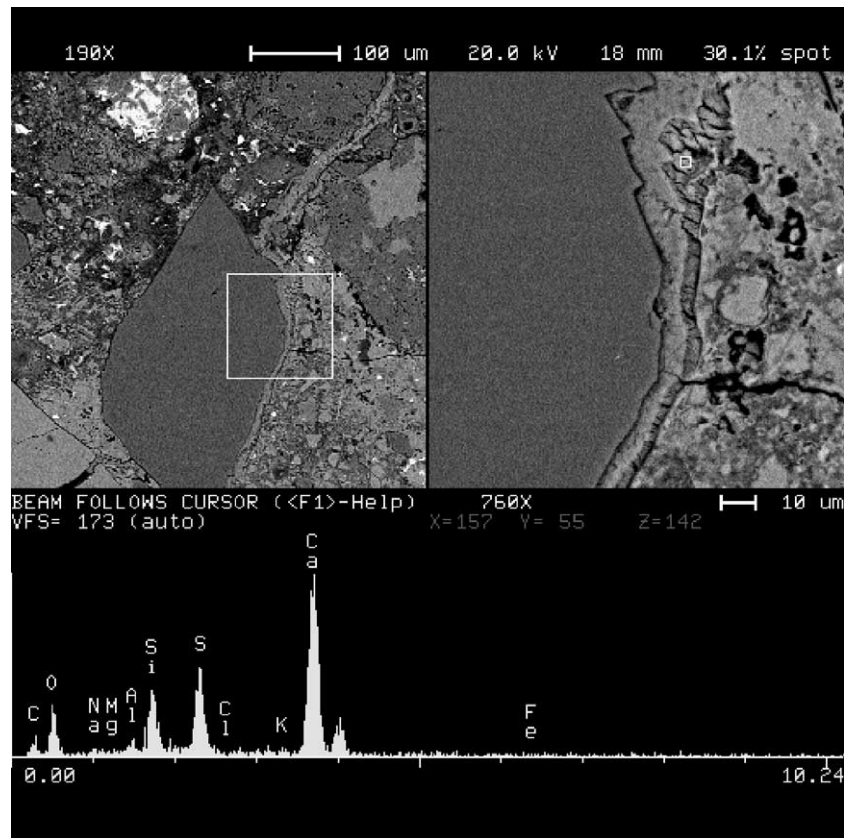
also thaumasite. A band of thaumasite deposited in a crack next to an aggregate is shown in Fig. 3. The thaumasite band is similar to that of ettringite bands as commonly found in deteriorated concrete. Gypsum deposits were also found parallel to the thaumasite deposits.

Fig. 3. BSE image of a band of thaumasite deposit.

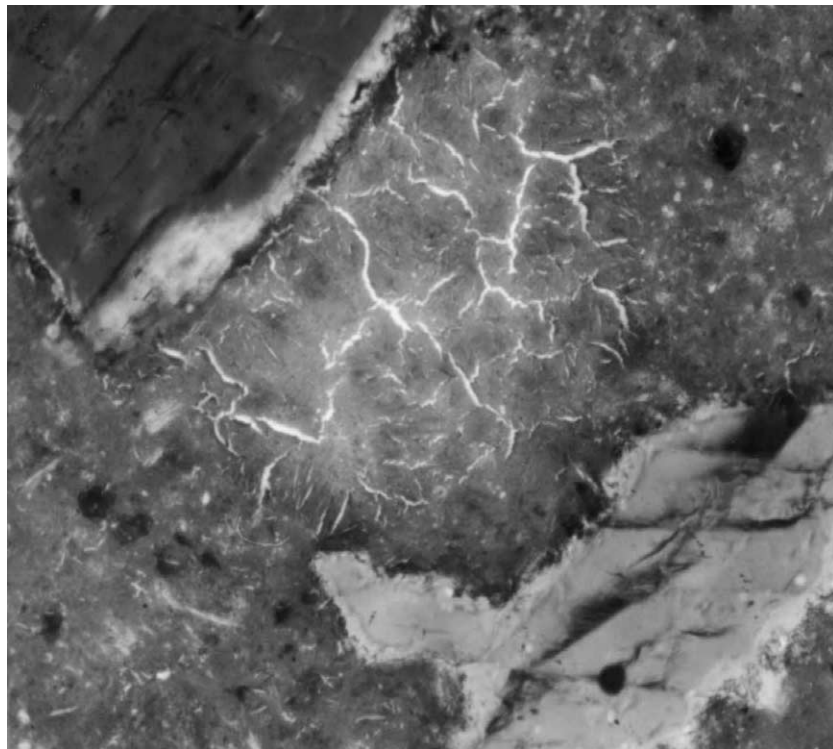
Fig. 4 shows a polarized light optical micrograph of ettringite deposits in association with thaumasite in an entrapped air void. Thaumasite differentiated from ettringite by its high birefringence and feather-like morphology. Figs. 5 and 6 are BSE images of the same location as shown in the optical micrograph in Fig. 4. Fig. 5 shows the composition of ettringite in the air void. Though the composition is quite consistent with ettringite, there is a significant amount of silica in the structure. Silica in ettringite has been described in the literature [13,14]. The other portion of the deposit is consistent with thaumasite. The morphology of ettringite is clearly different from that of thaumasite in the same air void. Ettringite has a needle-like structure, whereas thaumasite has a feather-like morphology and finer in structure. The occurrence of thaumasite and ettringite together and silicon-rich composition of ettringite suggests that ettringite is transforming into thaumasite or

Fig. 4. Optical micrograph showing deposits of thaumasite in association with ettringite (crossed polarized light, 200X).

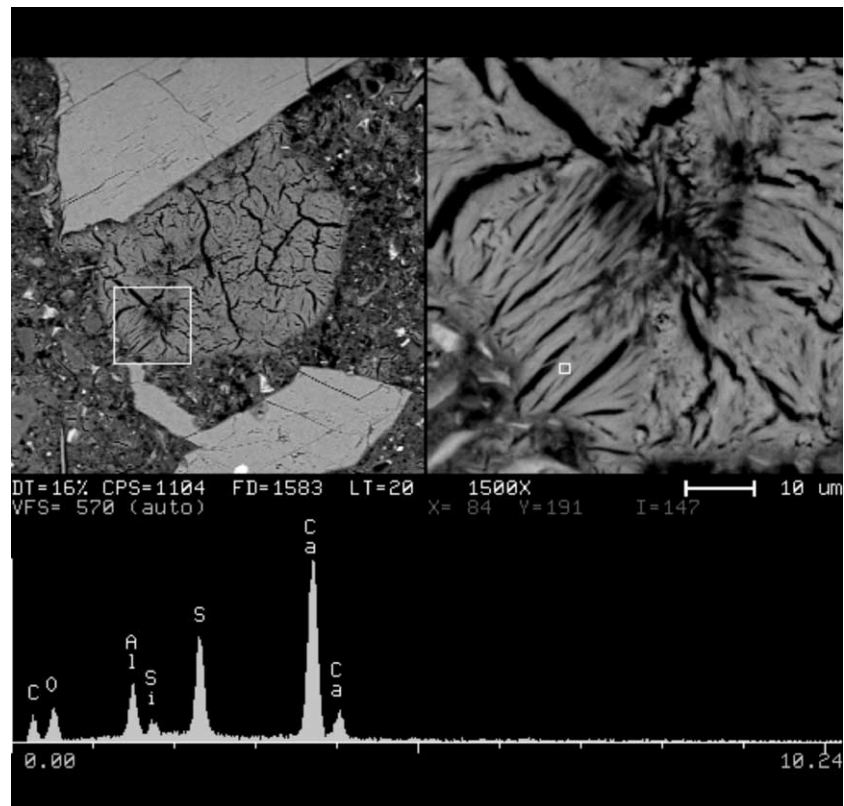
Fig. 5. BSE image showing deposits of ettringite in association with thaumasite in an entrapped air void (same area as Fig. 4).

that a limited solid solution series exists between the two minerals. This observation is consistent with the earlier hypothesis that ettringite is destroyed or ettringite is the nucleating site for thaumasite formation [15].

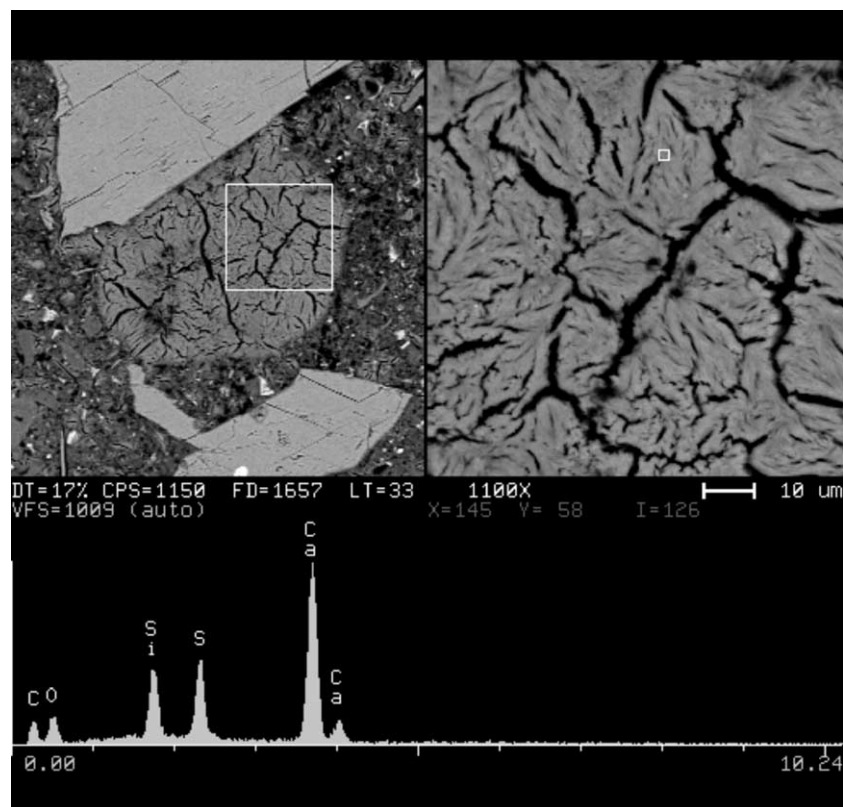
Fig. 6. BSE image showing deposits of thaumasite in association with ettringite in an entrapped air void.
