Deterioration of mortar caused by the formation of thaumasite on the limestone cladding of some Slovenian railway tunnels

Abstract

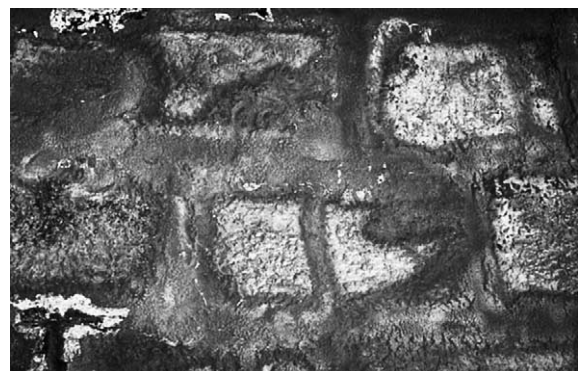
The ready-mixed repair mortar was applied by machine. According to the requirements of the design documents, this mortar should have been applied to the joints between the cladding stones to a thickness of between 2 and 5 cm. However, taking into account the appearance of the repaired surfaces it appears that the

mortar did not have satisfactory consistency and therefore had a tendency to run down the surface of the limestone blocks (see Fig. 1).

Fig. 1. Inappropriate consistency and application of repair mortar covering. It can be seen that the layer of repair mortar covers not only the joints but also the limestone blocks. Development of the reaction is best seen in the lower left corner of the figure.

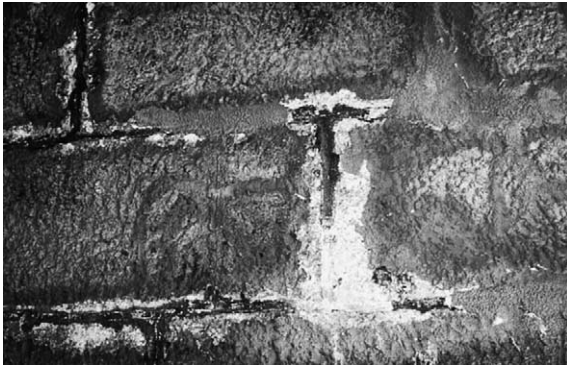
On the walls of the tunnels various types of damage were observed such as the swelling and flaking away of the mortar from the surfaces of the stone and the mortar joints. It is clear that the reaction has taken place on the inner side, at the jointing areas between the stone cladding and repair mortar or mortar joints and repair mortar. At these locations the repair mortar, which in its hardened state is usually of a dark grey colour, has changed into a soft, white mushy powder (see Fig. 2). At those locations where there is greater dampness, a light-grey mud, often in kidney-shaped clumps, can be observed.

Fig. 2. Degradation products of the repair mortar. On the dry sites, a white mushy powder can be seen.

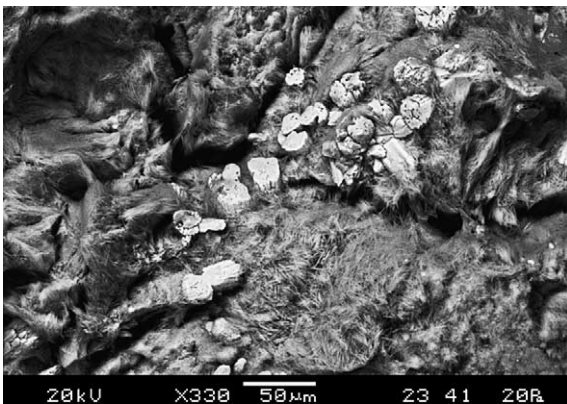
On the SEM images it is possible to see what the failed repair mortar looks like. From a typical image (see Fig. 3) it is clear that the preserved minerals of portlandite are surrounded by masses of thaumasite needles. The second way in which thaumasite occurs is in the form of roundish agglomerations, up to 0.4 mm in size, as can be seen from Fig. 4. In Fig. 5, which shows a magnified region of the previous image, fine white acicular crystals of thaumasite, with dimensions of up to maximum 5 μm length and 1–2 μm width, can be seen well. The spectrum of the semiquantitative chemical analysis of the crystals is presented in Fig. 6.

Fig. 3. SEM image of sulfate-attacked inner layer of the repair mortar, showing portlandite crystals surrounded by masses of thaumasite needles.

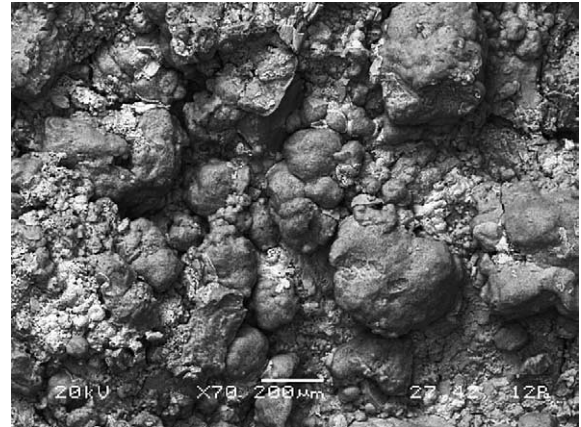
Fig. 4. SEM image of thaumasite in roundish agglomerations.

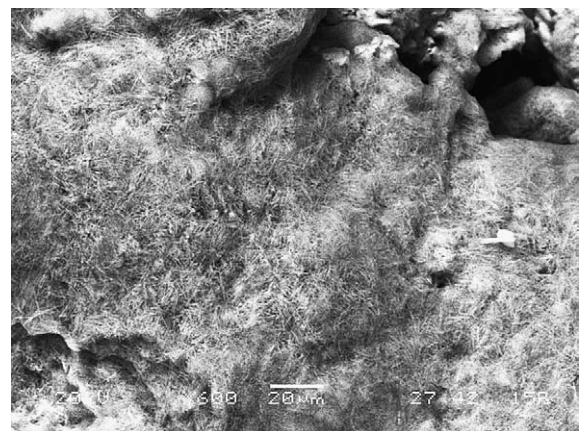
Fig. 5. SEM image of the thaumasite shown in Fig. 4, at a higher magnification.

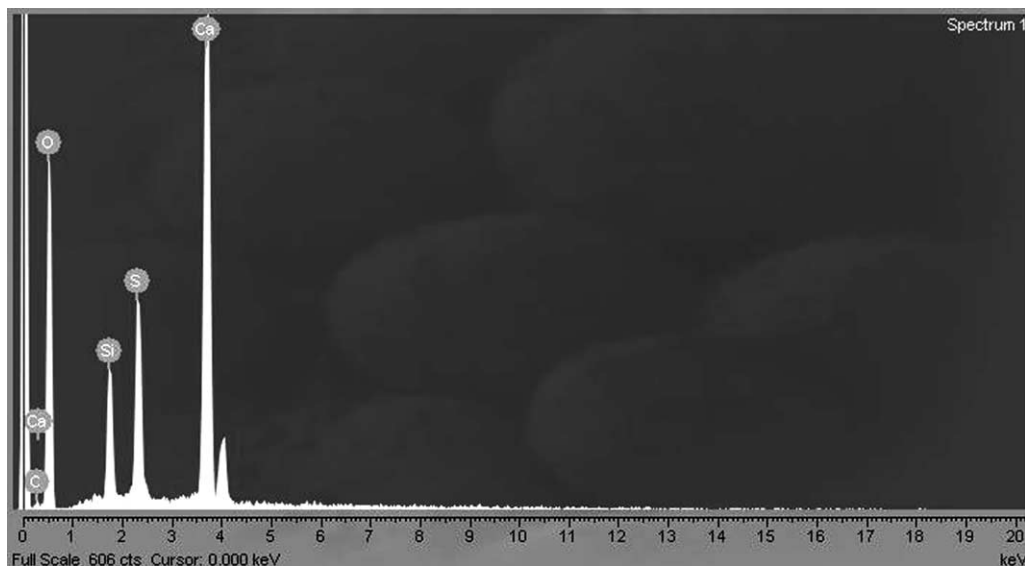
Fig. 6. Spectrum corresponding to the semiquantitative analysis of the fine acicular crystals.

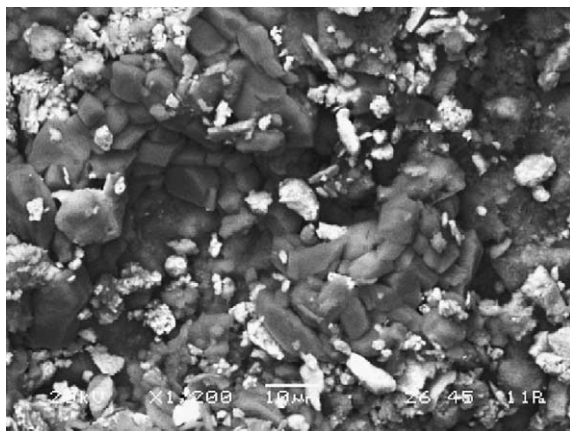
The images obtained using SEM analysis showed a large number of particles, containing iron, some carbon, and mostly a lot of well crystallized gypsum in the form of monoclinic crystals (see Fig. 7).

Fig. 7. SEM image of the outer layer of the degraded repair mortar. Monoclinic crystals of gypsum can be observed.
