# Thaumasite attack on concrete at Marbjerg Waterworks

Kirsten Eriksen \*

*COWI A/S, Parallelvej 2, DK-2800 Lyngby, Denmark*

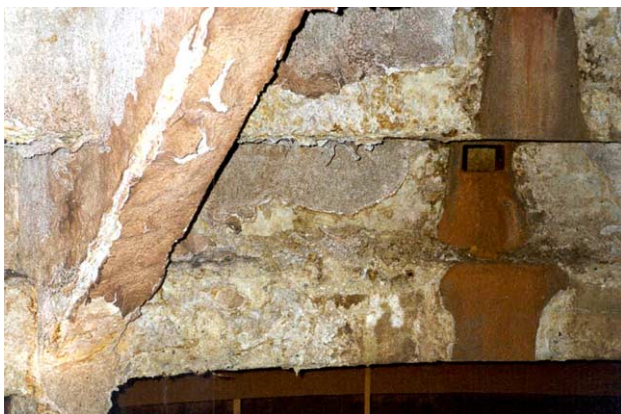
- Extensive spalling/exfoliation from 5–6 to 10–12 mm depth below the original surface was noted on most concrete surfaces in the space above the normal water table, including top of columns.

- The surface material was soft and greasy, whitish to brownish, and could easily be peeled off. The material contained sand and small aggregate particles with no adhesion to the binder. The material gave a colourless reaction to phenolphthalein.

Fig. 1. Concrete ‘dome’ with surface spalling, below the oxidation stairs.

The sulfuric acid attack at the surface is the first part of the attack. A probable explanation to this attack was considered to be oxidation of hydrogen sulfide, absorbed in the moist film on surfaces, and converted to

A repair solution with a new sacrificial mortar layer of low *w/c*-ratio was decided for the next 65 years—combined with regular inspections.

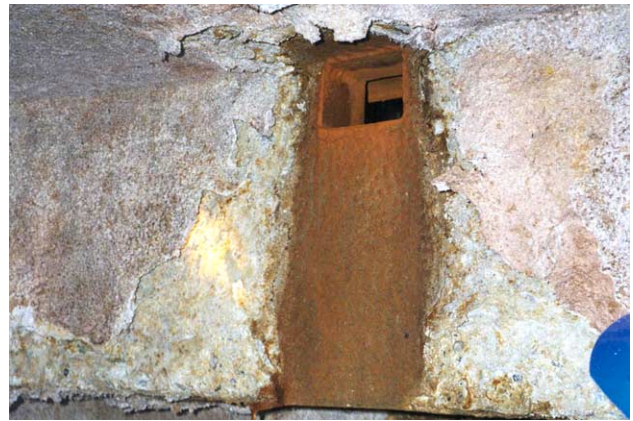
- No signs of reinforcement corrosion were noted, the reinforcement still being embedded in undamaged concrete.
- Spalling was not observed at places where water flowed back into the concrete tank, seeping down the walls from small pressure equalising windows.

Fig. 2. No spalling observed below window where the concrete is continuously wet.

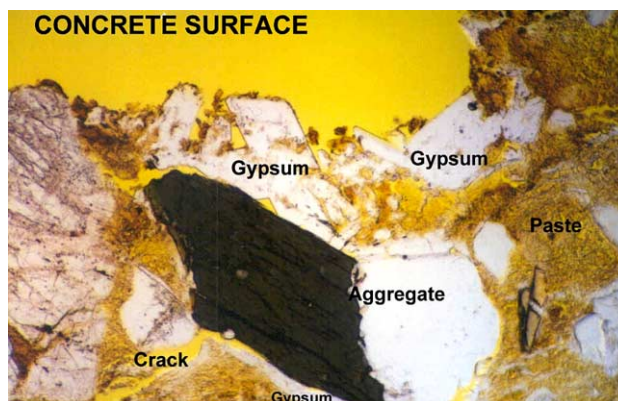
- In the outer 2–3 mm gypsum has formed in cracks around aggregate particles, in cracks through aggregate particles, and in cracks through the paste.

All the cracks run parallel to the surface. There is no calcium hydroxide left in the paste. The concrete is in a very bad condition due to acid attack and paste expansion; all cement particles have been more or less dissolved.

Fig. 3. Concrete surface with gypsum crystals in paste and in cracks. Photo size 1 × 1.5 mm.

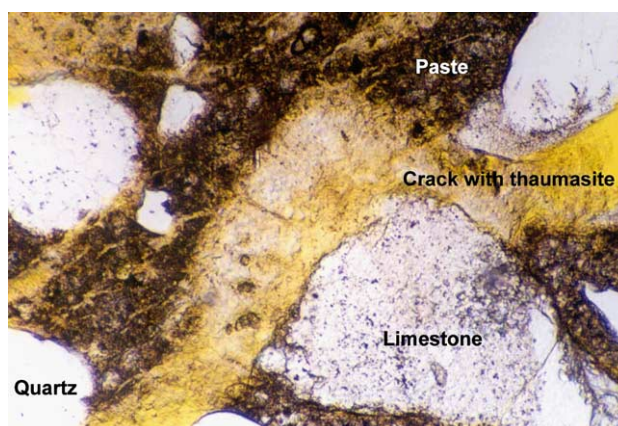
Fig. 4. Crack filled with thaumasite crystals, ≈4 mm below the surface. Photo size 0.6 × 0.9 mm.

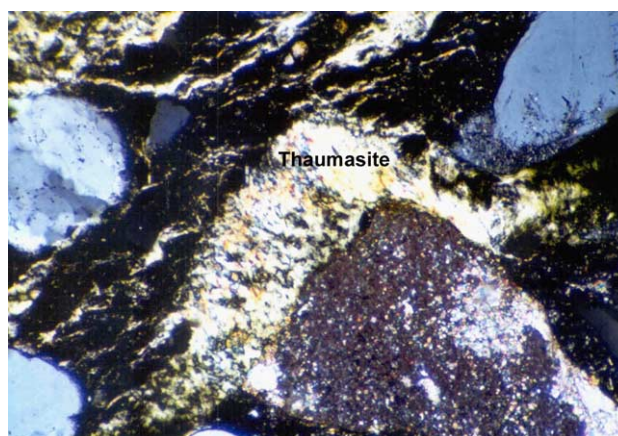
Fig. 5. Same as photo 4, crossed nicols. High birefringence of thaumasite is seen in coarse crack and also in fine veins through the cement paste.

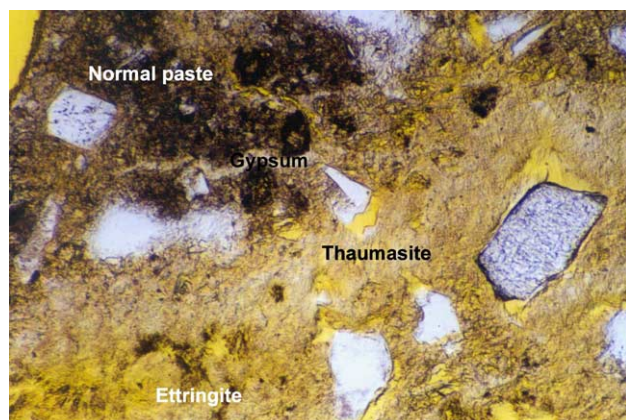
Fig. 6. Gypsum in finer cracks, thaumasite in large and finer cracks, and ettringite in porous paste. Photo size 0.6×0.9 mm.

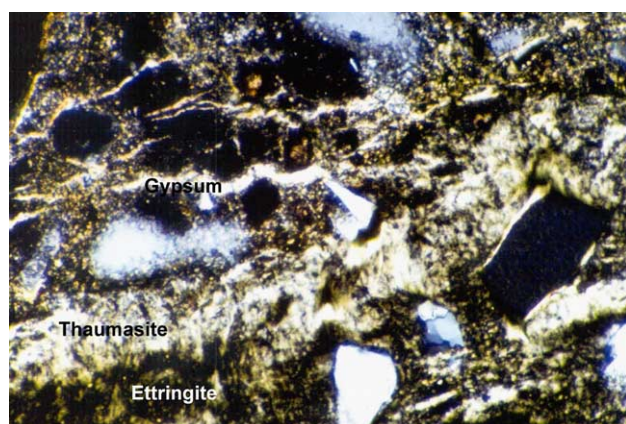
Fig. 7. Same as Fig. 6, crossed nicols.
