Thaumasite: evidence for incorrect intervention in masonry restoration

Valeria Corinaldesi, Giacomo Moriconi *, Francesca Tittarelli

Department of Materials and Environment Engineering and Physics, Marche Polytechnical University, Via Brecce Bianche, 60131 Ancona, Italy

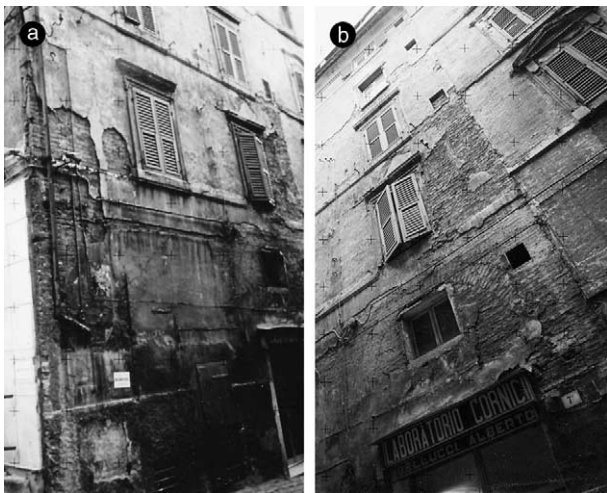
Fig. 1. Deterioration of the rendering mortar caused by ettringite (a) and thaumasite (b) formation in a building located in the historical centre of Ancona.

In relation to aggressive exposure, the former building, in spite of repeated interventions for transformation and maintenance, does not show particular deterioration. This is due to the employment of gypsum as a binder, which was mainly used in internal mortars during reconstruction after the damages of the second world war, and to the particular capillary rise of water from foundations. However, the external rendering mortar exhibits severe deterioration, apparently attributable to ettringite and thaumasite formation from a morphological point of view, since sharply detached mortar (Fig. 1a) is observable close to smooth removal of the same mortar (Fig. 1b), which is evidence of these products.

As a concluding remark, when repair or restoration interventions are to be made on masonry walls in which gypsum, ettringite and thaumasite are detected, a sulfate resistant binder should be used and precautions should be adopted in order to block water permeation of masonry.

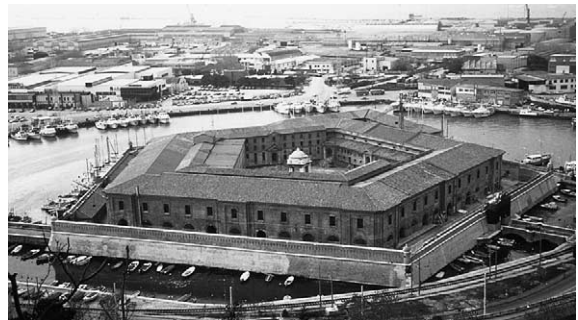
Fig. 2. The Vanvitelli's Mole in Ancona.

In contrast, the Vanvitelli's Mole certainly appears more exposed to the deteriorating action of marine environment as a whole, particularly due to the remarkable capillary rise of sea-water through its masonry walls. As a matter of fact, in this case severe deterioration in the form of widespread hollowed joints and detached rendering mortar is observable.

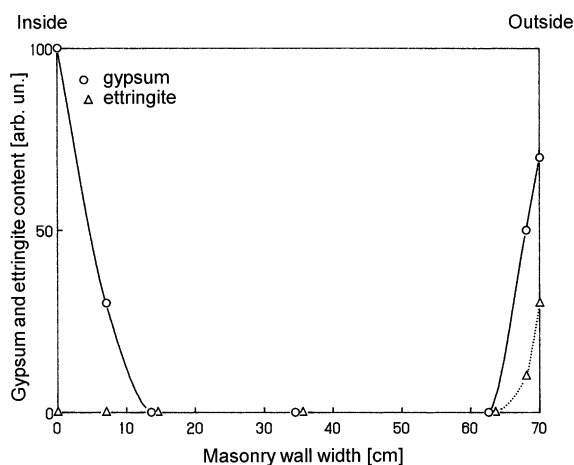
The results obtained from X-ray diffraction analysis on samples taken from the building shown in Fig. 1 allowed concentration profiles of gypsum and ettringite to be drawn along the cross section of the wall thickness, reported in Fig. 3. The presence of gypsum in the samples of jointing mortar removed from inside just behind the plaster, made of gypsum and sand, can be attributed to migration phenomena supported by thermo-hygro-metric changes. On the contrary, the presence of gypsum together with ettringite in the samples removed from the outside of the masonry wall is evidence of the hydraulic nature of the binder used to prepare the rendering mortar. This is valid for both the originally employed hydraulic lime or lime–pozzolan blend, or even for the cement used during later and more recent interventions of plaster resumption and maintenance. On the other hand, the total absence of thaumasite in these samples could mean that, if formed, it was washed out by at-

Since no significant capillary rise of water was observed in the masonry, the presence of ettringite in the external plaster and its related deterioration could be attributed to sulfate attack from the environment.

Fig. 3. Gypsum and ettringite content profile through cross section of masonry walls of the building shown in Fig. 1.

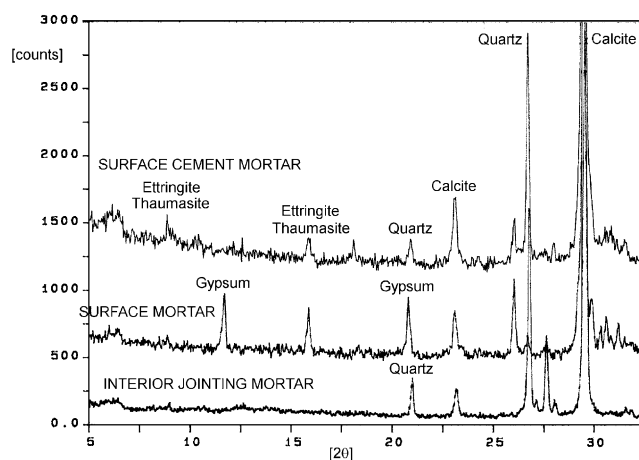
Instead, X-ray diffraction analysis carried out on samples of jointing mortar removed from masonry walls of the Vanvitelli's Mole, reported in Fig. 4, showed that

- the interior jointing mortar contained quartz and calcite, typical constituents of mortar made of lime and sand;
- the external jointing mortar (corresponding to the joints on the facade surface) contained gypsum and calcite, whereas the absence of quartz in it could mean that, during construction or even old repair works, sand was replaced by pozzolan in order to ensure durability of external joints;
- the external jointing cement mortar (so called because of the presence in it of anhydrous cement constituents), believed to be applied during recent interventions of repair and maintenance, contained calcite, quartz, ettringite and thaumasite.

Fig. 4. X-ray diffraction results obtained on jointing mortars picked up from masonry walls of the Vanvitelli's Mole.

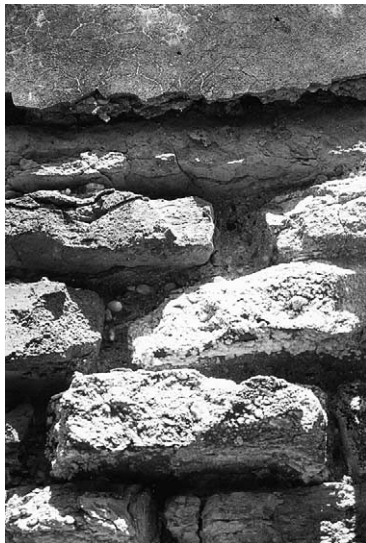
Moreover, gypsum, ettringite and thaumasite were also found in samples of deteriorated plaster (Fig. 5), almost certainly made with cement since it was detected in the rendering mortar. Again, the deterioration origin could only be an aggressive environment. Without neglecting marine spray, which has always accompanied the life of the building, deterioration has rapidly increased in the last decades, corresponding to an increasing content of sulfur dioxide in the atmosphere. This environmental attack is detrimental for cement

Fig. 5. Deterioration of rendering mortar of the Vanvitelli's Mole.
