# Thaumasite swelling in historic mortars: field observations and laboratory research

R.P.J. van Hees<sup>\*</sup>, T.J. Wijffels, L.J.A.R. van der Klugt

*TNO Building & Construction Research, P.O. Box 49, 2600 AA Delft, Netherlands*

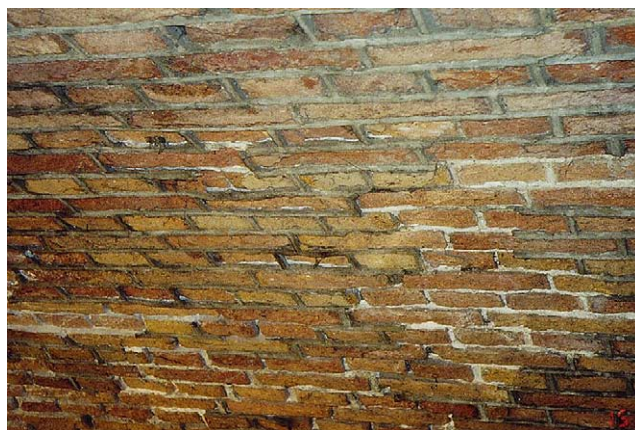
The damage mainly occurred in the vaults, where push out of the (cement based) re-pointing and chipping of bricks occurred (Fig. 2).

Fig. 2. Damage to masonry in vault intrados (case study 1).

The formation of thaumasite was due to the use of hydraulic lime as a binder and the ingress of water from the bridge deck and of (1) sulfate originating from the low fired brick used in the internal part of the masonry

and of (2) sulfur oxides from the exhaust gases of the diesel-driven engines of the tourist boats; the formation of monochloride was due to the use of hydraulic lime as a binder and the ingress of chlorides from de-icing salts through the bridge deck before it was replaced by a concrete deck.

As a repair measure, in the first place the ingress of water should be prevented. Further all cement based re-pointing mortar and the decayed part of the bedding mortar should be replaced. The use of cement rich in tricalcium aluminate or hydraulic lime should be avoided in the new re-pointing mortar. Blast furnace slag cement

(bfc) or highly sulfate resistant portland cement could be considered for conservation and the mortar should be applied as a deep re-pointing.

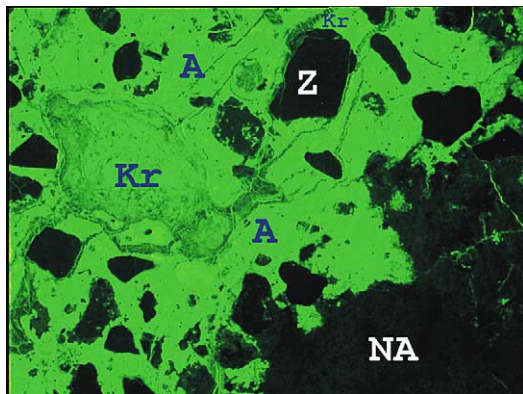
Fig. 4. PFM picture (fluorescence: 2.7×1.8 mm). Concentration of thaumasite. Cracks filled with needle like salt crystals are growing from the concentration. The binder around has suffered from dissolution, which can be seen from the colour (clear difference with the darker colour of the not decayed binder in the right, lower corner of the picture). Z=aggregate; Kr=crystal concentration (thaumasite); A=decayed zone; NA=not decayed zone. (For interpretation of the references in colour in this figure legend, the reader is referred to the web version of this article.)

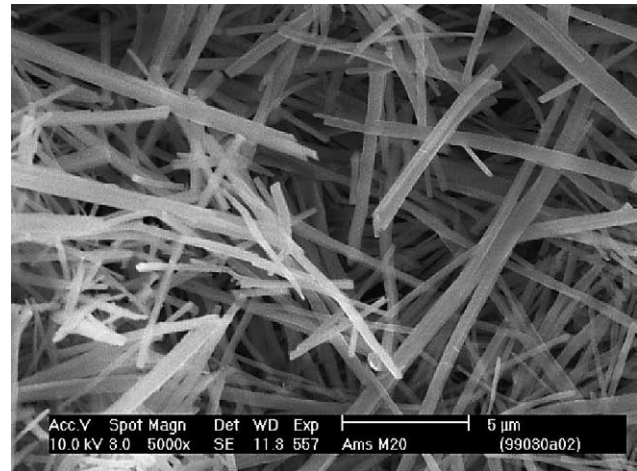
Fig. 5. SEM picture. Massive thaumasite cluster in the binder of the mortar (case study 1).

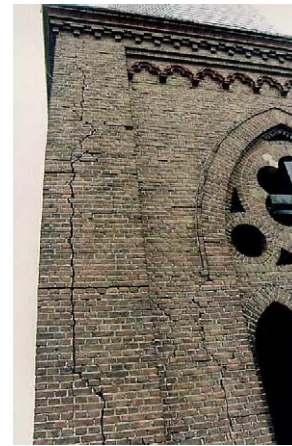
Fig. 6. Church tower (Noordwijk), case study 2, with both vertical and horizontal cracks.

In the case of the church tower the vertical cracks can easily be mistaken for structural cracks. However it was shown that the damaging mechanism consisted of thaumasite formation. The diagnosis was that the backing brick was rich in sulfate. Due to ingress of rain water this sulfate migrated into the bedding mortar of the backing masonry. Here, the sulfate reacted with constituents of the lime-cement to form thaumasite and ettringite.

An important consideration for the repair is that the backing masonry is still rich in soluble sulfate and practically no means exist to reduce the ingress of rain water.

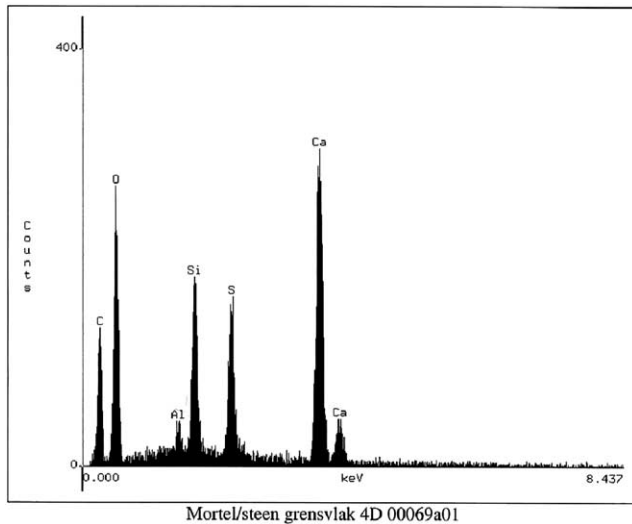
The presence of those compounds was found using polarising and fluorescent microscopy and SEM/EDAX analysis [2], see Figs. 7–10. These new compounds with large(r) volume made the bedding mortar and thus the backing brickwork expand. The expansion of the backing masonry caused the cracks in the non-expanding exterior masonry.

Fig. 7. EDAX-spectrum of mortar-brick interface showing presence of elements of thaumasite, ettringite and maybe calcium silicate (case study 2).

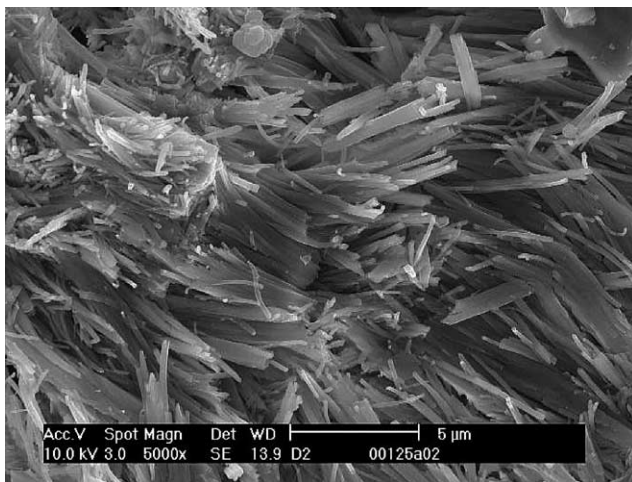
Fig. 8. SEM picture of the thaumasite in the mortar (case study 2).

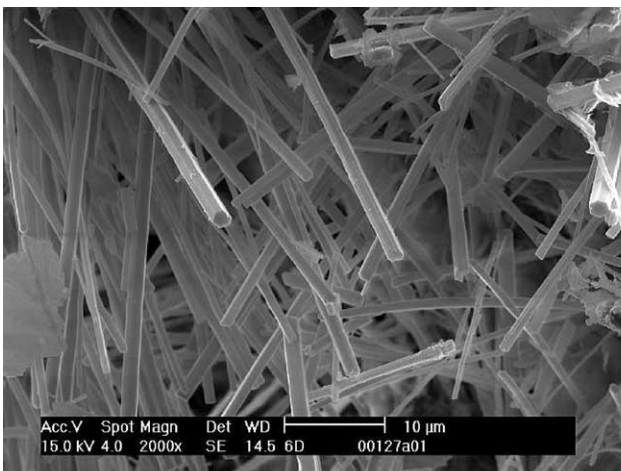
Fig. 9. SEM picture of the ettringite in the mortar (case study 2).

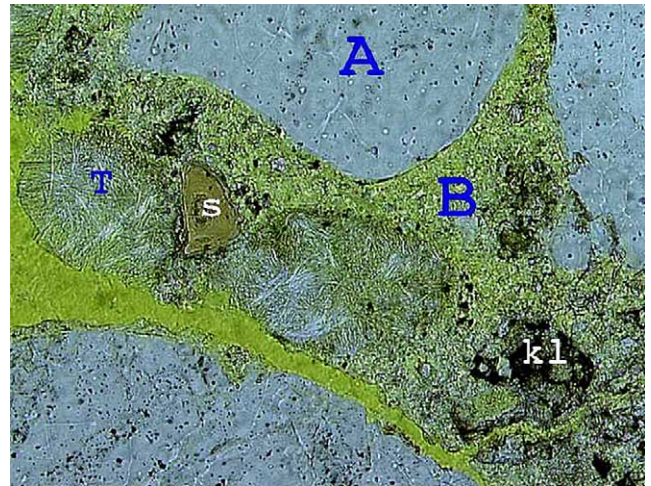
Fig. 10. PFM picture, case study 2. Cluster of thaumasite (T) and crack (solid yellow, i.e. void filled with resin from thin section preparation). B = binder, kl = clinker, s = blast furnace slag, A = aggregate. (For interpretation of the references in colour in this figure legend, the reader is referred to the web version of this article.)

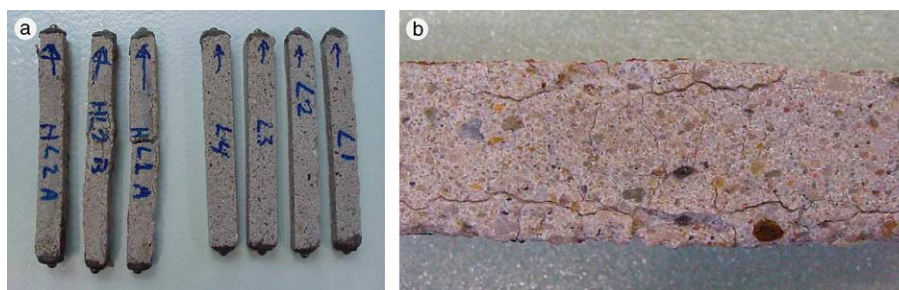
The results of the test on the prisms are shown in the Figs. 11–13. Fig. 11(a) and (b) shows the prisms after 15 weeks of submersion in a 3% sodium sulfate solution; the prisms made with hydraulic lime showed an expansion and a deformation as well as cracks. After 15 weeks of submersion in the sodium sulfate solution, the hydraulic lime prisms started to crumble. The cause of the crumbling was the formation of thaumasite. The presence of thaumasite was assessed, using X-ray analysis and SEM (see Fig. 13).

Fig. 11. (a) Mortar prisms after 15 weeks in a sulfate solution. Hydraulic lime based specimens showed expansion and deformation. Hydrated lime in combination with bfc did not show any expansion. HL = hydraulic lime, to the left; L = hydrated lime in combinations with bfc, to the right. (b) A detail of one of the hydraulic lime specimens is given.

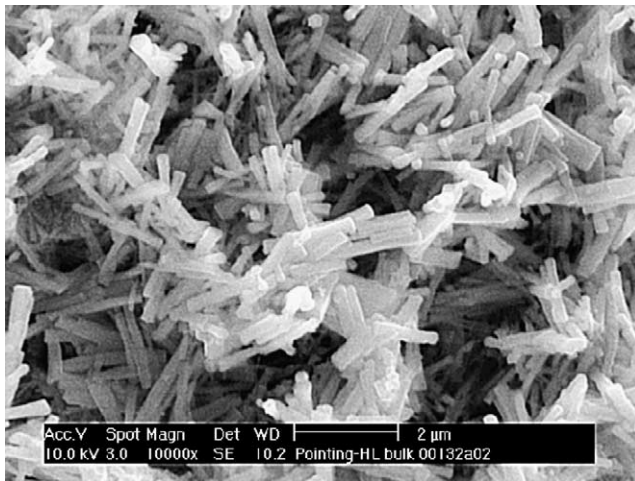
Fig. 13 is a SEM picture of the thaumasite as it was found in the hydraulic lime prisms; it shows the thick needles of thaumasite present in the pores of the crumbled mortar.

Fig. 13. SEM picture of thaumasite in mortar prism based on hydraulic lime.
