# Steam locomotive soot and the formation of thaumasite in shotcrete

M. Romer \*

*Swiss Federal Laboratories for Materials Testing and Research (EMPA), Laboratory for Concrete and Construction Chemistry,  
CH-8600 Duebendorf, Switzerland*

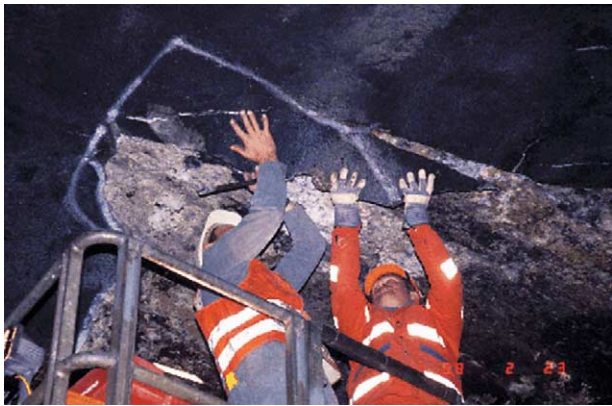
The inspection of the tunnel revealed several regions where the shotcrete was either detached and came off its support or where areas of concrete up to several square meters had already broken off. The fracture plane

Fig. 1. Location 42/154 with larger areas of loose shotcrete (dark due to a soot layer on the surface) and parts of the lining already broken off. Dripping ground water could be sampled on the clean masonry behind the technicians.

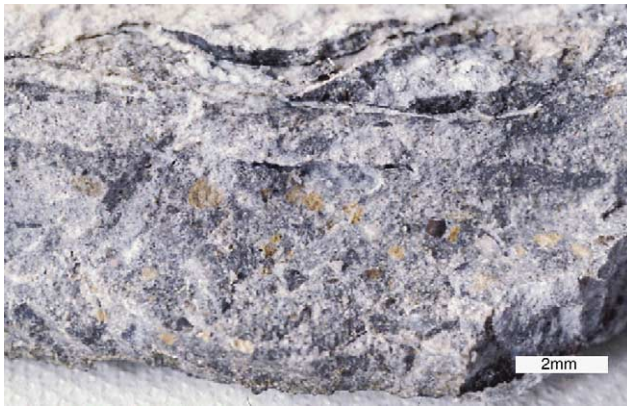
Fig. 2. Fracture surface through shotcrete lining showing several contact parallel bright textures in the shotcrete (tunnel surface at the bottom).

perpendicular to the lining showed one or more distinct bright layers at the rear of the shotcrete cutting through the concrete in a more or less parallel orientation to the support (Fig. 2) up to 15 mm inside the concrete. The back surface of freshly removed shotcrete samples was partly covered with a soot-like, black layer (Figs. 3 and 4). Within larger layers of whitish material its low strength could be recognised.

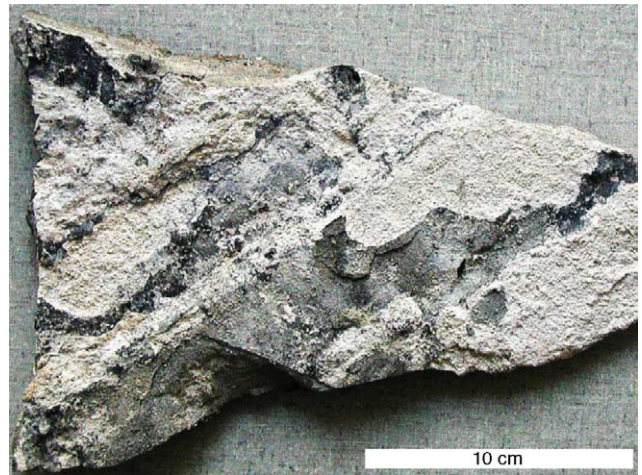
Fig. 3. Rear surface of the lining showing layers of soft, whitish material in the shotcrete and relicts of dark soot representing the original interface of masonry and shotcrete.

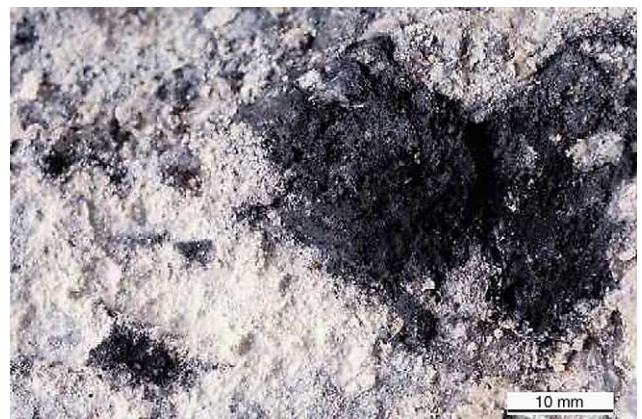
Fig. 4. Surface detail of shotcrete interface to stonework with soot relicts (black) next to soft alteration products (whitish) of the concrete.

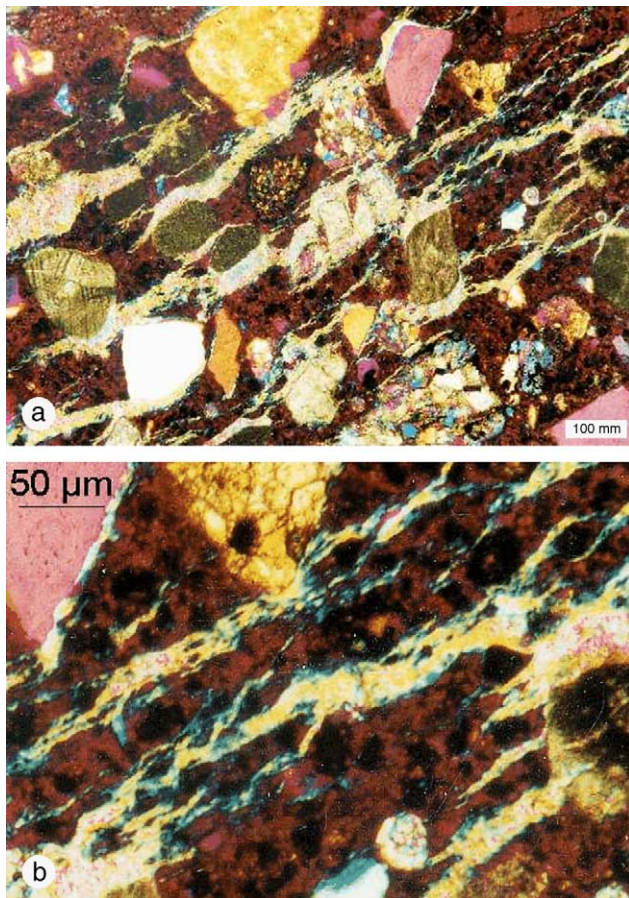
Fig. 5. Thin section (crossed polars) of shotcrete close to the rear surface, orientation perpendicular to the shotcrete lining. The dark colour of the hardened cement paste together with lack of small birefringent components indicates, that the cement paste is leached. Swarms of microcracks have been formed parallel to the shotcrete support and are filled with secondary minerals (thaumasite). Aggregate particles of different mineralogical composition show no sign of alteration.

The occurrence of larger and also slender cracks next to each other or turning into each other and forming swarms of microcracks indicates a continuous process of crack formation and widening. The fact that all these different generations of microcracks are filled with the same kind of secondary product (thaumasite) leads to the conclusion, that the secondary product is involved in the build-up of stress and the initial formation of the cracks. The formation of finely distributed thaumasite in the matrix of the hardened cement paste is therefore postulated as main deterioration mechanism.

Alteration of hardened cement paste of shotcrete into thaumasite is responsible for the detachment of the shotcrete from its support (stonework tunnel lining). It is concluded that over several decades the contact between shotcrete and weakly mineralised groundwater led to leaching of the hardened cement paste and subsequently to the formation of thaumasite in the shotcrete up to 15 mm from the contact with the support or more precisely with the percolating water.
