Effects of natural weathering on microstructure and mineral composition of cementitious roofing tiles reinforced with fique fibre

G.H.D. Tonoli^{a,*}, S.F. Santos^b, H. Savastano Jr.^b, S. Delvasto^c, R. Mejía de Gutiérrez^c, M. del M. Lopez de Murphy^d

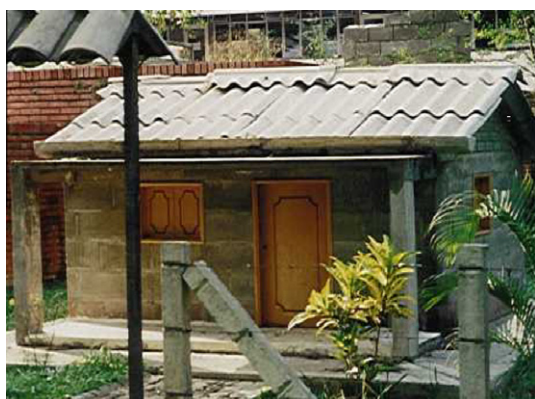
Fig. 2. Small prototype house roof structure.

Despite of being exposed to the weather, there is no visible sign of decay in the corrugated sheets, which have been mounted on a small prototype house roof structure. Until now, the roof stability and shape are maintained. It was observed a tendency of high real density of the matrix of tiles under natural weathering exposition (Table 3). This could be the consequence of the formation of additional crystalline cementitious phases in these tiles.

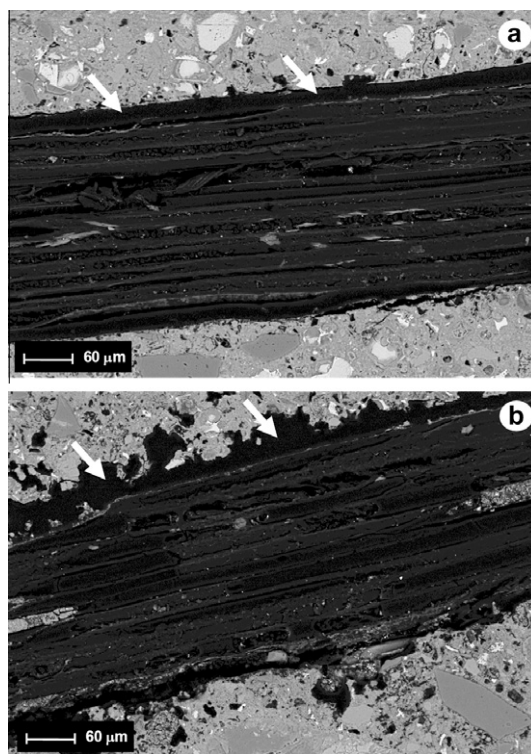
In Fig. 3 it is presented the consequence of weathering exposition of the tiles on the fibre–matrix interface (transition zone). The fibres are placed longitudinally and they are detached from the matrix (arrows) due to the shrinking upon drying. The fibre to matrix interface in weathering exposed tile (Fig. 3b) was much damaged in relation to the fibre to matrix interface in the tiles aged in laboratory (Fig. 3a). As reported by Savastano Jr. et al. [10], this damage in the interface is provoked by stresses during the fibre volume changes under continuous alternation of wetting, drying and carbonation in the tiles exposed to natural weathering. Matrix microcracking close to the fibres generates greater spaces or pores on the transition zone of tiles exposed to weathering, which also explains the higher porosity found in these tiles in relation to laboratory aged tiles (Tables 4 and 5).

Fig. 3. Back scattering electrons (BSE) image of the fibre to matrix interface (arrows) in 14 years old tile: (a) aged in laboratory, and (b) under natural weathering exposition.

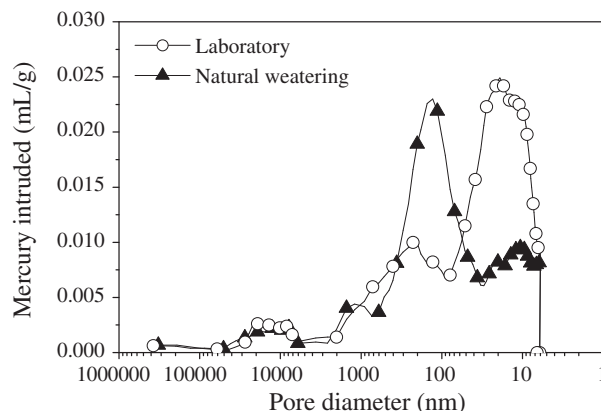
Fig. 4 presents the pore size distribution curve of the specimens from laboratory and natural weathering exposition. The peak between 10 nm and 100 nm is related to the cement paste (matrix) and the peaks between 100 nm and 1000 nm are capillary pores resulting from the manufacturing process. The amount of voids inside the fibre strands and cellulose fibres in fibre–cement actively influences the peak between 100 nm and 1000 nm [16], but can also be related to the pores in the fibre to matrix interface (transition zone) (Fig. 3b). Weathering exposed tile revealed a coarsening of pores greater than 100 nm in comparison with the tile aged in laboratory (Fig. 4). Coarsening has been associated to the SiO₂ (gel) formation during carbonation of C–S–H [17] and leaching of the cement matrix [18] or unstable phases of carbonates [19].

Fig. 4. Pore size distribution for specimens aged in laboratory and under natural weathering exposition.

During the weathering exposition the continuous hydration of the cement led to the reduction of matrix voids (densification showed in Table 3). Natural carbonation filled the small pores (below 100 nm) in the matrix, but remained the large pores, which increased the average pore diameter, as described by Mehta and Monteiro [12].

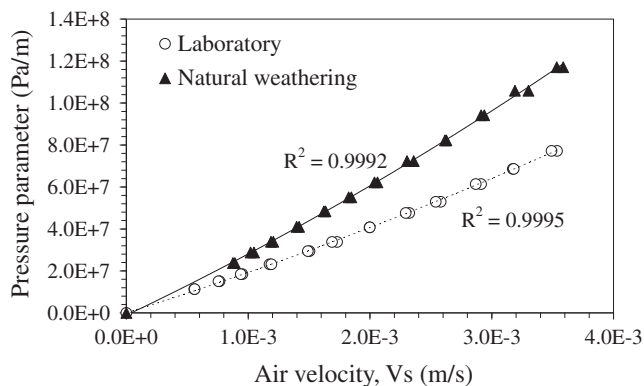
The air permeability is a physical property of extreme importance to the development of durable elements to civil construction. The permeability can be associated with the resistance to the penetration of degradation agents and also with the microstructure properties (e.g. particle packing and permeable pores). In Fig. 5 it can be observed that higher pressure is necessary to the same air velocity in the tiles aged under natural weathering exposition. Furthermore, the k_1 and k_2 values decreased in the case of tiles under natural weathering exposition in relation to laboratory exposition (Table 6). The decrease of k_1 indicates that friction and interactions between fluid and porous media increased [19]. The non-Darcian constant, k_2 , decreased in the case of natural weathering exposition, which can be interpreted as the increase of the tortuosity of the porous structure [19].

Fig. 5. Forchheimer's equation fitted to experimental data of specimens aged in laboratory condition and under natural weathering exposition according to the expression for compressible fluids.

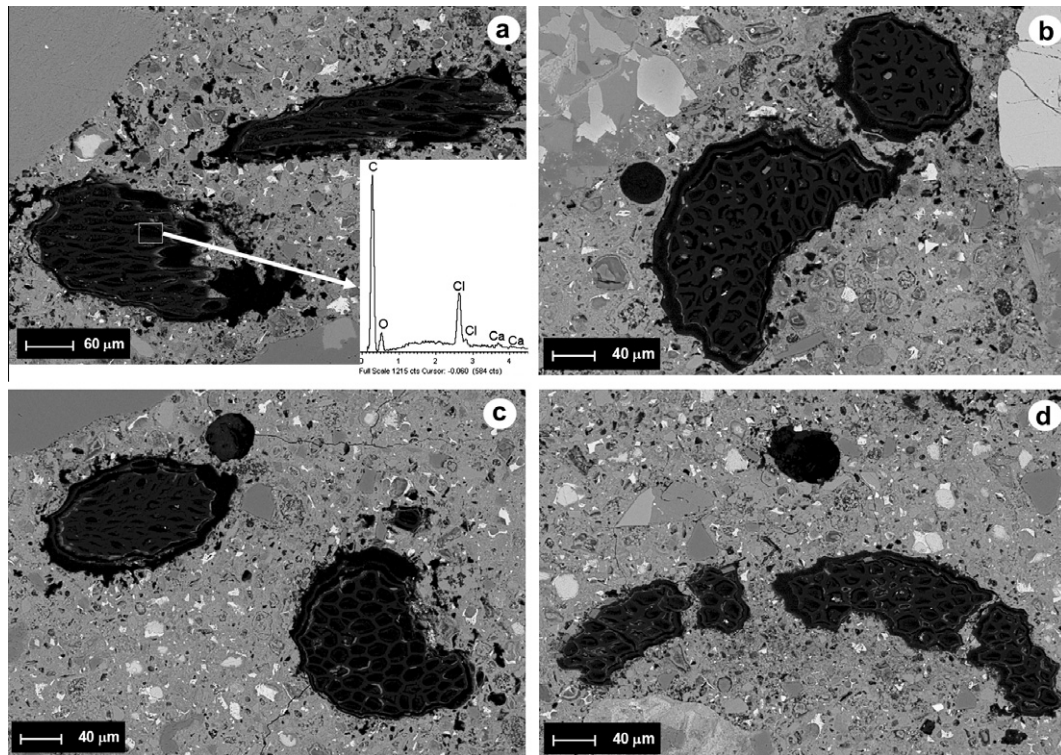
Fig. 6 presents SEM-BSE micrographs of the fibre cross-section in tiles aged in protected environment (laboratory). It can be seen

in Fig. 6a the energy dispersive X-ray spectroscopy (EDS) analysis indicating that the fique fibre was almost free from cement hydration products (for example, phases rich in calcium).

Fig. 6. SEM, back scattering electrons (BSE) image of the cross-sectioned figue fibre in 14 years old composite aged in protected environment (laboratory). EDS spectra was done in the fibre lumen.

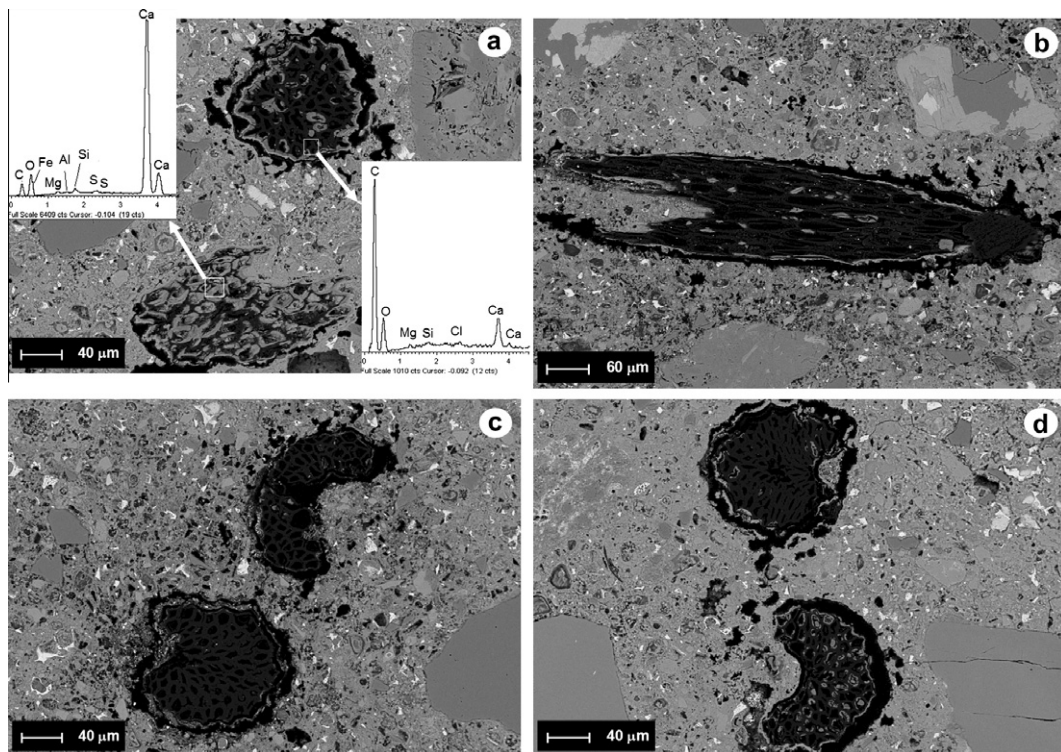
In the tiles aged under natural weathering (Fig. 7), it is evidenced the calcium re-precipitation both in the fibre surroundings (fibre–matrix interface) and into the fibre cavities (lumen). Fig. 7a depicts the EDS spectra into the fibre cavities showing the higher presence of calcium in comparison to Fig. 6a. In the tiles exposed to the natural weathering the rain water absorbed by the tiles led to the dissolution of some soluble cement hydration products in the bulk of the tiles. Part of these cement products was then carried out by the water and deposited into the fibre cavities, leading to the accelerated mineralization and loss of fibre flexibility. Additionally, after 14 years of weathering exposition some changes in the fibre chemical composition can be expected, as the reduction in the amount of lignin and hemicellulose [22], which also decreases the fibre strength.

Fig. 7. SEM, back scattering electrons (BSE) image of the cross-sectioned figue fibre in 14 years old composite, aged under natural weathering exposition. EDS spectra was done in the fibre lumen.

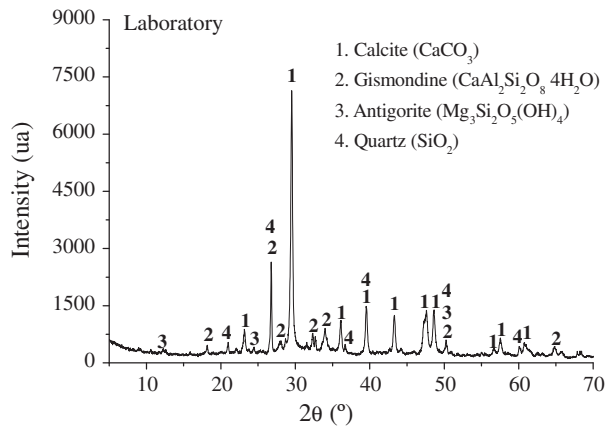
Fig. 8 depicts the main cementitious phases (detected by X-ray diffraction) present in the tiles aged in the internal environment of the laboratory. Other additional hydration products were identified in the tiles aged under external or natural weathering exposition (Fig. 9), which can be attributed to the continued hydration process when exposed to the weather. Calcium hydroxide (Ca(OH)_2) was not identified in both tiles, regarding that 5% by mass is the limit of the sensibility of the equipment. Such a result indicates that in both tiles (aged in laboratory or under natural weathering) it was occurred the adsorption of CO_2 in the cement based matrix and the consequent formation of calcite (CaCO_3) as stated in Tonoli et al. [19].

Fig. 8. X-ray diffraction pattern of the tile aged in the internal environment (laboratory).

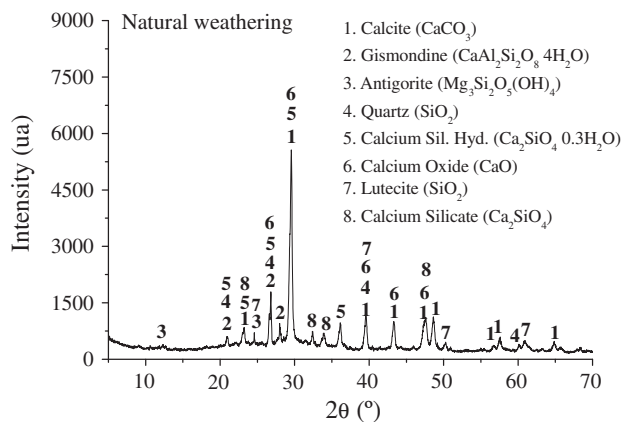
Diffuse peaks at 48.6° , 47.6° and 47.3° of both aged in laboratory and under natural weathering exposition, similarly to those reported by Cole and Kroone [23] confirmed the presence of poorly crystallized calcite. Anhydrous calcium silicate peaks were only found in the weathering exposed tile, as an indication that the matrix of this sample had not yet completely hydrated. The main peak of C–S–H (29.5°) is coincident with the main peak of calcite and calcium oxide in the specimen aged under natural weathering exposition. Peaks of high Ca/Si C–S–H [24] do not appear in the weathering exposed tile. Some cementitious phases (antigorite and gismondine) identified in the X-ray diffraction of the laboratory cured tile seem to be less stable in contact with the rainwater than calcite for example.

Fig. 9. X-ray diffraction pattern of the tile aged under external exposition.
