Using electrical, magnetic and acoustic sensors to detect damage in segmental concrete pipes subjected to permanent ground displacement

Mohammad Pour-Ghaz^{a,*}, Junhee Kim^b, Srinivasa S. Nadukuru^b, Sean M. O'Connor^b, Radoslaw L. Michalowski^b, Aaron S. Bradshaw^c, Russell A. Green^d, Jerome P. Lynch^b, Amir Poursaei^e, W. Jason Weiss^f

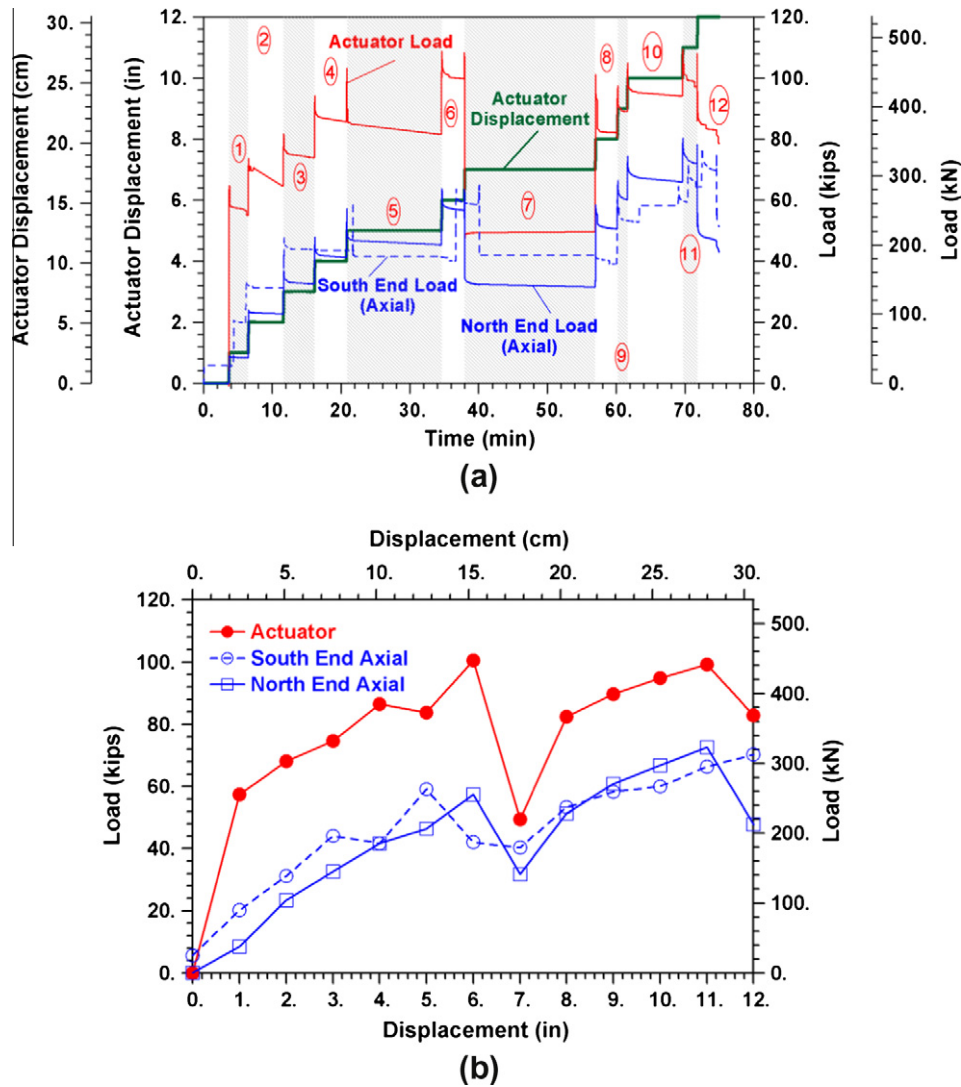
The average load in the actuators during the relaxation periods and the average axial forces measured by load cells at both ends of the test basin are plotted in Fig. 6b. This figure is useful for tracing the damage accumulation in the pipeline. The development of damage is accompanied with a dramatic reduction in load due to the increase of the compliance (loss of stiffness) of the system.

During the first four applied displacement steps the load in the actuators and at both ends of the pipeline increased with the displacement. During the fifth step, the load slightly decreased in the actuator and a slight increase in the end load was observed at both ends of the pipeline. A significant decrease in load is observed at the seventh displacement step indicating significant damage to the pipeline. Further decrease in load is observed in the twelfth step. It is noted that damage starts to accumulate in the pipeline from the first displacement step; however, it cannot be seen by only looking at the load–displacement plot as the damage up to the seventh step is not significant to increase the compliance of the system to affect the measured loads.

Fig. 6. Actuator displacement, load and the total load at the north (moveable) and south (fixed) end of the test basin.

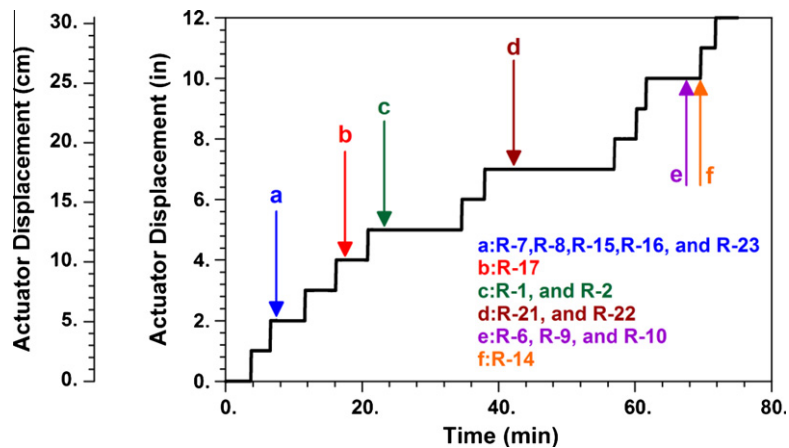
The rupture sequence of the CST sensors is shown in Fig. 7, along with the actuator displacement. Additionally, Fig. 8 shows the location and rupture sequence of the CST sensors on schematics of the pipe segments for six different fault displacements. The arrows in Figs. 7 and 8 indicate the rupture of a CST sensor.

Fig. 7. Sequence of signals received from conductive surface tape (CST) sensors in relation to the actuator displacement.

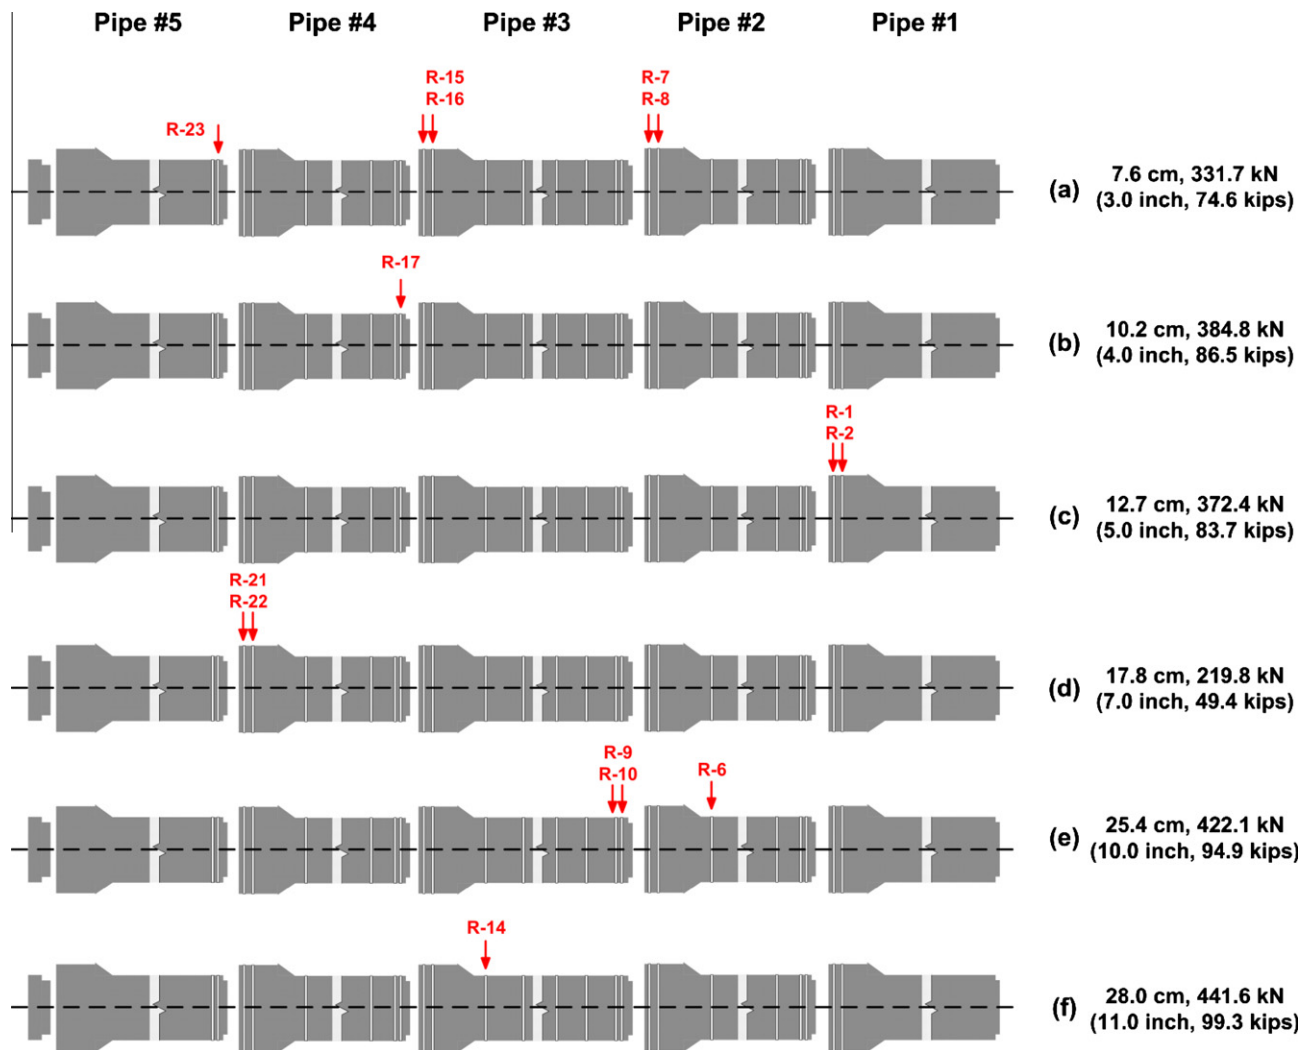
As may be observed from Figs. 7 and 8, significant damage occurred during the second displacement step in the bell sections of Pipe Segments 2 and 3 (Joints 2 and 3, respectively). This damage extended beyond 3.8 cm ($\approx 1\frac{1}{2} \text{ in.}$) on the bell section of both pipe segments since both sensors installed on the bell sections of Pipe Segments 2 and 3 detected the damage. The mode of damage that occurred is schematically illustrated in Fig. 9a and can be attributed to the relative rotation of the spigot inside the bell section.

With an increase in the displacement during the fourth step (Figs. 7 and 8), further damage developed at Joint 3 where R-17 is located (Fig. 8b). This damage is probably due to wedge-breaking action and did not extend beyond 1.27 cm ($\approx 1/2 \text{ in.}$). Up to the fifth step, the majority of the damage is localized at the joints in the vicinity of the fault line (i.e., Joints 2 and 3). Damage at this point began to occur at Joint 1. The signals slightly lag the displacement of the actuators.

During the tenth and eleventh displacement steps, damage started to extend beyond the joints and occurred in the body of Pipe Segments 2 and 3 (i.e., R-6 and R-14). These sensors were located 30 cm ($\approx 1 \text{ ft}$) away from the end of the bell section. This type of damage is due to rotation of the pipes at the joints accompanied with compressive axial forces. A schematic illustration of this type of damage is shown in Fig. 9d.

Fig. 8. Location of the detected damage by sensors. Arrows indicate the location of the damage captured by conductive surface tape (CST) sensors.

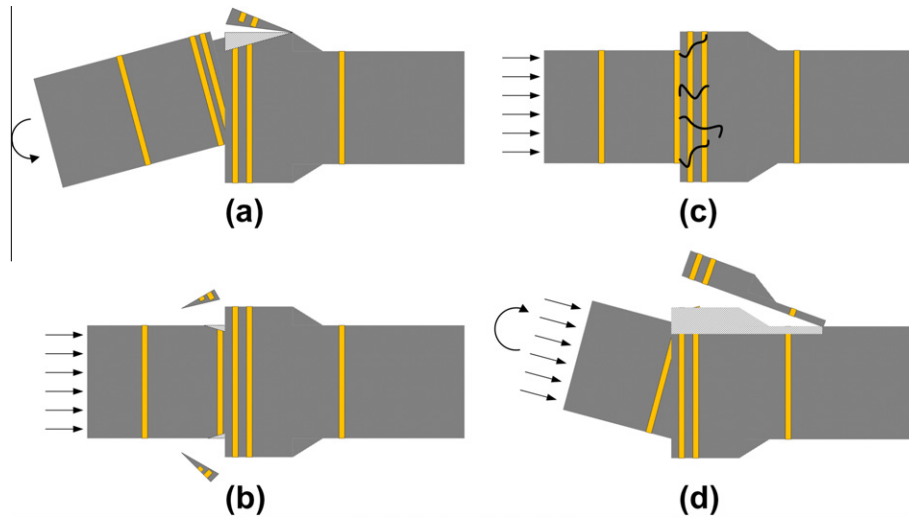
Fig. 9. Schematic illustration of (a) failure of bell due to angular rotation, (b) wedge-breaking due to compressive force, (c) failure due to telescoping and (d) failure of the joint due to rotation and telescoping.

The types of damage illustrated in Fig. 9 can be seen in the photographs shown in Fig. 15. Figs. 15b and c show the damage to Joints 2 and 3, which appear to have rotated and telescoped (Fig. 9d). It should be remembered that the photographs in Fig. 15 show damage at the time of excavation, however, the damage to Joints 2 and 3 increased progressively over time, from wedge-breaking damage to the spigot (Fig. 9b) to telescoping and crushing of the bell (Fig. 9c), and eventually to rotational and telescoping type failure (Fig. 9d). The wedge-breaking type of damage that was observed at Joint 3 is shown in Fig. 15e. The damage to Joints 1 and 4 is similar to the schematic illustration shown in Fig. 9c.

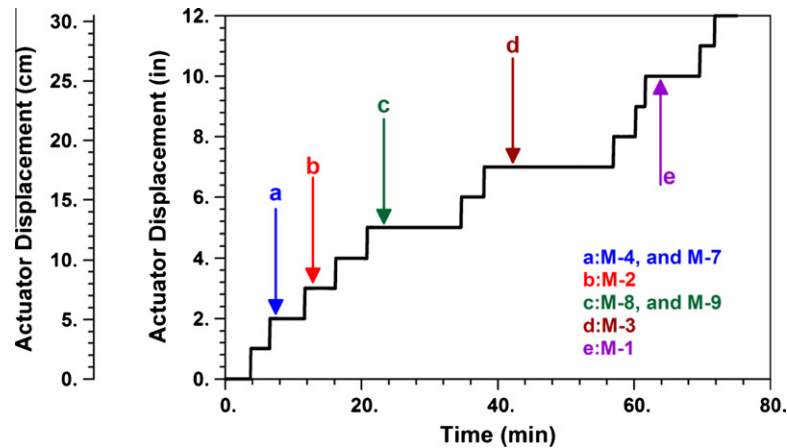
Fig. 10 shows that the magnetic sensors at Joints 2 and 3 indicate relative movement of the spigot with respect to the bell. These

Fig. 10. Sequence of signals received from magnetic (M) sensors in relation to the actuator displacement.

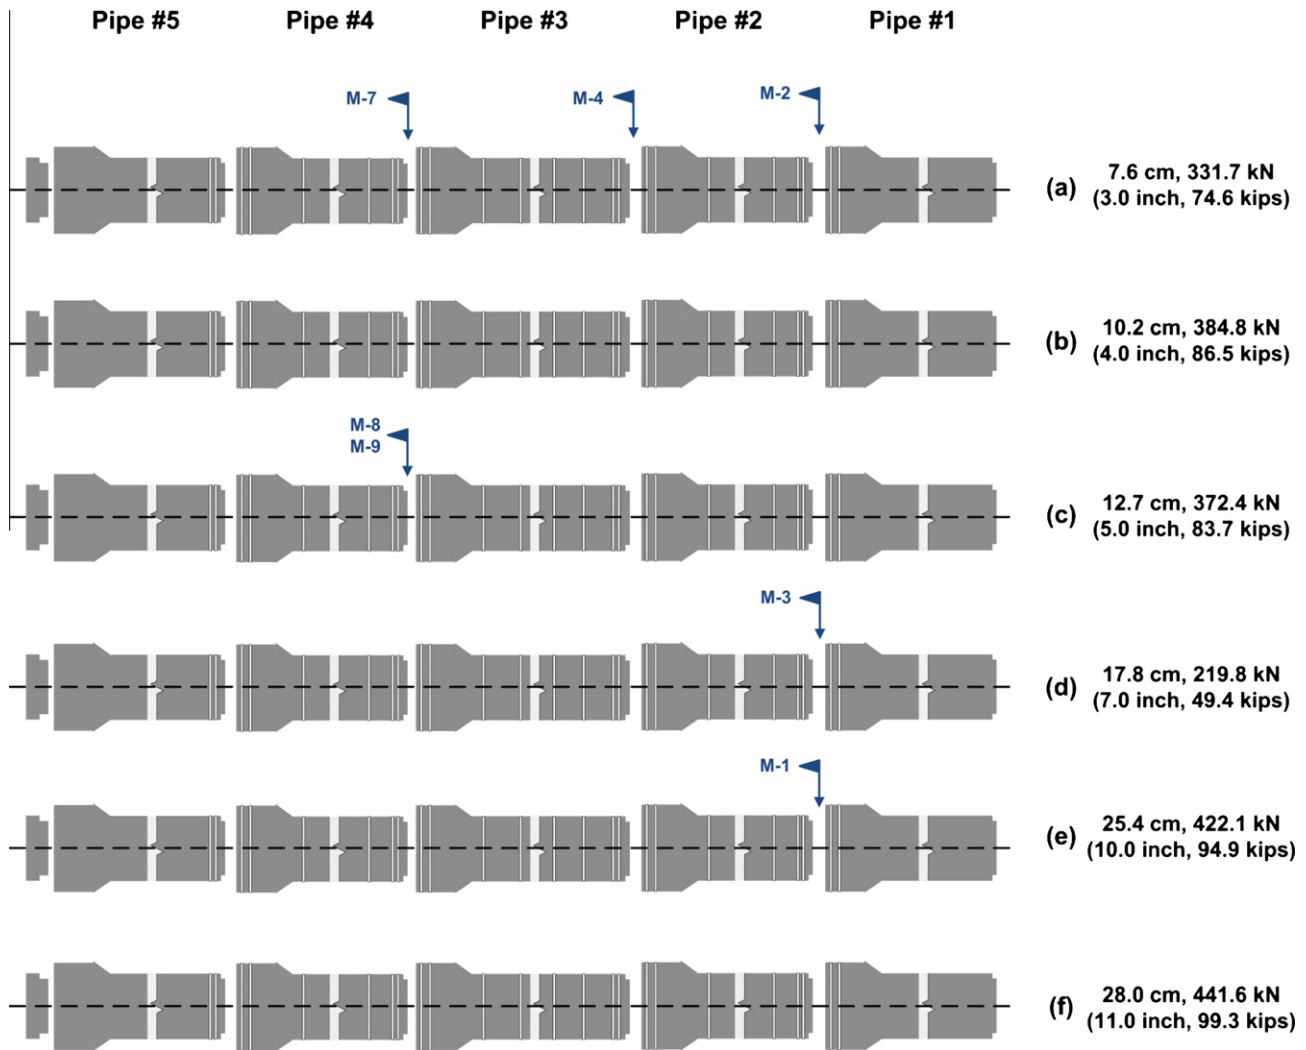
signals are consistent with the signals from CST sensors (Figs. 8a and 11a). A magnetic sensor at the Joint 1 (M-2) also indicates relative displacement of the bell-and-spigot after the third displacement step. There is a slight delay in the response of this sensor,

Fig. 11. Location of the detected damage by sensors. Flags indicate the location of the damage captured by magnetic (M) sensors.

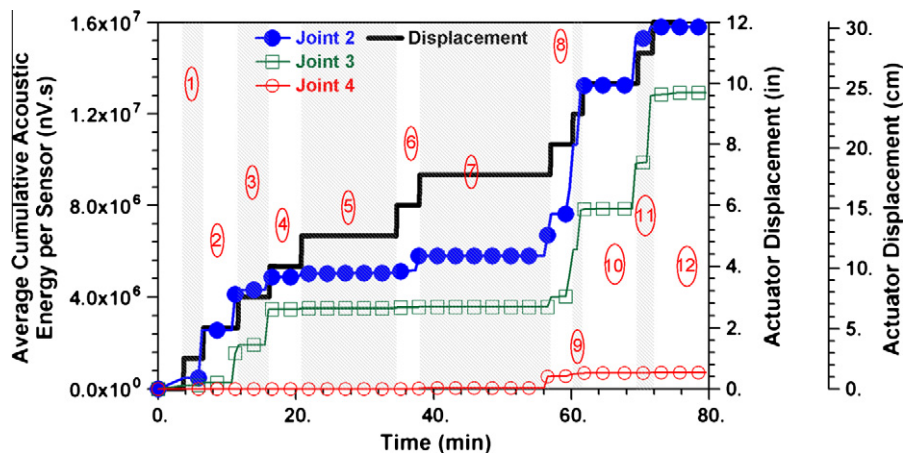
Fig. 12 shows the average captured acoustic energy per sensor at Joints 2, 3, and 4. The amount of energy captured at Joints 2 and 3 are orders of magnitude larger than the amount of energy captured at Joint 4. This is consistent with the results from the CST and magnetic sensors in that the damage to Joints 2 and 3 was greater than at Joint 4. A significant amount of energy is captured during the first two displacement steps. This is consistent with the results shown in Fig. 7 where the damage was observed at Joints 2 and 3. Note that in all cases acoustic activity starts before any damage is detected by CST sensors in Fig. 7. A sudden

increase of acoustic energy at Joint 4 was observed after the seventh displacement step. This observation is consistent with the signals received from CST and magnetic sensors. Also a significant decrease in load was observed at this actuation step (Fig. 6b).

A significant increase in acoustic energy is observed during the eighth displacement step at all joints. However, no signals from CST and magnetic sensors are received during this step (see Fig. 7) because the majority of the sensors installed at Joints 2 and 3 failed previously. During the relaxation period after the tenth displacement step no acoustic activity is captured; however, during this period signals from CST and magnetic sensors indicate damage at Joint 2 and Pipe Segment 2. This suggests that the damage to the joint occurred during the displacement and that the delay in the CST sensors might be due to the widening of the crack and the commensurate rupture of the CST.

Fig. 12. Average captured cumulative acoustic energy.

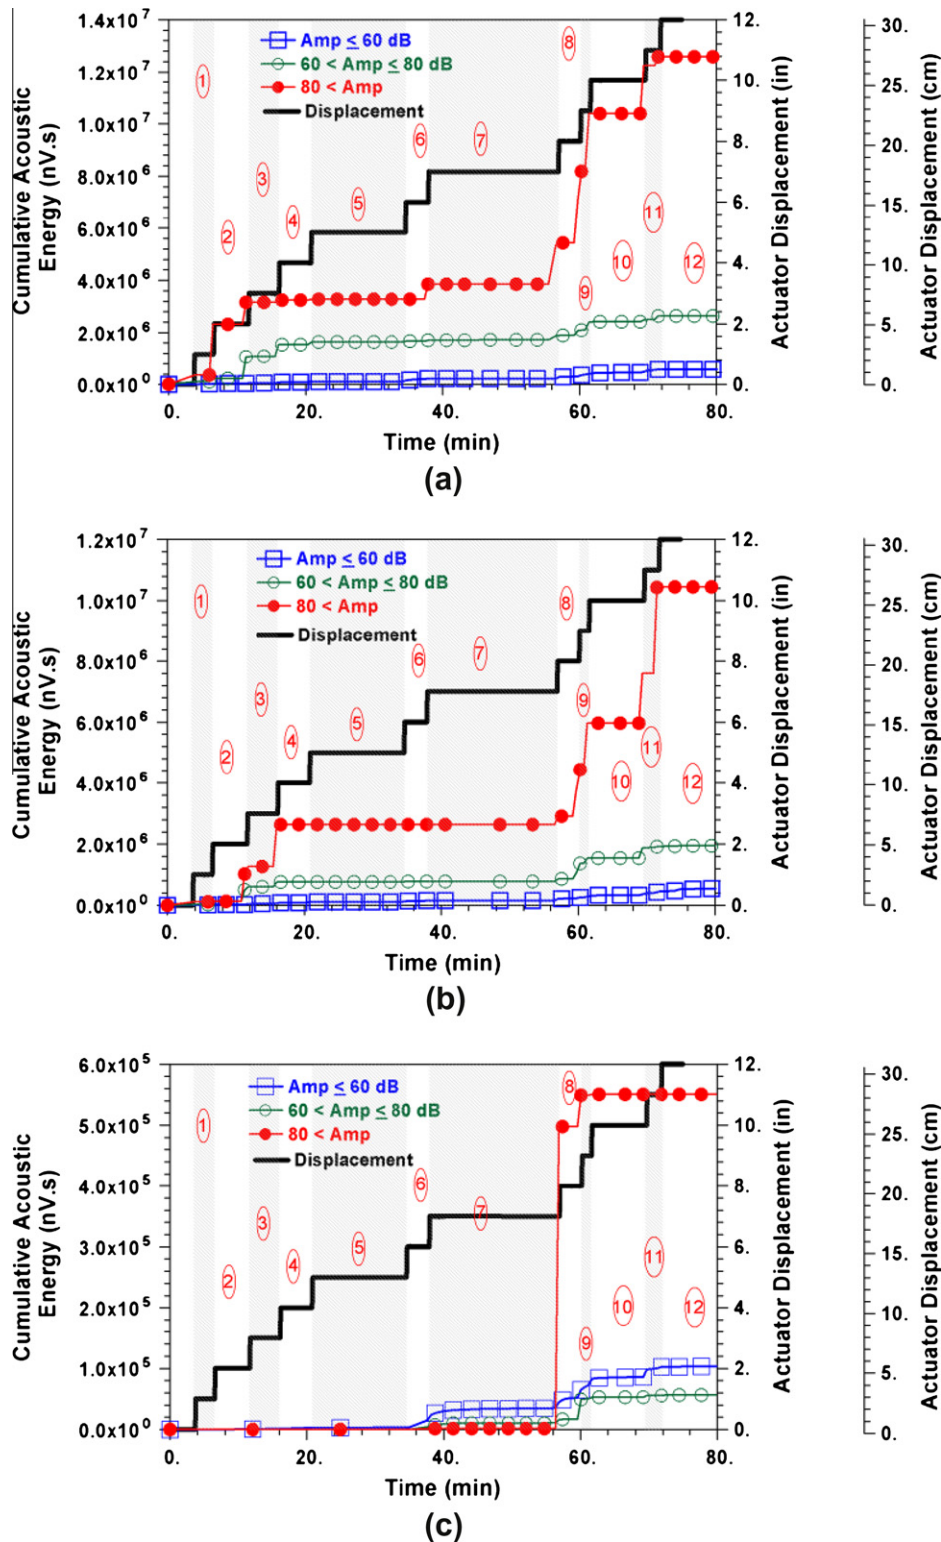
Fig. 13 shows the cumulative acoustic energy at each joint categorized in three groups based on peak amplitude of the acoustic signal: <60 dB, 60 to 80 dB, and >80 dB. Smaller amplitudes can generally be attributed to the movement of the soil, micro-cracking of the concrete pipe, or cracking of the concrete far away from the sensor. High amplitude acoustic activity is generally associated with discrete cracking in the close vicinity of the sensor. Fig. 13 shows that the cumulative acoustic energy from high amplitude waves increases significantly after the eighth displacement step.

Fig. 13. Average captured cumulative acoustic energy at Joints (a) 2, (b) 3, and (c) 4.

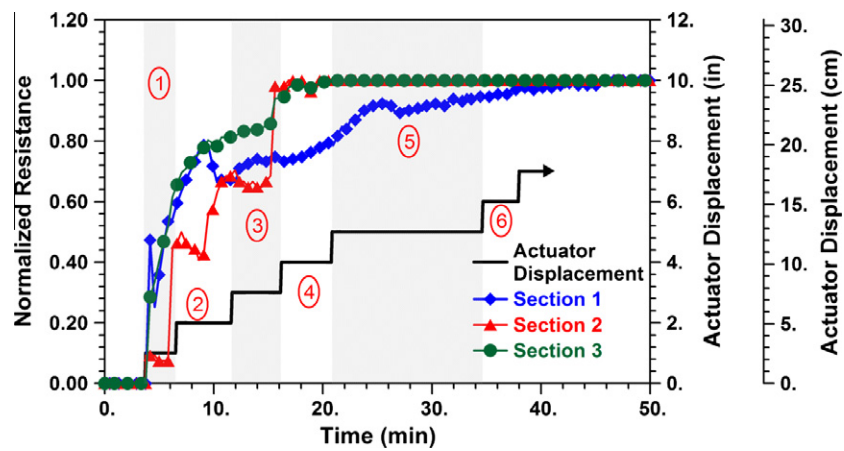
Fig. 14 illustrates the results of resistance measurements of the conductive grout at Joint 4. The resistance results are normalized to the maximum value measured. The normalized value of the resistance can be considered as an indirect measure of damage. As may be observed in Fig. 14, the resistance of the grout increases even at early stages of loading and continues to increase up to end of the seventh displacement step and then reaches the maximum value corresponding to the complete damage at the joint. This is consistent with the reduction of the loads (actuator and axial) in the seventh displacement step in Fig. 6b.

All three sections of Joint 4 approximately follow the same trend of resistance increasing; this indicates that the damage is almost uniformly distributed around the joint (i.e., telescoping). The majority of the damage is accumulated in the joint up to the end of the third displacement step. These results are consistent with the results obtained from CST sensors in Fig. 7a (Fig. 8a) where the damage is detected at spigot section of the Joint 4.

Fig. 14. Resistance increase of conductive grout due to damage at Joint 4.

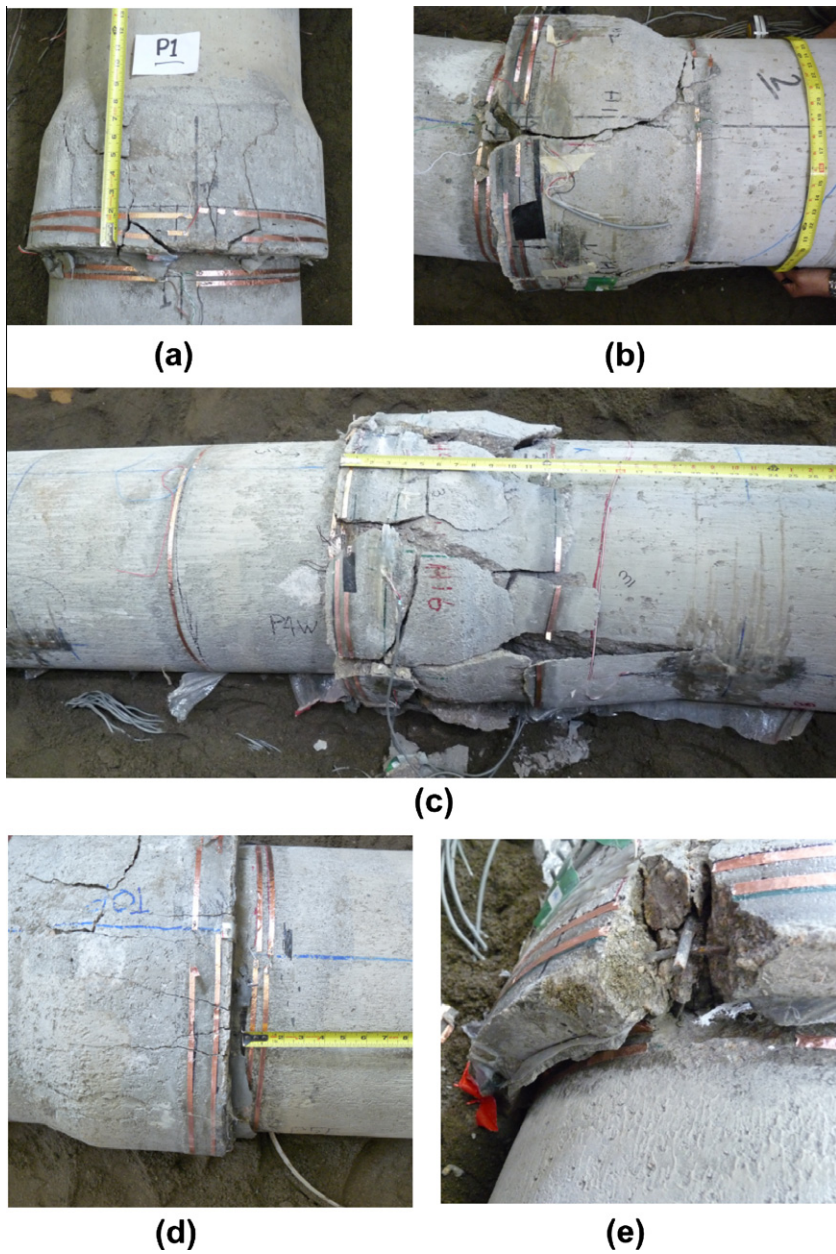
At the end of the experiment the pipeline was excavated and visually inspected. Fig. 15a through 15d illustrate the damage that developed during the test at Joints 1–4. Clearly, each of these joints was damaged. The observed damage is in agreement with the damage detected using the sensing methods. Specifically, the CST

Fig. 15. Damage to joints observed after excavation (a) Joint 1, (b) Joint 2, (c) Joint 3, (d) Joint 4, and wedge-breaking type of damage seen in Joint 2.

Except for the damage to Pipe Segments 2 and 3 that was detected by the CST sensors R-6 and R-14 (Figs. 8e and f), no other visually observed damage was found on the pipe segments away from the joints (along the pipe length).
