# Sulfate attack of concrete building foundations induced by sewage waters

A case history of a severe degradation of concrete foundation plinths and piers of an about-35-year-old building located in Northern Italy is described. Significant amounts of gypsum, near ettringite and/or thaumasite were detected by X-ray diffraction analyses performed on ground concrete samples. Large gypsum crystals were mainly located at the interface between the cement paste and aggregates, as observed by scanning electron microscopy coupled to energy-dispersive spectroscopy microanalysis. The degradation effects increased with decreasing the distance of concrete structures from an absorbing well located in the courtyard of the building. The well was recognized as the sulfate source due to the microorganism metabolism of sulfur compounds present in the sewage. Consequences of this attack were a very poor bond strength between cement paste and aggregates and a severe cracking of the concrete cover of the steel reinforcement. © 2002 Elsevier Science Ltd. All rights reserved.

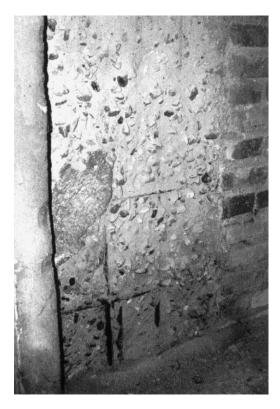
A building about 35 years old, located in the suburbs of Torino (Northern Italy), presents a severe degradation of concrete foundation plinths and piers, from the plinth level up to 2 m. However, the degradation does not affect all the foundation structures in the same extent, but it seems more severe in the plinths and piers located close to the internal courtyard of the building and the deterioration effects decrease with increasing the distance from the ground level. The bond strength between the cement paste and aggregates is poor, and the concrete cover of the steel reinforcement is, in many cases, cracked or even spalled off (Fig. 1). Consequently, the metallic reinforcement is significantly corroded.

Fig. 1. Example of severe degradation of concrete and steel reinforcement of the building foundations:  $P_2$  pier.

By a visual inspection of the foundations, a qualitative scale of degradation was defined: the most severe deterioration occurred in plinths and piers  $P_1$  and  $P_2$ ; the deterioration degree was lower in  $P_3$ ,  $P_4$  and  $P_5$ , whereas piers  $P_6$ ,  $P_7$  and  $P_8$  were almost intact. However, in all cases, poor quality concrete was observed, with significant aggregate segregation at the bottom of the piers. These observations, combined with the rebound hammer test results, clearly indicated two trends. First, concrete strength increased from the plinth to the higher part of the piers and, second, the lowest values were recorded on the plinths located in the proximity of the absorbing well. Strength values of 10-12 MPa or less were measured on the plinths and on the bottom of piers  $P_1$  and  $P_2$ , whereas at a height of about 2.5 m from

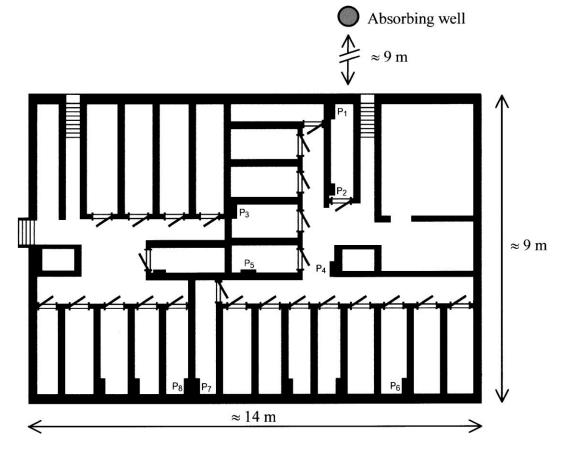
ban sewage system, temporarily an absorbing well was used for collecting sewage. This was 8 m deep, located in the internal courtyard at about 9 m from building foundations. After then, it was disused but not completely eliminated. An inspection demonstrated that stagnant water was still present on its bottom. This paper deals with the case history to illustrate how concrete was subjected to sewage attack.

Fig. 2. The map of the investigated building with the details of the sampling points  $(P_1-P_8)$  and the location of the absorbing well.

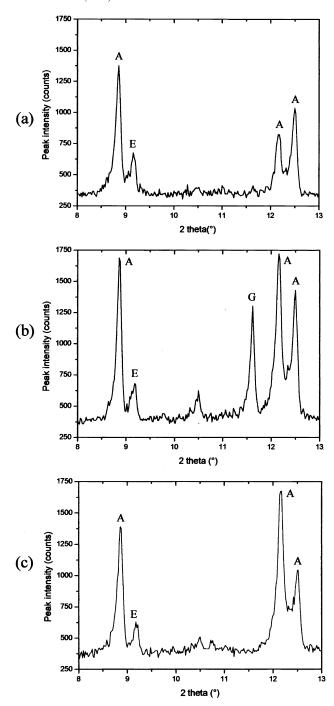
From XRD patterns of the samples collected from P<sub>1</sub> plinth and pier, the typical products of a sulfate attack were clearly identified. The most interesting part of the patterns is reported in Fig. 3. Gypsum was detected only in the sample collected at a height of 1 m from the plinth, whereas small amounts of ettringite/thaumasite were present in all P1 samples (from the plinth, at a height of 1 and 3.5 m, respectively, from the plinth). Also in this case, the amount of the sulfate-based products decreased by increasing the distance of the sampling point from the absorbing well. In fact, the XRD patterns of the P2 samples were similar to those of the corresponding P<sub>1</sub> samples, whereas only traces of gypsum were detected in the samples from P<sub>3</sub> to P<sub>5</sub>. Any evidence of the above products was in P<sub>6</sub>, P<sub>7</sub> and P<sub>8</sub> samples. XRD patterns also presented the prevalent peaks of silicate aggregates, whereas peaks of carbonate aggregate were identified only in very few cases independently of the collecting zone.

Fig. 3. XRD patterns of degraded concrete  $P_1$  samples: (a) plinth sample; (b) sample collected at a height of 1 m from the plinth; (c) sample collected at a height of 3.5 m from the plinth (A=aggregate: mica and potassium aluminium silicate; E=ettringite/thaumasite; G=gypsum).

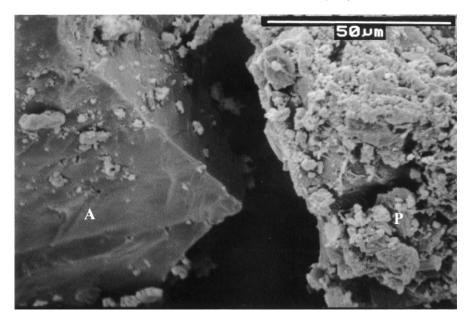
The SEM observations confirmed the XRD data. The P<sub>1</sub> plinth sample showed only limited regions affected by gypsum and/or ettringite, even if it appeared to be highly porous and cracked. Frequently large voids were observed all along the transition zone between cement paste and aggregates (Fig. 4). The aggregate surface seemed to be almost clean: only very few cement paste particles remained attached on it due to their poor adhesion or even to dissolution of a preexisting interfacial phase. In the 3.5-m sample, neither gypsum nor ettringite nor thaumasite was identified, whereas the 1-m sample was significantly affected by the presence of

Fig. 4. SEM image of a large void between quartz aggregate (A) and cement paste (P) in P<sub>1</sub> plinth sample.

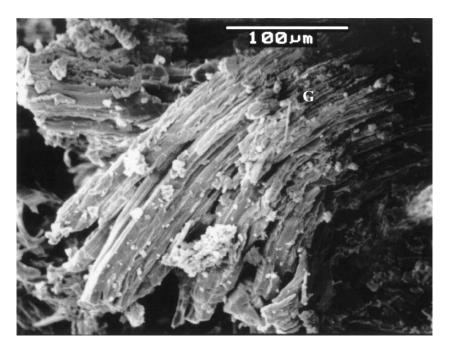
gypsum, sometimes growing as long rams horn-shaped grains (Fig. 5), very similar to the fibrous crystals of Satin spar mineral [1]. A low-magnification image of the contact region between quartz aggregate and columnar gypsum crystals is shown in Fig. 6. In all cases, the phase composition was determined by EDS analyses. Very frequently, the growth of gypsum crystals at the transition zone between cement paste and aggregates led to a partial or almost com-

Fig. 5. SEM image of some horn-shaped gypsum crystals (G) grown in the P<sub>1</sub> sample at a height of 1 m.

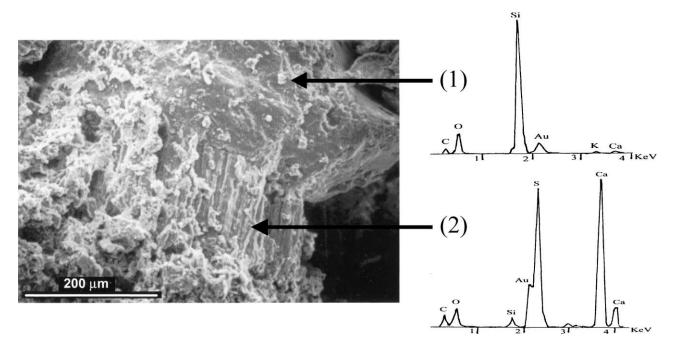
Fig. 6. SEM micrograph, combined with EDS analyses, of a degraded concrete P<sub>1</sub> sample at a height of 1 m: point (1) quartz grain; point (2) gypsum crystals.

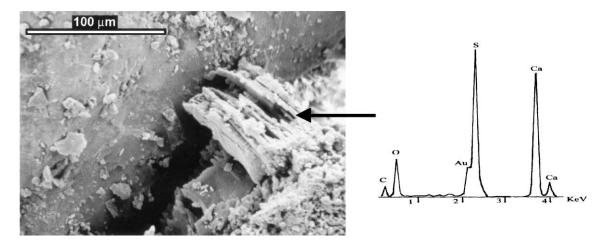
plete detaching (Figs. 7 and 8) between cement paste and aggregate, which should be responsible for the significant strength loss. Gypsum was only sometimes detected in the cement paste.

Fig. 7. Detail of the transition zone between cement paste and quartz aggregate in P<sub>1</sub> sample at a height of 1 m: gypsum crystals growing at this interface, as detected by EDS.

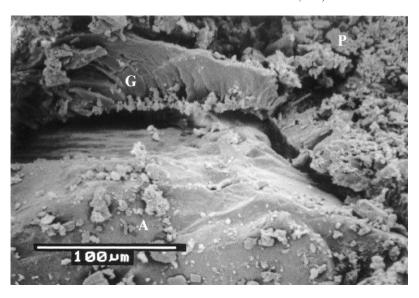
Fig. 8. P<sub>1</sub> sample at a height of 1 m: debonding at the transition zone between cement paste (P) and quartz aggregate (A) due to a large stack of gypsum crystals (G).
