Performance of concrete wharves constructed between 1901 and 1928 at the Port of Montréal

K.H. Khayat*, A. Tagnit-Hamou, N. Petrov

Abstract

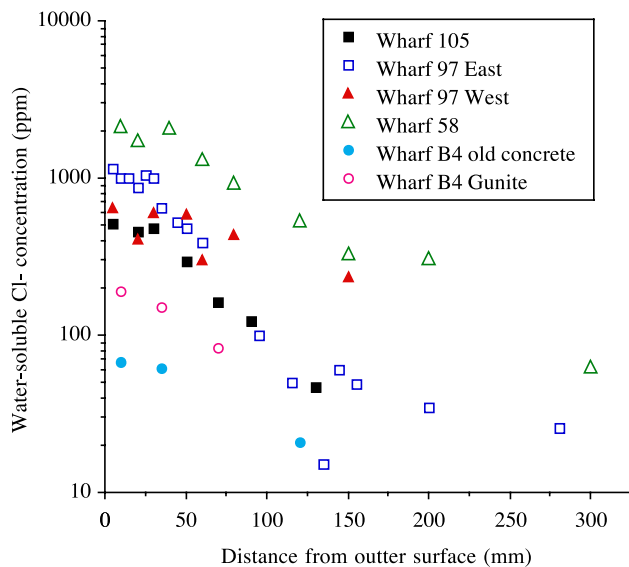
Fig. 1. Penetration of free chloride ions in various investigated concretes.

The water-soluble chloride ion concentration in Wharves 58 and 97 East was more than two times greater (1000–

2000 ppm) than those found in the other wharves. This may be due to the higher concentration of cracks and spalling of the cover of such concrete. The higher chloride ion permeability in Wharf 58 points to greater porosity of the concrete, which enables the absorption of higher quantities of expansive corrosion products without creating significant cracking. In this wharf, the reinforcing bars in the caisson were not uniformly spaced to effectively control cracking, and together with the high intrinsic porosity of such concrete, this has led to sporadic cracks over the outer reinforcing steel.

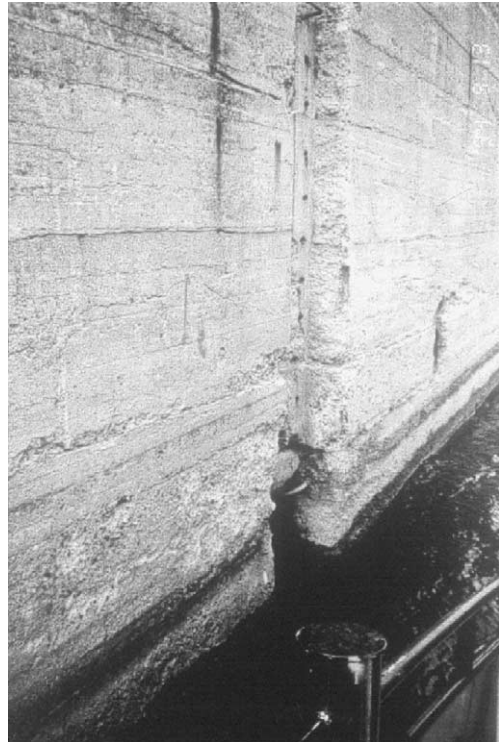
The condition of concrete surfaces of all wharves examined with regard to the age of concrete was generally acceptable, except for a significant level of scaling damage near the water line and ice abrasion, as shown in Figs. 2 and 3. Extensive pattern map cracking was also observed in some areas, which is typical of frost damage and the presence of ASR. In some places at the water level, the horizontal construction joints are seriously damaged with spalled-off concrete reaching 350 mm. In this zone near the water level, the scaled surface usually has several exposed aggregate particles (Fig. 4). Since the wharves are constructed with non-air-entrained concrete, the presence of the

frost damage is not surprising. A relatively high permeability and low mechanical properties indicate that the hydrated cement paste is porous and has low resistance to abrasion. Damage due to freezing and thawing cycles and ice abrasion is common in all examined wharves, but it is more visible on surfaces where other types of damage have also occurred, such as ASR or corrosion of reinforcement. Once cracking or scaling begins due to frost action or abrasion, the internal structure of the concrete becomes more porous facilitating the penetration of water, oxygen, CO_2 , and chloride ions. This can promote corrosion of the reinforcement and further cracking as well as coarse aggregate pop-out due to ASR gel formation.

Fig. 3. Photograph of typical ice abrasion damage of Wharf 58.

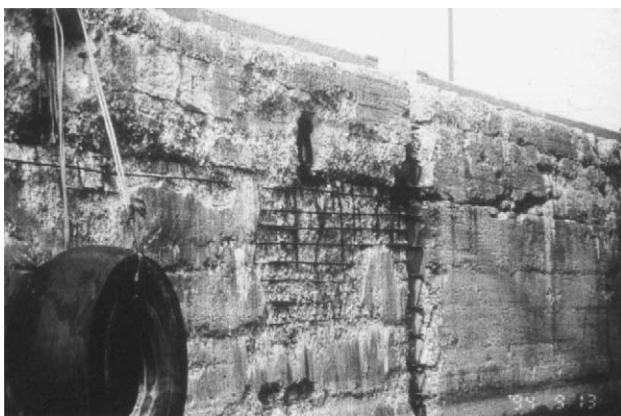
Fig. 2. Photograph of typical scaling damage of Wharf 105.

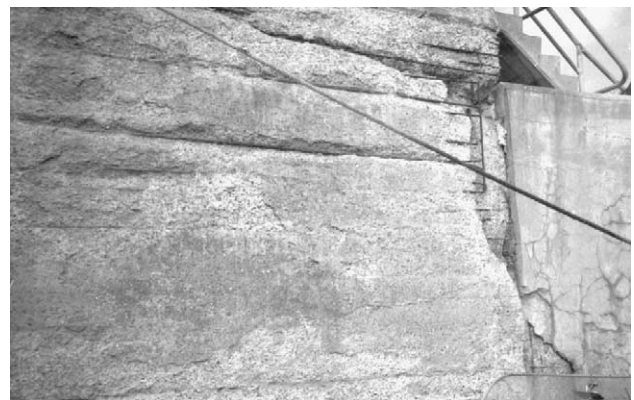
Fig. 4. Photograph of typical scaled surface damage and exposed aggregate particles of Wharf 97 East.

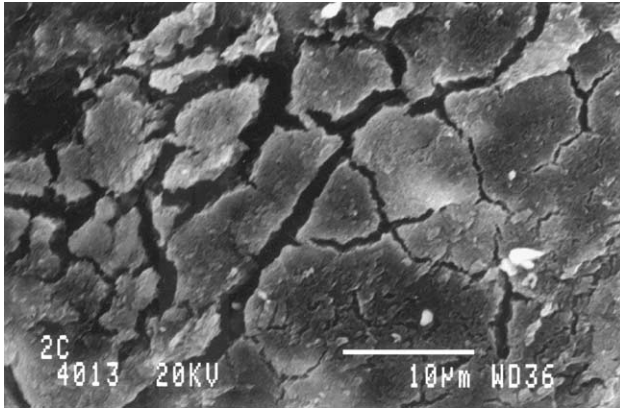
Two of the three wharves evaluated (Wharves 97 East and 58) are found to present a significant degree of damage due to ASR, which is characterized by map cracking and by the exudation of silica gel at construction

Fig. 5. Micrograph of concrete in Wharf 97 East showing ASR product.

joints. Such damage was confirmed by petrographical analysis of the aggregate and SEM examination of the concrete. This shows that the examined ASR is not related to the period of construction. However, the wharves where ASR is observed in advanced stages are often used for the storage of deicing salt and cement clinker. Therefore, the alkali contamination of concrete is probably due to outside sources. The presence of ASR gel and leaching at the construction joints was systematically observed at surfaces of ASR-affected wharves. As was the case in Wharf 105, petrographical analysis showed that coarse aggregate particles often contain veins filled with silica gel [2]. SEM observation revealed the presence of ASR reaction products in the paste (Figs. 5 and 6) that coexist with secondary ettringite (Figs. 7–9). The coarse aggregate was observed to have some cracks (Fig. 10).

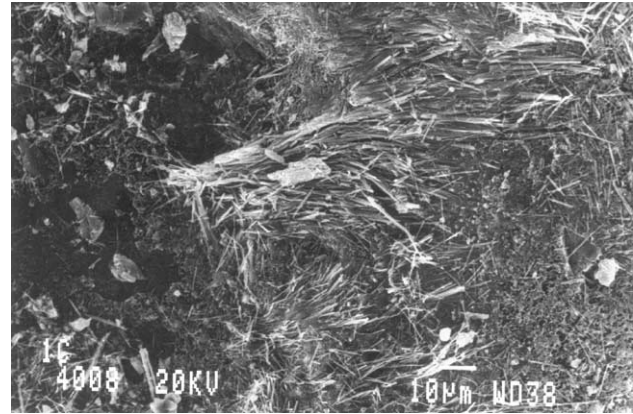
Secondary ettringite and gypsum, which are characteristic of sulfate attack, are also present. However, Wharf 105 had a relatively greater concentration of secondary ettringite and gypsum than the other two wharves. The level of ettringite in these concretes was far less than that observed in Wharves 45 and B4, as discussed below.

Fig. 7. Micrograph of concrete in Wharf 105 showing secondary ettringite.

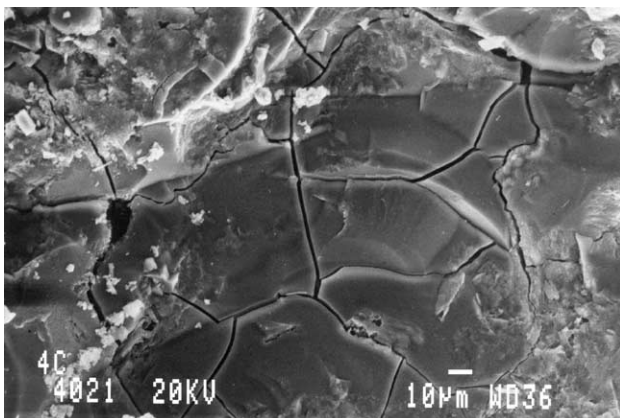
Fig. 6. Micrograph of concrete in Wharf 58 showing ASR product.

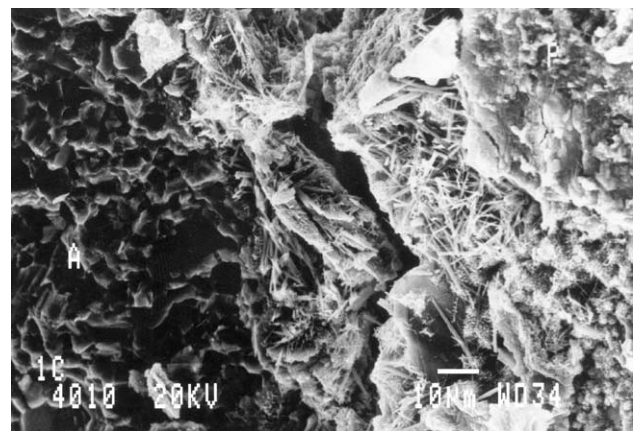
Fig. 8. Micrograph of concrete in Wharf 105 showing secondary ettringite in the paste–aggregate interface.

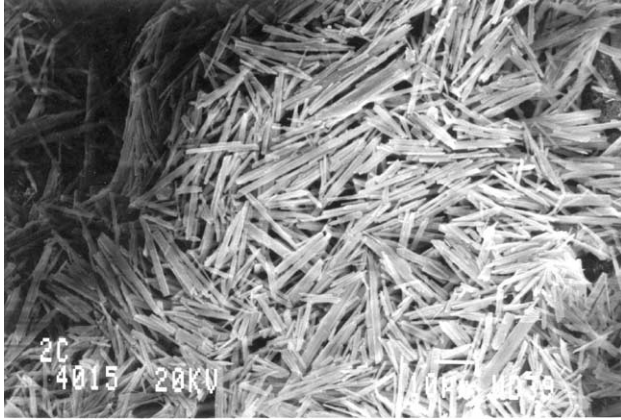
Fig. 9. Micrograph of concrete in Wharf 97 East showing secondary ettringite.

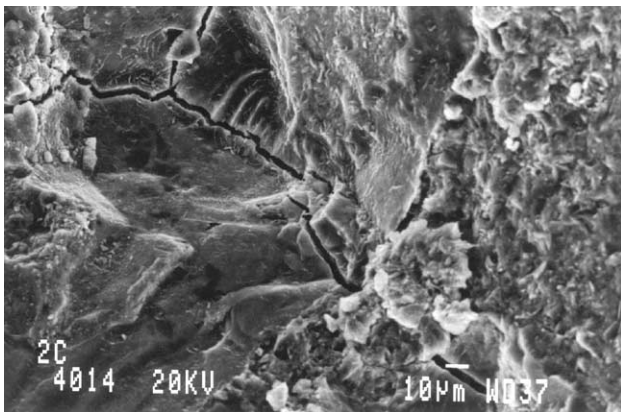
Fig. 10. Micrograph of concrete in Wharf 97 East showing cracks in aggregate.

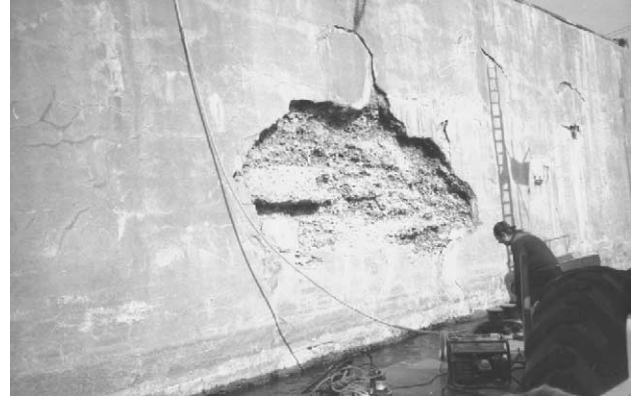
Fig. 11. Photograph of typical damage of Wharf 45 showing the bad anchoring of previous repair concrete.

14-mm nominal-size coarse aggregate. The photograph of Wharf 45 in Fig. 11 illustrates the type of severe damage observed in the structure. In several places, large cavities were visible on the exterior concrete surface, which is mainly due to the fact that the repair shell was not properly anchored to the base concrete when shallow pin anchors were used. As the base concrete continued to undergo degradation following the 1936 repair, the damage weakened the bond between the base and repair concrete and eventually resulted in spalling of the repair concrete (Fig. 12). In such cavities, the concrete is noncohesive and can be removed easily with a geological hammer.

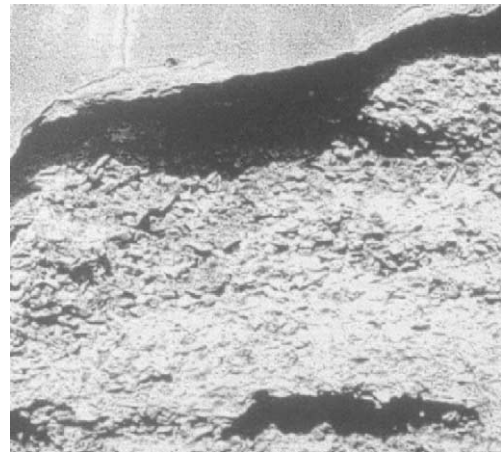
Fig. 12. Photograph of typical damage of Wharf 45 showing large cavities with noncohesive concrete.

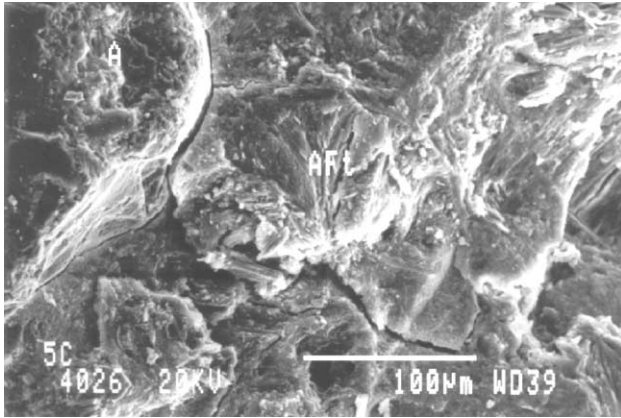
Fig. 13. Micrograph of concrete in Wharf 45 showing secondary ettringite.

located 450 mm from the surface, large concentrations of ettringite and gypsum were found in the paste (Fig. 13). The limestone aggregate is shown to be porous and contains several microcracks. Furthermore, the calcium silicate hydrate (C-S-H) was often observed to be porous (Fig. 14). Concrete samples examined near the outer surface of the wall showed greater concentrations of ettringite than gypsum. No $\text{Ca}(\text{OH})_2$ crystals were found by SEM in the investigated concrete section. On the other hand, a small content of $\text{Ca}(\text{OH})_2$ was detected by XRD analysis (Table 3). The XRD analysis of the repair concrete showed signs of sulfate diffusion and precipitation of secondary ettringite.

The deterioration of the cement paste in Wharves 45 and B4 due to ettringite and gypsum formation reduced the strength and stiffness of the concrete [4]. The large amount of gypsum and ettringite is caused by reaction of sulfate ions with Ca(OH)_2 , monosulfate and C-S-H [5]. These phases, especially Ca(OH)_2 and monosulfate, are dissolved to provide calcium and aluminum ions needed for the formation of secondary ettringite and/or gypsum. The limestone aggregate can also contribute some calcium ions. In addition to the expansive nature of the formation of secondary ettringite and gypsum, the dissolution of the Ca(OH)_2 and C-S-H can contribute to the decrease in mechanical properties. Mehta [6], in a critical review of sulfate attack on concrete, cited several cases of deterioration by this process and noted that some structures exhibited deterioration although the concrete mixture was of a high quality. Although the concrete of Wharves 45 and B4 show some deterioration due to freezing and thawing cycles and ASR, the main cause of damage is due to sulfate attack. The origin of the sulfate is not certain. As indicated above, the river water's concentration of sulfate content is negligible. It is believed that the main source of the sulfate is coal, as the old wharves were used for many years as a storage area for coal. The sulfate from the coal in a water solution can percolate through the freeze–thaw damaged concrete, thereby causing deterioration of the concrete. Price and Peterson [7] noted that frost damage can lead to an increase of microcracking that can accelerate the penetration of sulfate ions and sulfate attack.

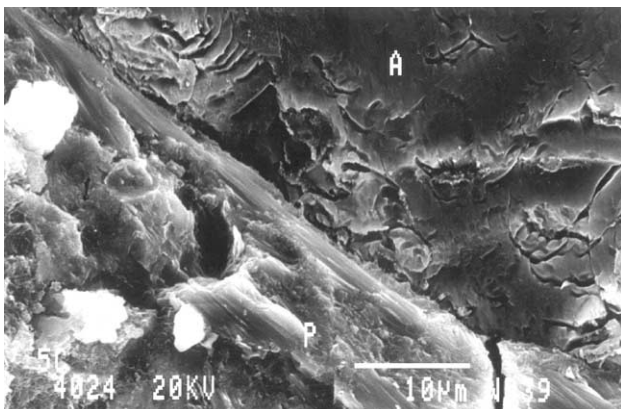
Fig. 14. Micrograph of concrete in Wharf 45 showing porous C-S-H.

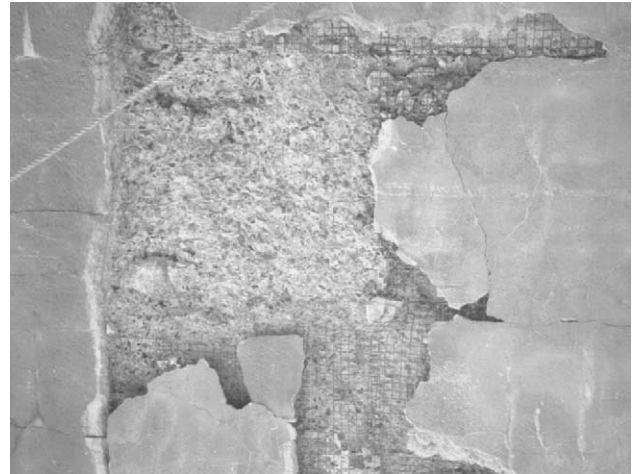
Wharf B4 was constructed in 1905 and received on outer repair shell of approximately 100 mm in thickness of Gunite mortar reinforced with a welded wire mesh grid and anchored using shallow pins. The surface of the repair concrete is divided through large cracks into several sheets that appear to be poorly bonded to the base concrete, as shown in Fig. 15. In certain places, large cavities were present in the concrete, which is mainly due to the fact that the outer concrete shell was not properly anchored to the base concrete. Therefore, the base concrete continued to undergo degradation after the repair, which weakened the

Fig. 15. Photograph of poorly bonded repair concrete and typical large cracks of damaged Wharf B4.

bond between the base and repair sections, eventually resulting in spalling of sections of the repair concrete.

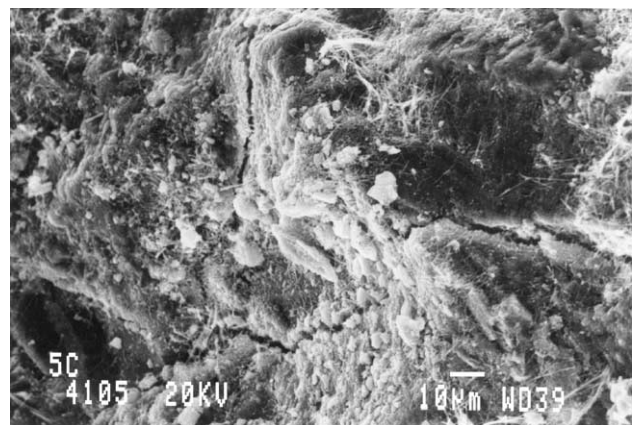
Fig. 16. Micrograph of concrete in Wharf B4 showing microcracking in the paste.

was found to be highly cracked. The amount of ettringite and gypsum was quite significant (Figs. 16 and 17), with silica gel from ASR found in several places. Secondary ettringite was also observed in the Gunit repair section. XRD analysis confirmed the SEM observations (Table 3).

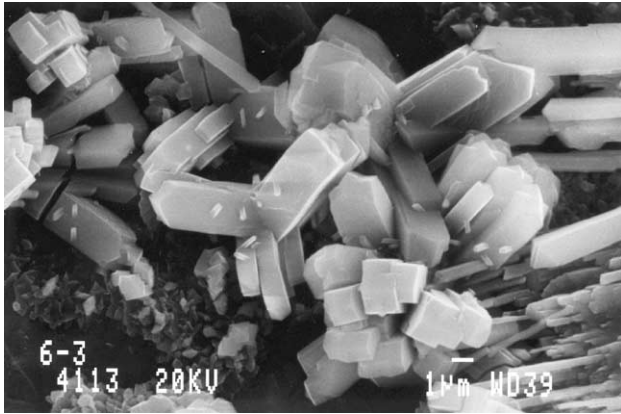
Fig. 17. Micrograph of concrete in Wharf B4 showing gypsum.
