# Deterioration of concrete in a hydroelectric concrete gravity dam and its characterisation

Ahmad Shayan a,\*, Jack Grimstad b

Received 21 January 2005; accepted 8 September 2005

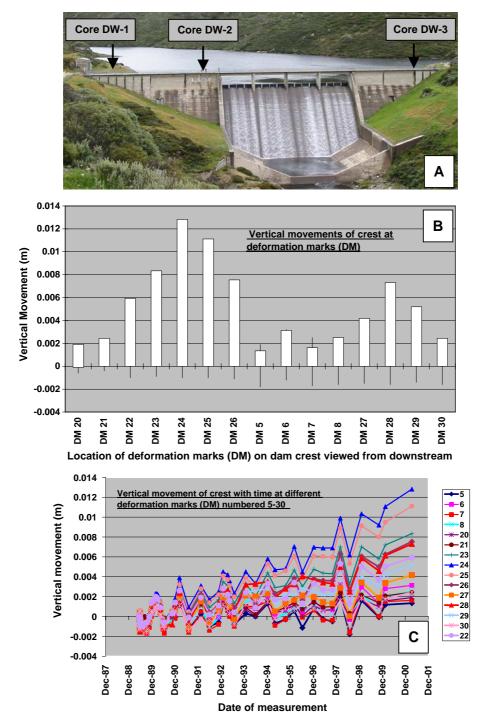
The dam and power station investigated are a part of the Snowy Mountain Hydro-Electric System and are under the control of Snowy Hydro Ltd. Routine measurements of movements in the dam wall had revealed that some sections of the dam had shown as much as 13 mm movement over the 13 years of measurement between 1988 and 2001, i.e. 1 mm/year. Fig. 1A shows a general view of the dam wall observed from downstream, and graphical presentation of the movements measured on various locations on the crest. Regularly spaced surveillance points had been located on the crest and deformation markers (DM), suitable for the measurement of vertical movement, installed on the crest. Fig. 1B shows the total vertical movement at each DM location on the crest, over the

measurement period, and Fig. 1C illustrates the change in the vertical movement over the same period for each measurement site. Note that the DM positions in Fig. 1B correspond to the same locations on the crest shown in Fig. 1A, i.e. locations of DM5-DM8 correspond to the spillway location. In order to maintain a high level of operational efficiency, in February 2002 Snowy Hydro Ltd. commissioned a review of this facility including the power generation components and the concrete structures. A preliminary inspection was first carried out on the power station and dam wall by the authors to ascertain their long-term durability. As a result, alkali-aggregate reaction (AAR) was suspected as the cause of deterioration of the concrete in the power station. Stronger evidence of AAR was observed on the dam wall, which were similar to previously reported cases of AAR in Australian dams [1-4].

Fig. 1. General view of the dam from downstream (A), vertical movement of crest at different positions on the crest (B), and trend of expansion at each location with time (C).

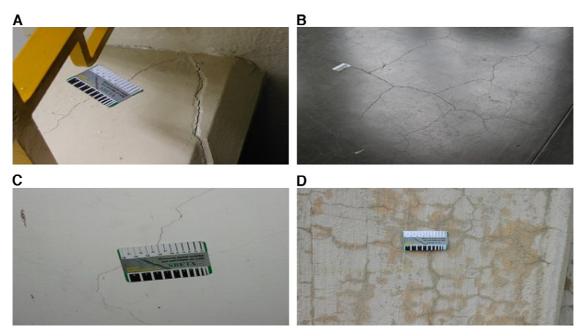
Fig. 2. (A) Cracking at the RHS of the beam of the assembly bay. (B) Crack pattern in the second slab in front of the Roll-a-door of the assembly bay. (C) Cracking observed on the staircase wall on the floor below the assembly bay floor. (D) Map-cracking pattern of an exterior column of the power station. Similar cracking is also present on the exterior walls.

Fig. 5 shows the microstructure of the hydrated cement phase in core PS-2 (floor of the Assembly Hall), and its composition, which is very low in alkali content (K and Na). Note that the cement hydrate is rich in Ca, and has a much lower Si content, as in the unhydrated cement. Detailed examination of the specimen did not reveal evidence of AAR in this core. The mortar matrix appeared porous in this specimen, and may indicate a high water/cement ratio in the original concrete, which would make it prone to excessive shrinkage. The cracking seen in the floor of the Assembly Hall may be due to excessive drying shrinkage.

This type of AAR products were distinctly present in the core taken from the outside column of the power station, i.e. core PS-3, which shows map-cracking (Fig. 2D). Extensive reaction sites were noted in this core, and there is no doubt that the map-cracking in this column and adjacent walls, is due to AAR.

It appears that the concrete floor in the power station is not exhibiting AAR, and may not need treatment. The exterior walls of the power station would need a breathable surface coating such as a water-repellent silane to prevent moisture ingress and allow the concrete to dry out. The interior walls may be treated with a surface coating appropriate for its current function.

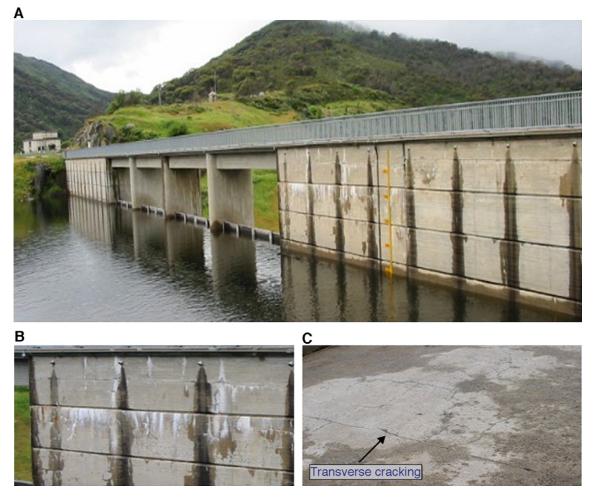
Fig. 3. (A) Upstream view of the dam showing cracking of the block RHS of the spillway section. (B) Close up view of cracking of block D, RHS of spillway. (C) Cracking at the upper surface of block D.

Data obtained for core DW-2 clearly shows the extensive nature of AAR in the cracked block to the left of spillway and is considered to be the cause of damage to the concrete in this area. The fact that these features were not evident in the petrographic thin sections arise because such evidence is easily removed during the cutting and polishing processes involved in the preparation of the sections.

The dam wall may need anchorage in the areas of badly cracked block. The uncracked and the mildly cracked blocks are not expected to need treatment. Details of anchorage could be arranged by companies specialising in the field, but it should consider the residual expansion potential of the concrete.

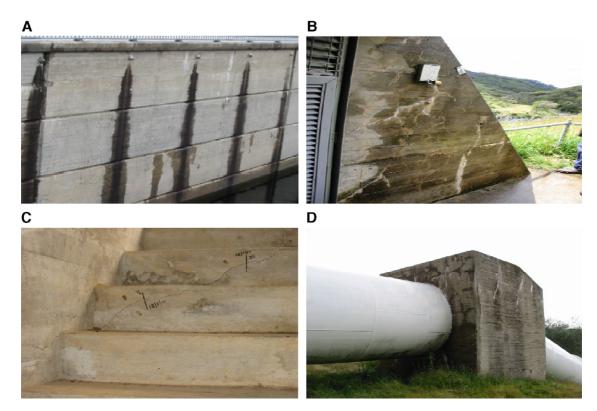
Fig. 4. (A) Milder cracking in the upstream face of the middle block to the left of the spillway. (B) Cracking of the buttress at the gallery entrance, due to AAR. (C) Cracking in the wall and staircase of the gallery—left entrance from downstream. (D) View of the pipeline anchor block exhibiting cracking.

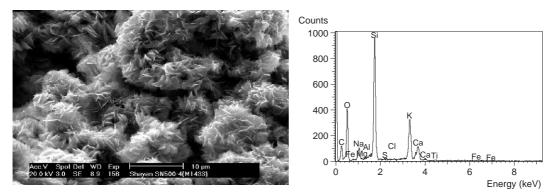
Fig. 6. Crystalline AAR product and its EDX composition.

PS-7, taken from the Workshop wall. Fig. 6 shows crystalline AAR products formed on an aggregate surface, and the composition indicated by the EDX spectrum is rich in Si, K and Na, unlike the hydrated cement phase. Fig. 7 shows a location where smooth AAR gel has formed at an aggregate boundary, and the composition is relatively richer in Ca due to contact with the hydrated cement (RHS). Similar K-rich AAR gel was found around some quartz grains, i.e. in the intracrystal spaces between them. These features are very similar to those reported for AAR-affected structures elsewhere [12] and in Australia [1–4].

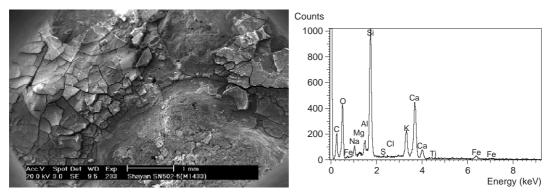
Fig. 10. AAR gel product covering large areas around aggregate and its EDX composition.

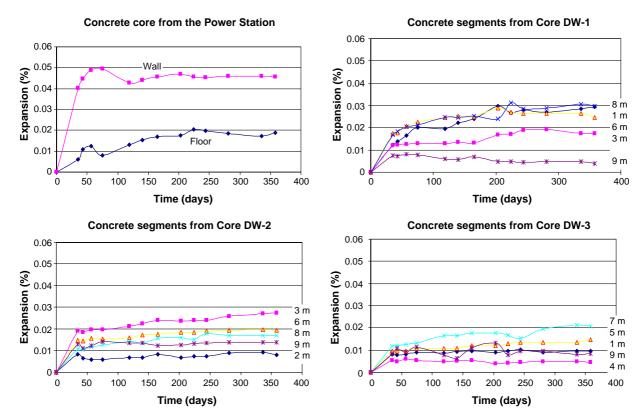
The core from the wall has continued to show a higher overall expansion than the core from the floor (Fig. 14). This is largely due to a higher initial expansion which could be related to water absorption by concrete and by the dehydrated AAR products in the former core. This is consistent with the observation of AAR products in the core sample taken from the wall and its absence in the concrete from the floor of the power station. Therefore, under wet conditions the walls of the

The expansion potential of the cores from the dam wall vary within each 10 m segment, as shown in the graphs presented in Fig. 14. The average expansion of the 10 m core segments at 1 year is calculated by taking the mean expansion for the five segments tested. The average water absorption for each segment is similarly calculated based on expansion at 30 days, and the difference is considered to be the residual AAR expansion potential of the core (Table 4).

Fig. 14. Expansion of segments of concrete cores drilled from various parts of the structure, as indicated.
