# Sodium chloride crystallization in a “salt transporting” restoration plaster

B. Lubelli <sup>a,b,\*</sup>, R.P.J. van Hees <sup>a,b</sup>, C.J.W.P. Groot <sup>a</sup>

<sup>a</sup> TUDelft, Delft, The Netherlands

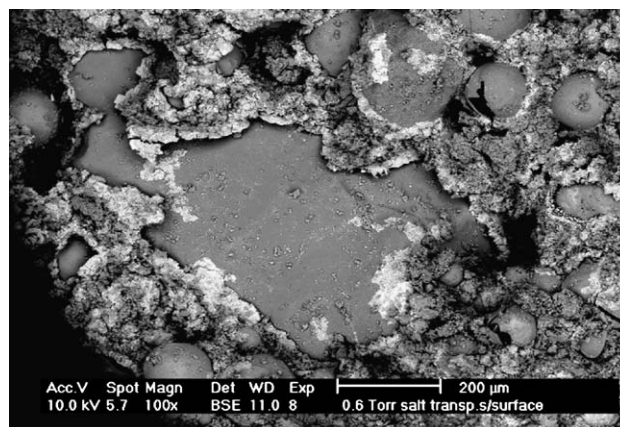
The location of salt crystallization in pores, i.e. the pore size in which the salt had preferentially crystallized, was investigated also by means of ESEM. Broken cross sections as well as the evaporation surface of plaster specimens contaminated with NaCl were observed by means of a Back-Scattered Electron (BSE) detector. The chemical composition of the crystals was checked by means of an Energy Dispersive Spectroscopy X-ray Microanalysis. From the several observations it can be concluded that the salts crystallize in the binder structure, accumulating mainly at the interface with the aggregate (Fig. 7). No salt has been detected inside the hollow aggregate confirming that this does not take part in the moisture transport. The mullite spheres are therefore not meant for salt accumulation, as it often happens for lightweight aggregate used in restoration plasters. It was not possible to detect salt in small pores, also because of the limited resolution due to the use of broken, not polished, sections; most of the visible pores (larger than 0.5–1 μm) appear to be empty (Fig. 8).

Fig. 7. ESEM photomicrograph showing NaCl crystallization at the binder/aggregate interface (surface of the plaster).

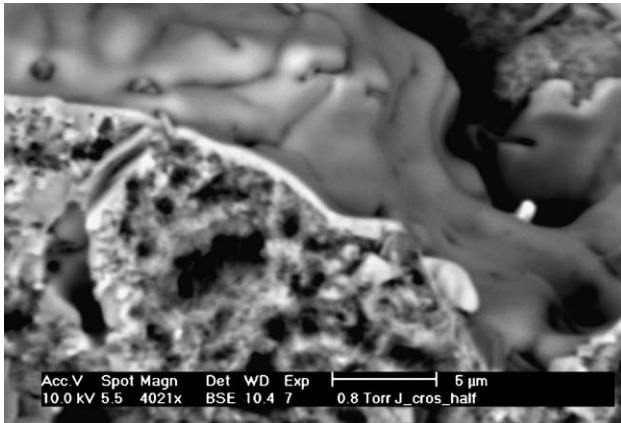
Fig. 8. ESEM photomicrograph showing NaCl crystallizing as a layer over the binder (cross section of the plaster).

The crystal habits of the sodium chloride have been also studied by means of a BSE detector. The crystal shape may vary from a smooth layer (usually observed in the bulk of the plaster) (Fig. 8) to an agglomeration of more or less regularly shaped crystals. Elongated needle like crystals are often observed on the evaporation surface, growing from the binder (Fig. 10).

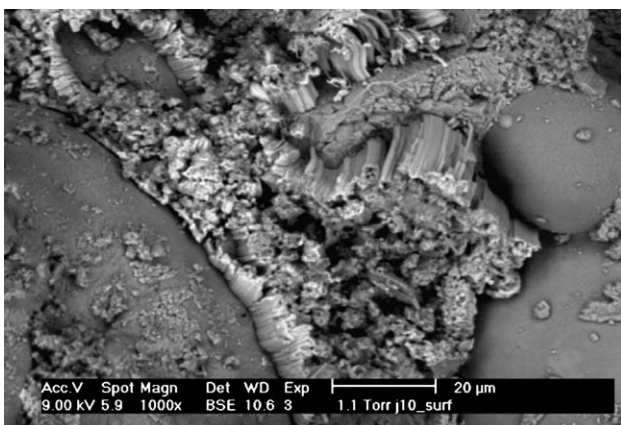
In specimens subjected to several salt crystallization and dissolution cycles damage occurred at the surface in the form of sanding: the loss of cohesion observed may be due to salt growing at the interface between the binder and the aggregate and pushing them apart (Fig. 9).

Fig. 9. ESEM photomicrograph showing NaCl crystallizing at the binder/aggregate interface (surface of the plaster).

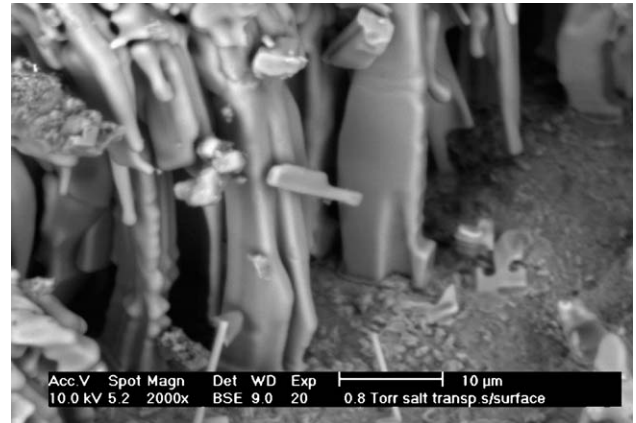
Fig. 10. ESEM photomicrograph showing needle-like NaCl crystals growing from the binder (surface of the plaster).

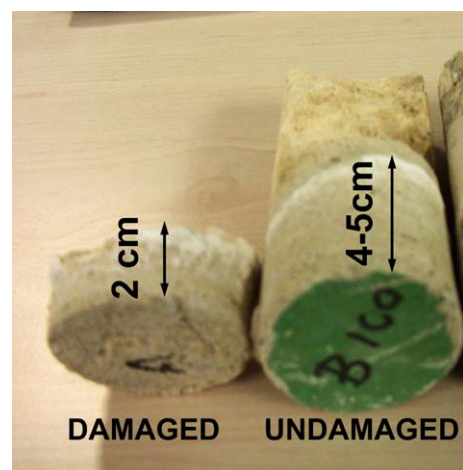
Fig. 11. Location of salt accumulation in damaged (A) and undamaged (B100) cores (building in Curacao, NLA).

In Curacao, after 7 years from the application of the plaster, cores were sampled from damaged and sound areas of the wall. It resulted that in the undamaged areas, where the plaster layer was thicker (4–5 cm), the salt had accumulated inside the plaster resulting in no visible damage. In the damaged area, where the plaster was thinner (2 cm), the salt had reached the surface giving place, instead of harmless efflorescences as hoped for a “salt transporting” plaster, to crystallization in the pores of the material and therefore to damage (Fig. 11). The damage appeared as peeling of the paint and sanding of the plaster layer after only 3 years from the application.

A sufficient thickness of the plaster layer is therefore necessary to avoid surface damage.

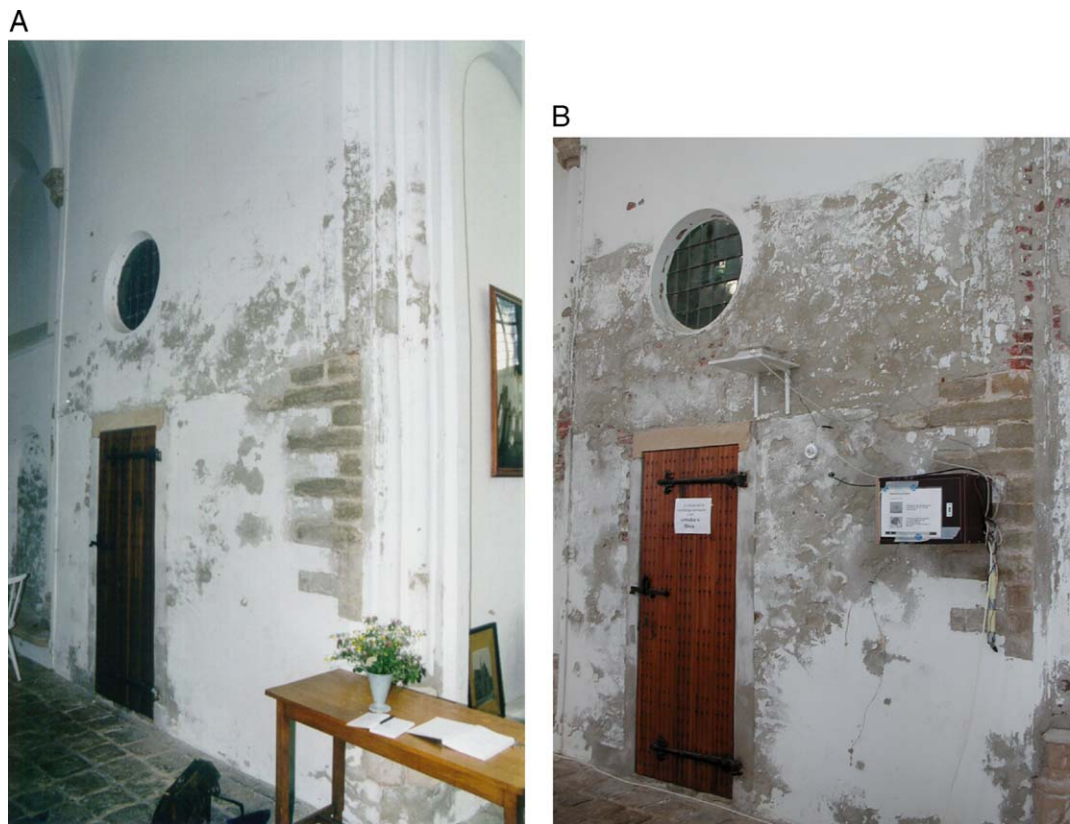
Fig. 12. Evolution of the damage in the years 2000 (left) and 2004 (right) (St. Nicholas Church, Brouwershaven, The Netherlands).

In the church of Brouwershaven, where the evaporation rate is slow and the moisture supply sufficient, salt accumulates near the outer surface of this plaster where it crystallizes, not only as harmless efflorescences, but also in the pores of the material, causing damage. Moreover, as soon as the salt has accumulated near the surface, it becomes very sensitive to the RH changes. If the salts present in the plaster are hygroscopic, (as in this case), they may undergo repeated dissolution/crystallization cycles whenever the RH of the air varies through the RH of crystallization of the salt(s). These dissolution/crystallization cycles enhance the decay. This process has been clearly demonstrated to be the cause of the damage occurring in the interior of the above mentioned church [9]. Due to the RH changes the hygroscopic salts present just beneath the surface of the plaster, dissolved and crystallized several times in a week, enhancing the decay. Clear increase of the damage has been observed in few years time (Fig. 12) in areas in which the RH of the air was the only moisture source (Fig. 13).

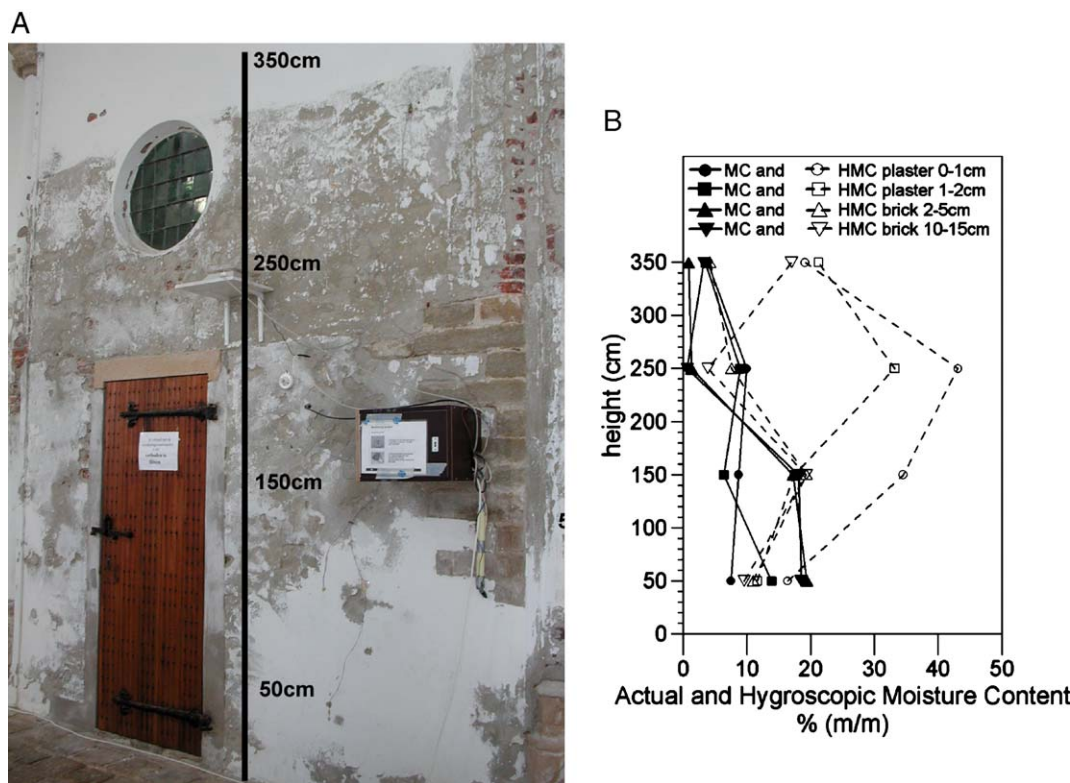
Fig. 13. Left: Sampling area; right: Actual Moisture Content (MC) and Hygroscopic Moisture Content (HMC) in the wall, showing that in the upper part of the damaged area no rising damp is present (St. Nicholas Church, Brouwershaven, The Netherlands).

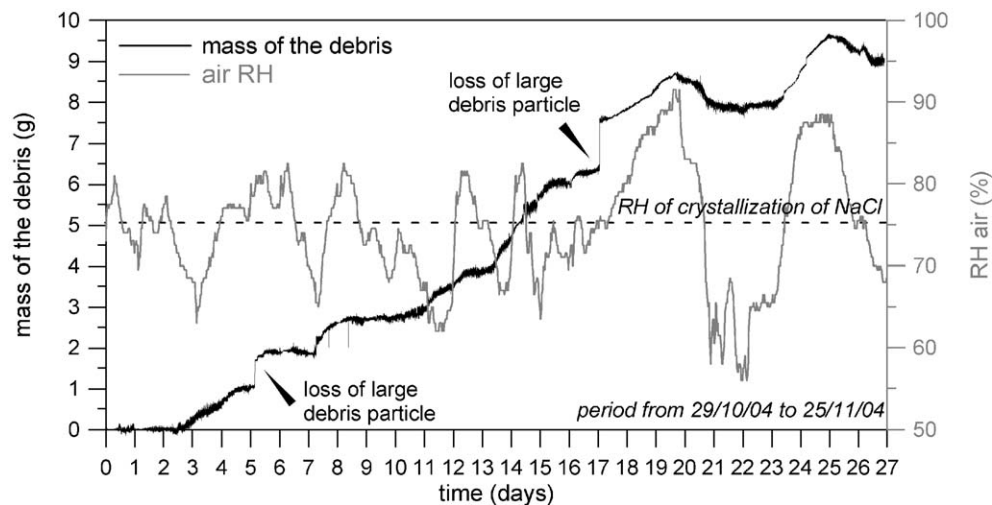
Fig. 14. Combined monitoring of the debris falling from the plastered wall and of the air RH: the graph shows that most of the debris are falling during the periods in which the RH increases (St. Nicholas Church, Brouwershaven, The Netherlands).

The damage, measured as debris falling from the wall, has been monitored together with the RH of the air: it resulted that most of the debris were falling when the RH increased and the salt, cementing the de-cohesioned particles of the plaster, dissolved (Fig. 14). This process has been reproduced and
