Extended studies of degradation mechanisms in the refractory lining of a rotary kiln for iron ore pellet production

Jesper Stjernberg^{a,*}, John C. Ion^a, Marta-Lena Antti^a, Lars-Olof Nordin^b, Bo Lindblom^b,
Magnus Odén^c

Changes, over a period of 8 years, in the chemical composition and morphology of deposit and lining materials in a production rotary kiln for iron ore pellet manufacture are described. The following have been studied: two types of refractory brick used as lining material; deposited chunk materials from the lining; the interaction zones between deposits and linings. Morphological changes at the deposit/lining interface, and the active chemical reactions, are established. Larger hematite grains in the deposit material (5–50 µm) primarily remain at the original deposit/lining interface. The remainder penetrates fissures, voids and brick joints, forms a laminar structure with corundum from the bricks, and migrates in grains in the lining material. Potassium penetrates more deeply into the bricks than hematite, resulting in the formation of kalsilite, leucite and potassium β-alumina, which contribute to degradation of the lining.

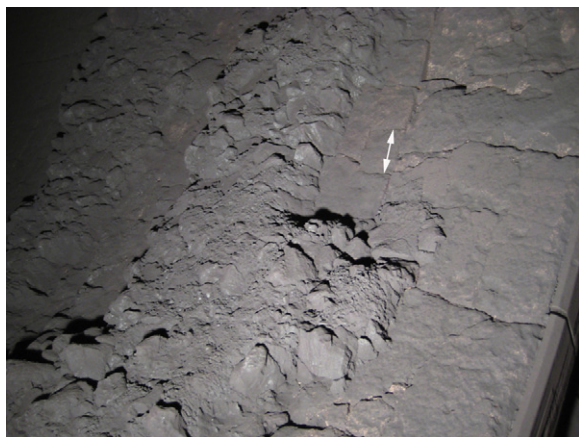
The formation and location of the deposits in the kiln varies, but in general, there is more deposition of material in the warmer zone closest to the burner. The deposition can reach a thickness up to 30 cm; with peaks protruding like stalactites, with lengths up to 1 m. However, some zones in the kiln can be without any deposition. A thin layer of deposition is considered protective, as it insulates and lowers the liner temperature, and is protective against wear. When this layer grows too thick, mechanical action occasionally causes fallout of heavy chunk formations that can cause exfoliation of the lining, creating a new hot face where pellet residues and fly ash once again come into contact with fresh lining material, and are able to deposit in chunks.

Fig. 1. Photo showing deposits in the kiln KK2, Kiruna, Sweden, June 2010. The white arrow in the image marks the brick width, which is 17.5 cm.

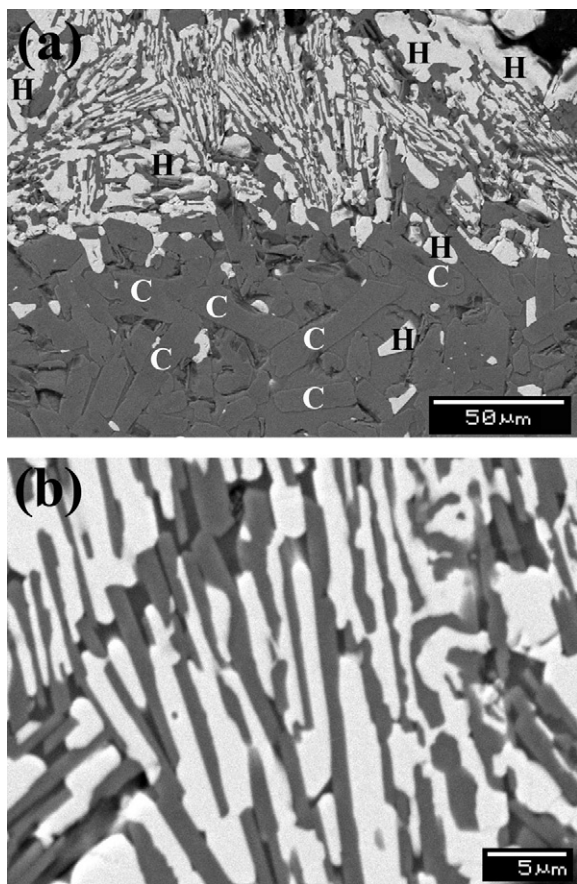
Fig. 3(a) and (b) shows the lining–deposit interface in a sample collected 6 m from the outlet of the kiln, where the bauxite based bricks have served as liners for 14 months. Cracks parallel to the hot face were observed at this location. In all the cracks examined some hematite from the deposit material remained on the lining material as the deposits flaked off, i.e. the deposit failed cohesively. The hematite dominated deposits seen in the top of Fig. 3(a) (white grains, marked H) remain on the brick surface in a distinct front. At some locations they form a laminar structure with alumina from the brick (corundum grains marked C), shown with a higher magnification in Fig. 3(b). The white lamellae comprised iron oxide with ~1 wt% of aluminium and ~3 wt% of titanium, while the dark lamellae comprised aluminium oxide with ~1 wt% each of potassium and silicon. Very little glassy bonding phase exists around the corundum grains in the lining material.

Fig. 3. SEM micrographs showing (a) a lining–deposit interface sample, collected 6 m from the outlet of the kiln, June 2010, and (b) a part of the deposit material in (a) with a higher magnification. H = hematite, C = corundum.

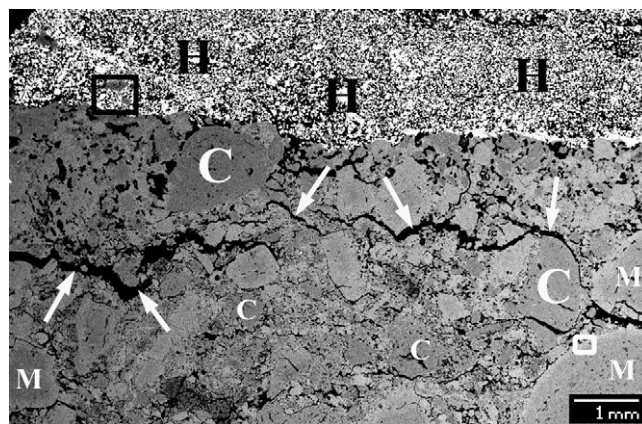
Fig. 4 shows the lining–deposit interface in a sample collected from the outlet of the kiln (to the right in Fig. 1), where bauxite based bricks have served as liners for 4 years. The hematite dominated deposit material is seen at the top of the micrograph

(white grains marked H) forming a distinct interface with the remaining brick. The white arrows in Fig. 4 mark a crack approximately parallel to the lining–deposit interface. Grains of mullite are marked M, corundum is marked C. (This convention is used hereafter.)

Fig. 4. SEM micrograph showing an overview of the interaction zone between deposit and lining, of a sample collected in the outlet of the kiln, June 2008. Arrows mark cracks in the lining. H = hematite, C = corundum, M = mullite.

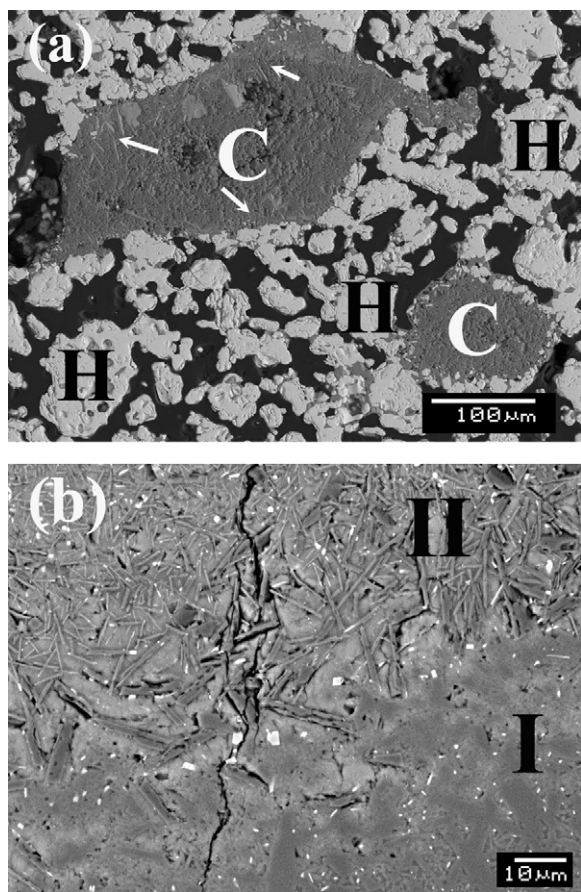
Fig. 5(a) and (b) are enlargements of the areas marked with black and white frames in Fig. 4. Dislodged corundum grains (the dark grains in Fig. 5(a)), are released by erosion when the grain boundaries become corroded in the lining, and migrate into the deposit material surrounded by hematite grains. Note also the needles of hematite formed closest to the surface inside the corundum grain (marked with white arrows in Fig. 5(a)). Hematite and corundum are isomorphous, and have been observed to form a solid solution at elevated temperatures.^{8,9} The finer interlocked mullite structure (marked I in Fig. 5(b)) loses its interlocking as it transforms to rod-like crystals (marked II in Fig. 5(b)), around the mullite aggregates. This is also observed around all other mullite aggregates at this location. White spots in the micrograph are regions of high titanium concentration.

Fig. 5. SEM micrographs, showing (a) dislodged corundum grains (dark grains) migrated through the deposit material, and (b) mullite aggregate transformed in contact with potassium. Note the difference in magnification in the images. H = hematite, C = corundum, I = primary mullite, II = secondary mullite.

The effect of potassium on mullite aggregates in the lining is to cause the aggregates to lose their interlocking form: the mullite transforms to needle-like formations in the lining (seen in Fig. 5(b)). These structures are also observed by Iqbal and Lee,^{10–12} where primary mullite was produced from clays. They observed nucleation of primary mullite, with sizes less than 0.5 μm , while the alumina-rich secondary mullite started to grow from the primary mullite, in needle shaped formations with lengths greater than 1 μm , in the presence of an amorphous

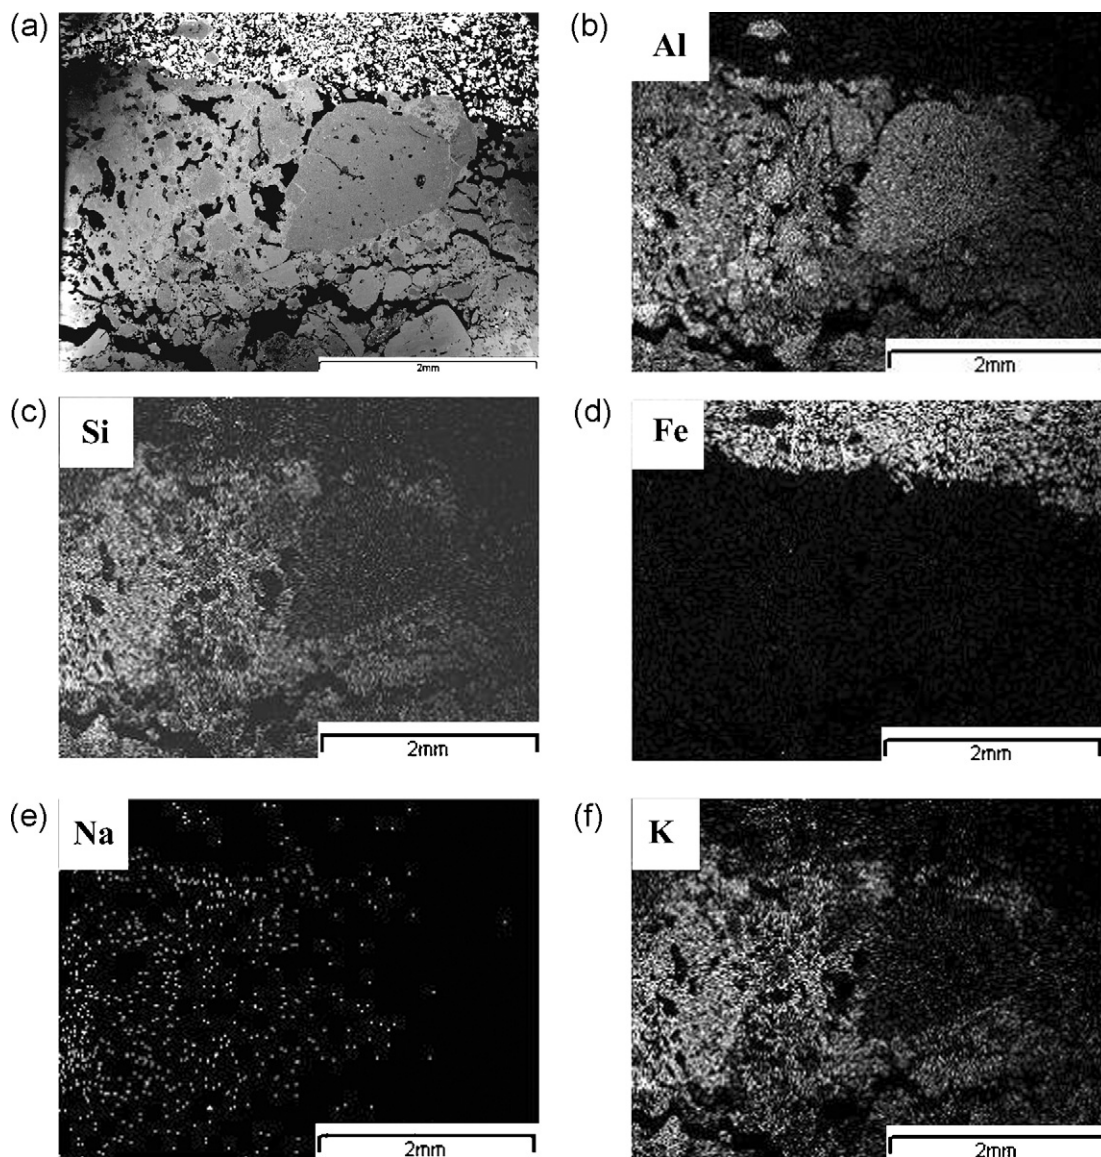
from the same area are shown in Fig. 6(b)–(f). Iron is seen to remain on the original lining surface. Potassium however, has migrated deep into the lining, and reacted primarily with mullite, while the reaction with corundum is more moderate. Very little sodium is detected into the lining material, compared with potassium.

Fig. 6. (a) Back scattered SEM micrograph of parts of Fig. 4, and (b) Al, (c) Si, (d) Fe, (e) Na, (f) K shows EDS mappings of the corresponding area.

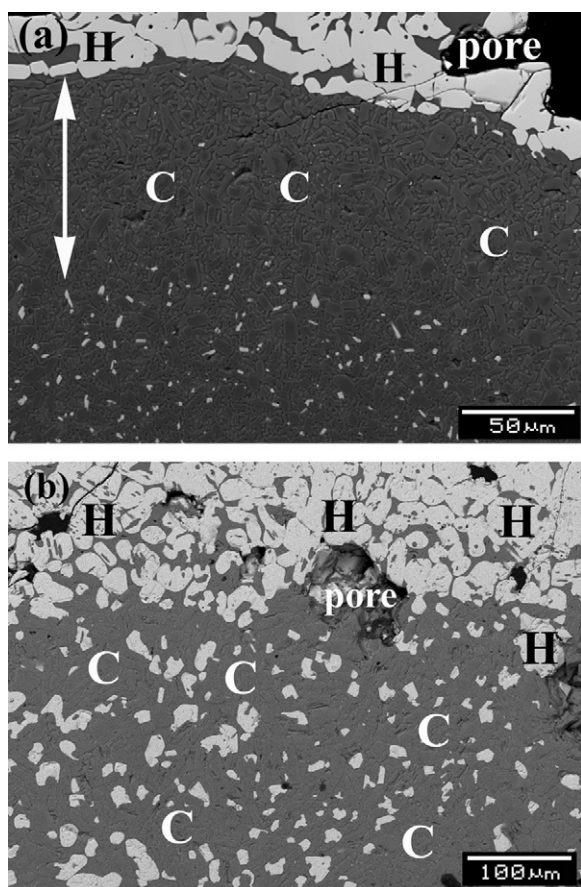
Fig. 7(a) and (b) shows the deposit–lining interface in a sample collected 12 m from the outlet of the kiln, where the bauxite based bricks have served as liners for 6 years. These two samples of the same quality, collected at the same time and location in the kiln, exhibited different properties. In Fig. 7(a), the hematite dominated deposit material seen in the top of the micrograph remains on the brick surface in a distinct front. The grains of hematite in the deposit material have sintered, and increased the particle-to-particle contact area, which results in grain growth and a more homogenous layer of hematite. Titanium oxide is observed as small white grains in the lining. However, a zone of $\sim 100\ \mu\text{m}$ closest to the deposit material (marked with a white arrow) is depleted in titanium oxide. In Fig. 7(b) however, migration of hematite grains through the lining material is seen. The corundum grains are embedded in a more glassy grain boundary phase in Fig. 7(a), compared with Fig. 7(b).

Fig. 7. (a) and (b) SEM micrographs showing lining–deposit interface of samples collected 12 m from the outlet of the kiln, June 2010. Arrow marks Ti depleted zone, H = hematite, C = corundum.

Titanium oxide inclusions were observed in the bulk of the liner, Fig. 7(a). However, a zone $\sim 100\ \mu\text{m}$ in width closest to the deposit was depleted of these inclusions, possibly by migration through the lining towards the hematite in the deposit. Moreover, iron oxide and alumina form a laminar structure (as seen in Fig. 3(b)) where it appears that while potassium diffuses from the iron oxide into the alumina, titanium migrates from the alumina zone and diffuses into the iron oxide lamella. This might be the driving force for the formation for this laminar structure. Separation of titanium from alumina, and instead formation of a solid solution between titanium and iron oxide, is in agreement with previous work.⁸ One reason for this is that corundum does not dissolve titanium in its lattice.¹⁷ The separation of titanium oxide from alumina rich regions in the lining, by migration

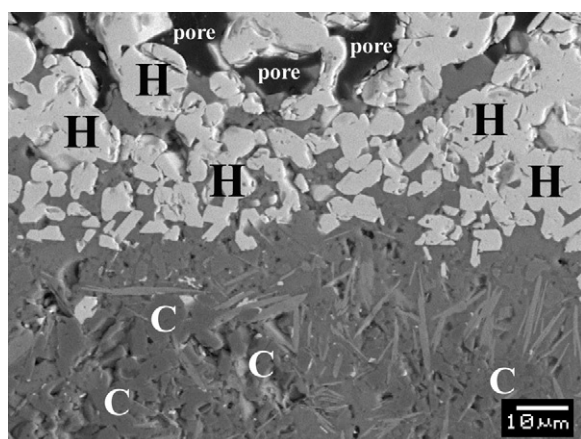
Fig. 8 shows the deposit–lining interface in a sample collected 30 m from the outlet (3 m from inlet) of the kiln, where the chamotte based bricks have served as liners for 6 years. Deposit material, dominated by hematite (white grains), is seen in the top of the micrograph. Hematite grains $5\text{--}50\ \mu\text{m}$ in diameter remained on the lining surface in a distinct front. Corundum grains were detected in the lining material, together with some rod-like formations. A zone in which grains from the brick mixed with hematite grains form a denser layer ($\sim 30\ \mu\text{m}$ thick) than the more porous deposit material above.

Fig. 8. SEM micrograph showing a deposit–lining interface sample, collected 30 m from the outlet of the kiln, June 2008. H = hematite, C = corundum.

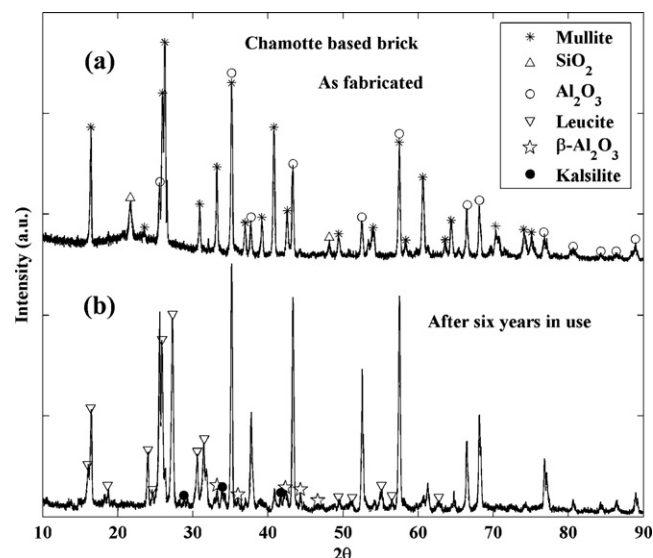
Fig. 9(a) and (b) shows XRD diffraction patterns recorded from a sample collected at this location, compared with that recorded from an as-fabricated brick of similar quality. In Fig. 9(a) a majority of confirmed peaks correspond to corundum and mullite, including traces of cristobalite and quartz (both SiO_2). In Fig. 9(b) mullite is seen to be almost depleted to an undetectable level, as is SiO_2 . Instead, new phases have formed, notably leucite ($\text{K}_2\text{O}\cdot\text{Al}_2\text{O}_3\cdot 4\text{SiO}_2$). Minor peaks in the diffraction pattern correspond to potassium β -alumina ($\text{K}_2\text{O}\cdot 11\text{Al}_2\text{O}_3$) and kalsilite ($\text{K}_2\text{O}\cdot\text{Al}_2\text{O}_3\cdot 2\text{SiO}_2$); these are phases detected in the sample but in concentrations less prominent than leucite and corundum.

Fig. 9. (a) Diffractogram recorded on a brick sample that has served as refractory liner for 6 years in the kiln (collected 3 m from the inlet of the kiln, June 2008) and (b) diffractogram recorded on a brick sample in its fabricated condition.

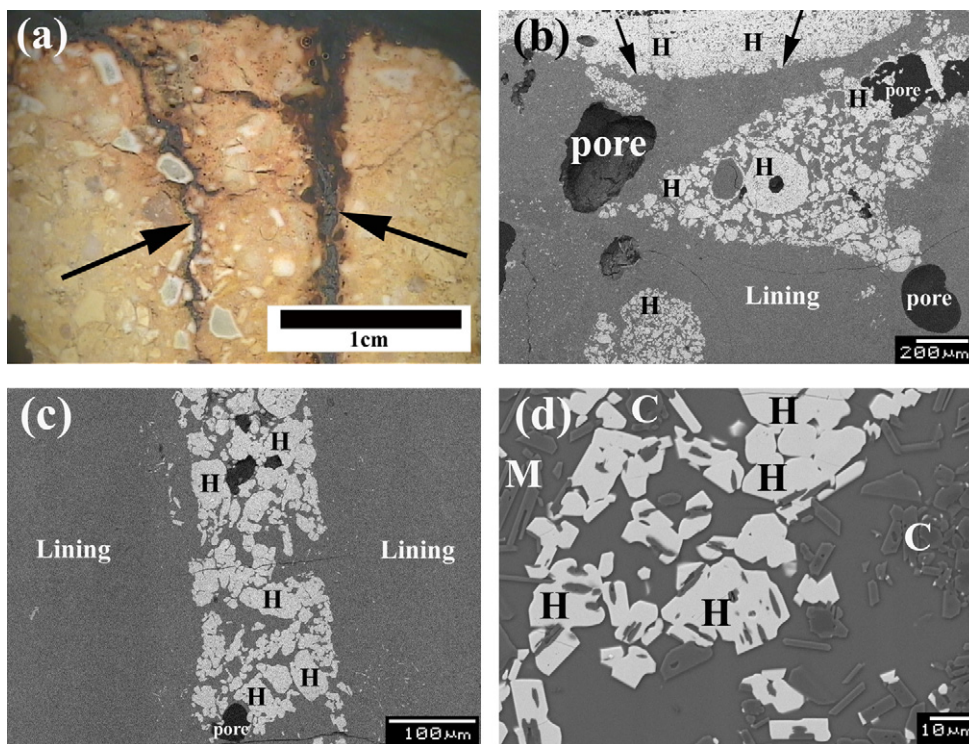
Fig. 10(a)–(d) shows the deposit–lining interface in samples collected 25 m from the outlet of the kiln, where the chamotte based bricks have served as liners for 8 years. Hematite is the dominant phase in the deposit material (dark in the OM micrograph and white in SEM micrographs). Fig. 10(a) shows how material from the deposits has penetrated fissures (arrow to left in the micrograph) and joints (arrow to right in the micrograph). Hematite filled joints are $400\text{--}800\ \mu\text{m}$ broad while hematite filled fissures are $100\text{--}200\ \mu\text{m}$ in width. Fig. 10(b) shows how the grains of hematite have started to sinter, resulting in grain growth and a more homogenous layer of hematite at the interface (marked with arrows). Clusters of hematite, which have migrated through the lining, are formed deeper in the lining. These clusters give the lining a reddish colour, Fig. 10(a). The material in the bonding phase between the hematite grains that migrated through fissures and joints appears to be of a non-crystalline morphology (Fig. 10(c) and (d)). This bonding phase exhibits high concentrations of potassium (above 10 wt%) and sodium ($\sim 3\ \text{wt}\%$), with traces of sulphur and phosphorus.

Fig. 10. (a) Optical micrograph showing a deposit–lining interface sample, where the arrow to left marks a fissure and the arrow to right marks a brick joint, (b) SEM micrograph showing deposit–lining interface where hematite has migrated into the lining, (c and d) SEM micrographs hematite filled fissures. H = hematite, C = corundum. All samples collected 25 m from the outlet of the kiln, June 2010.

The penetration of deposit material into fissures and joints acts like a glue in the brick joints, such that the bricks are sintered together and act as a monolithic lining. This is probably one of the reasons that the lining could serve as long as 8 years in one location (collected 25 m from the outlet in June 2010). Nevertheless, the zone of iron penetration is just a few mm, and the concentrations of iron containing phases were still too low to be detected by XRD analysis. However, a high concentration of cristobalite is still present, which is significant for a brick that has served as liner for 8 years at a location where fly ash falls.
