Sample Preparation — the Key to SEM Studies of Failed Concrete

Stella L. Marusin

Wiss, Janney, Elstner Associates, Inc., 330 Pfingsten Road, Northbrook, IL 60062, USA

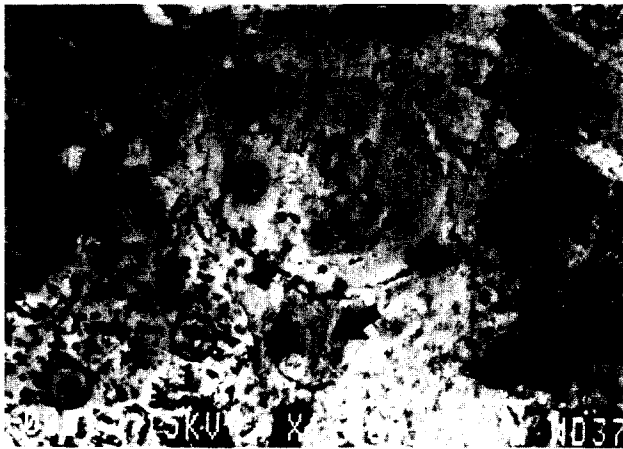
Fig. 8. FTS — another SE micrograph of a badly damaged concrete sample; note the sulfur accumulation of arrowed area and presence of aggregate particles P in a dot map study in Fig. 9 (1000 ×).

Based on our experience, FTS (preparation described by Gudmunson *et al.*²²) may not be suitable for many SEM studies. In addition to all the disadvantages described with ordinary TS, the original or newly created cracks and voids are filled and widened with fluorescent material. Such a typical and important feature of DEF as the cracks radiating from DEF in paste are destroyed by the sample preparation. As shown in Fig. 5 there is no significant difference between SE and BS images for FTS. DEF, identified by our X-ray studies, is hardly visible in a large void (A), and it is almost invisible in the paste and at the aggregate particle–paste interface (see arrows). Due to the FTS preparation, SEM investigations must be done almost exclusively on BS images. As shown in Figs 6–8, some locations are so badly damaged by the preparation that it is not possible to identify DEF (or other crystals) in SE micrographs, even if high magnification is used. An SE micrograph of badly damaged DEF of location B in Fig. 5 is in Fig. 6, and of location C is in Fig. 7. Presence of DEF in both locations was identified by X-ray elemental analysis. Another SE micrograph of the badly damaged concrete samples in Fig. 8 does not provide any useful information. Even the presence of the aggregate particle P is undetectable without a dot map study in Fig. 9. Although sulfur accumulations shown in the dot map study of the arrowed location in Fig. 8 were identified as ettringite by X-ray elemental analysis, the smearing of com-

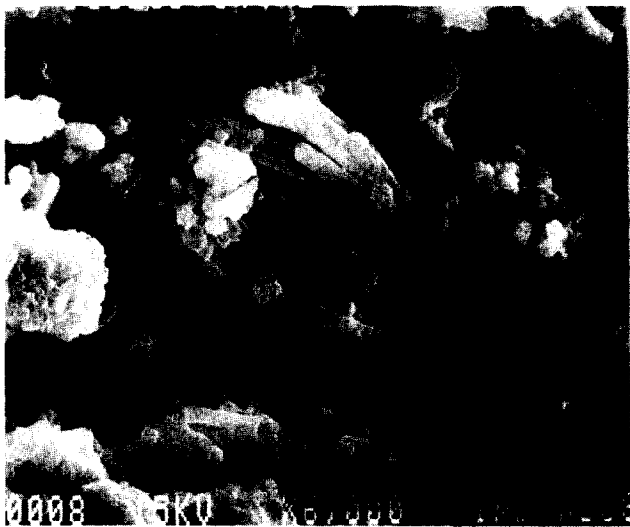
Fig. 15. SUS — SE micrograph of DEF crystals at location ▼ in Fig. 14 at 6000 ×.

Unpolished surfaces, obtained by cutting the sample with a diamond bladed saw, retain original cracking patterns and crystals. As shown in Fig. 13, both SE and BS images can be successfully used for this investigation. As shown in Fig. 14, sulfur accumulations are clearly shown in dot map studies and, as shown in Fig. 15, crystalline morphology can usually be clearly seen on SE images at high magnifications. A graph of the X-ray elemental analysis and an oxide calculation of the DEF of Fig. 15 are shown in Fig. 16. A typical example of DEF crystals in cement paste with cracks radiating into the surrounding locations is shown in Fig. 17.
