# Seismic retrofitting of expressway bridges in Japan

## 2. Seismic retrofit of high hollow circular reinforced concrete piers having cut-off of longitudinal reinforcement and varied wall thickness

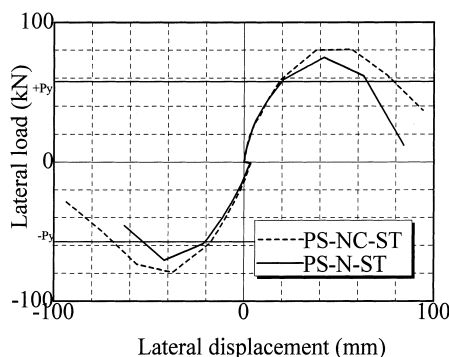
Fig. 8. Envelope of load-displacement curve (1).

**Load-bearing behavior and ductility ratio:** Envelopes of load-displacement curves obtained by the loading tests for specimens PS-N-ST and PS-NC-ST are shown in Fig. 8.

Results of the tests are listed in Table 5. For specimen PS-N-ST, yield displacement ( $\delta y$ ) was 21.0 mm. At the point, yield strain was already exceeded for the outermost longitudinal reinforcement in cross-sections Ir and Ic. Since the cross-section was circular, the difference between the load causing the outermost longitudinal reinforcement to yield and the ultimate strength was large. With increase in the applied displacement, strength increased, and yielding occurred consecutively upward from the cross-section IIc to IIIc and so on. At the time of displacement of  $1.5 \delta y$ , the outermost reinforcement at all cut-off points yielded. While the calculated ultimate strength in the cross-section Ir was 87.2 kN, strength decreased from the peak of 74.5 kN at  $2 \delta y$  due to the extension growth of diagonal cracks between zones III and IV, and at around  $3.5 \delta y$  suddenly decreased due to the crushing of concrete at the top of the reinforced concrete column. Yield load for PS-NC-ST, with concrete compressive strength 1.8 times that of PS-N-ST, was calculated as 62.8 kN. On PS-NC-ST, the outermost longitudinal reinforcement already yielded in the cross-sections Ir and Ic at 59.4 kN as for PS-N-ST, and at the time of displacement 1.5 times that at the yield point or at a displacement of 8.8 mm ( $\delta y$ ), the outermost longitudinal reinforcement at the cut-off points in the cross-sections IIc and IIIc also yielded. Large concrete strength and solid cross-section at the top of the reinforced concrete column resulted in no substantial decrease in strength until  $+3 \delta y$ . The maxi-

um strength was 80.4 kN, slightly larger than that of PS-N-ST. Beyond that point, no concrete crushed at the top of the column unlike PS-N-ST. Load carrying capacity, however, decreased due to shear failure in zones III and IV.

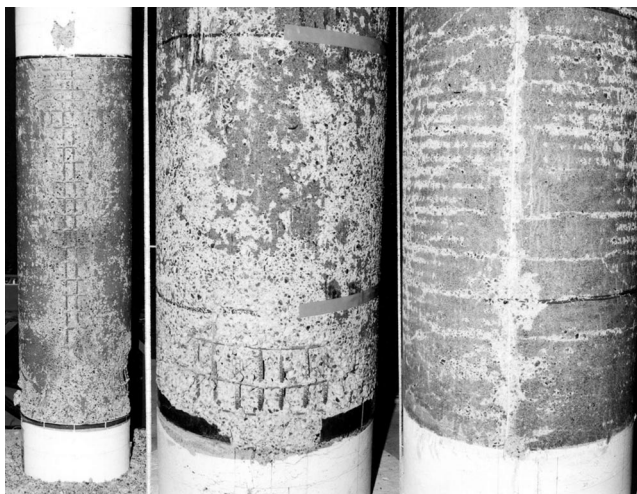
Fig. 14. Conditions after CFS were peeled off.

Fig. 14(a)–(c) show the conditions of specimens after CFS were peeled off. Fig. 14(a) shows the condition of specimen PS-CF-ST on the surface in loading direction (the west surface). It is clear that the surface of concrete delaminated all over with a uniform width, and that the

concrete on the surface transverse to the loading direction (north-south surface) at the bottom end of reinforcement crushed. Fig. 14(b) and (c) show zones I and II on the north side of specimens PS-CF2-ST and PS-CF3-ST, respectively. For specimen PS-CF2-ST, concrete at the bottom end of reinforced portion was destroyed, and longitudinal bars buckled. No noticeable damage was, however, observed in any other area. Only traces of flexural and diagonal cracks remained in non-reinforced areas in zone IV. In specimen PS-CF3-ST, no serious damage was observed but remaining flexural cracks were observed overall, and traces of diagonal cracks, although in small numbers, were also found. There was also delamination of concrete cover due to local crush near cross-section Ic. Specimen PS-CF2-ST seems to have suffered greater damage than PS-CF3-ST, but damaged locations were limited and ultimate strength was slightly larger.

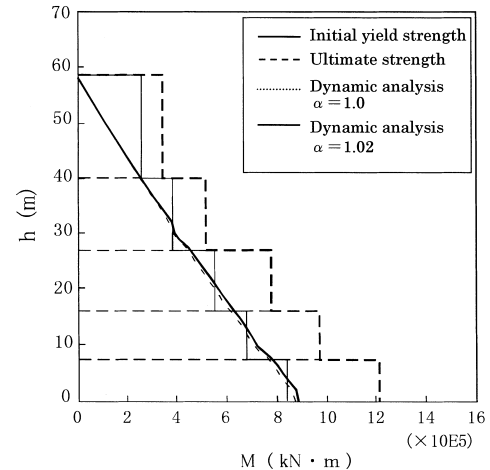
Fig. 16. Comparison between seismic bending moment and bending strength.

As a result of the analysis, it was found that type-I seismic wave (inter-plate type) had larger response acceleration because the pier had a long natural period. The maximum response acceleration was largest at the center of gravity of the superstructure at around 600 gal, and tended to decrease downward. The first mode was predominant. The tendency of response acceleration to decrease was declining at the middle height, and a slight influence of the second mode of vibration was also observed. Fig. 16 is a comparison between bending moment acting during an earthquake and the bending strength of the existing pier before retrofit. As shown in the figure, it was revealed that the design response acceleration caused no yielding around the bottom, but the yield point had already been reached in cut-off sections. Reinforcement was, therefore, applied to prevent the cut-off sections from yielding until the yield around the bottom. The acting bending moment at the time of yield around the bottom was obtained based on the assumption that maximum response acceleration in-

creased at the same rate at all heights until yielding of the bottom.

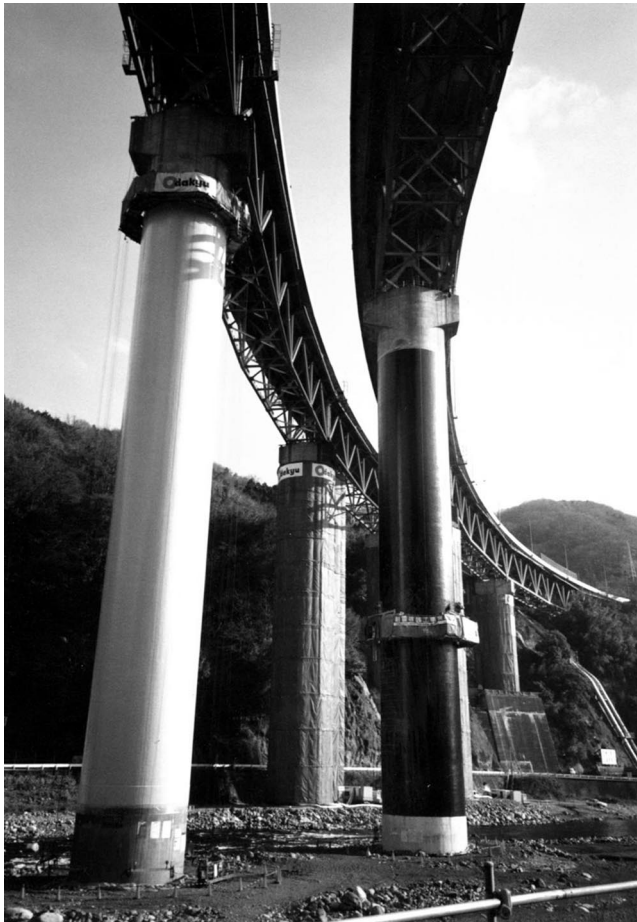
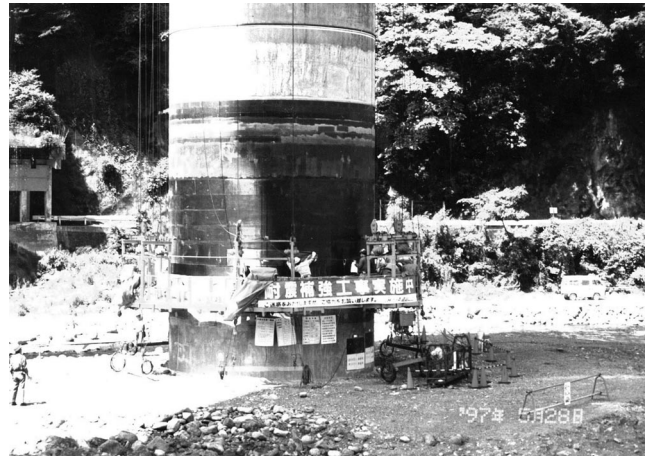
Fig. 18. Application of CFS jacketing.

CFS jacketing, the effect of the CFS jacketing on the prevention of shear failure was verified. The CFS content was determined by a non-linear earthquake response analysis in consideration of a multi-degree-of-freedom system. Figs. 18 and 19 show the application of the CFS jacketing.
