Construction of Benten Viaduct, rigid-frame bridge with seismic isolators at the foot of piers

Hanshin Expressway Public Corporation, 4-1-3 Kyutaro-machi, Chuo-ku, Osaka, Japan

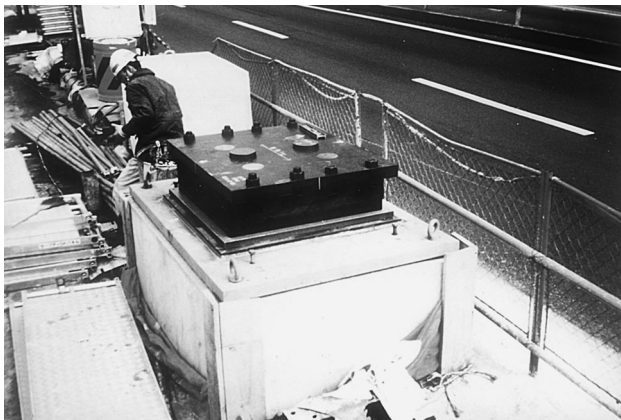
Fig. 7. Seismic isolation bearing.

Seismic isolation bearing was designed referring to the 'Manual of Isolation Design for Highway Bridge'. There are two types of seismic isolators: lead rubber bearing (LRB) and high damping rubber (HDR). LRB is a laminated-rubber bearing including lead plugs inside to give bi-linear deformation characteristic, while HDR is made of laminated super elastic gum.

Benten Viaduct has so many dimensions statically indeterminate that LRB was adopted because it would be softer on various temperature ranges and harder under strong earthquake force. Each LRB bearing was designed

to be of the same height nevertheless the difference of the design supporting load in order to make the deformation characteristics similar. The appearance of seismic isolation bearing is shown in Fig. 7.

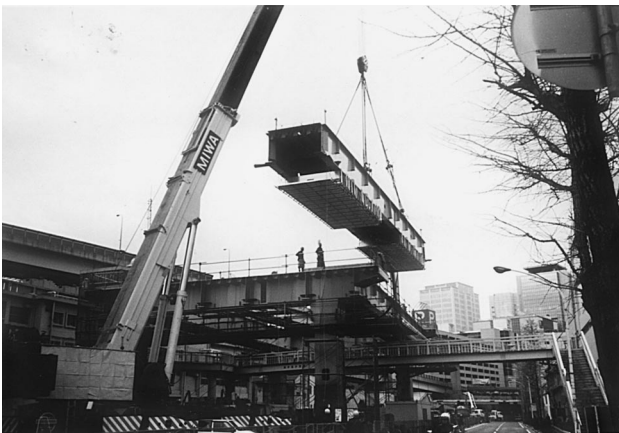
Fig. 9. Erection of main girder.

difference of temperature of $\pm 10^{\circ}\text{C}$. To keep accuracy of erection, columns and cross-beams were built up first. After that, plate girders with steel deck were erected measuring and correcting the errors at each pier point. The deviation of erection was less than 5 mm at every isolators.

Camber for the dead load was solved statically using a partial rigid-frame model. It was found that a horizontal deformation of 3.2–4.7 mm would be caused by the influence of dead load. Since the actual stiffness of each member was supposed to be stronger than the designed one, the influence of camber on the isolators due to the dead load was ignored (see Figs. 9 and 10).

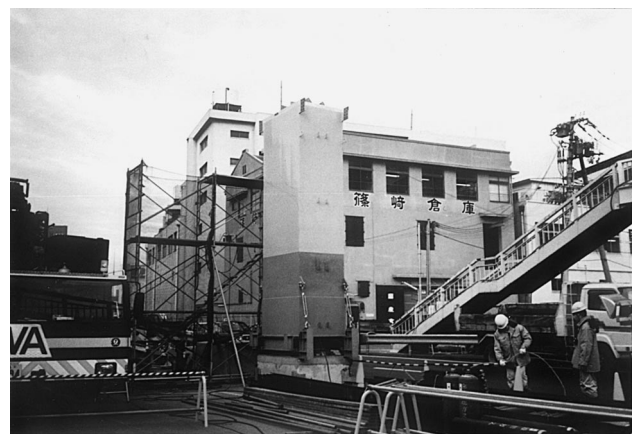
Fig. 11. Temporary stabilizer system for column.

The steel piers were unstable on the soft seismic isolation bearings until they formed a three-dimensional rigid frame. In the practical fieldwork, a stabilizer system was invented as shown in Fig. 11. This system was introduced to stabilize the columns before the erection of girder and deck, and it could also secure the accuracy of piers and bearings. The stabilizer was designed to have a temporary horizontal bearing capacity against 0.15 G.
