Effect of rebar cleanliness and repair materials on reinforcement corrosion and flexural strength of repaired concrete beams

Abstract

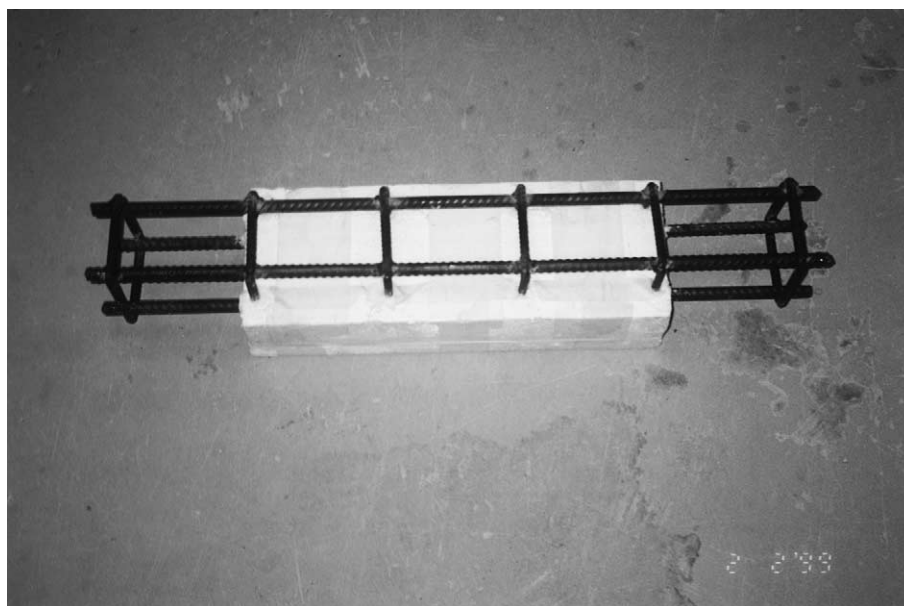
Fig. 1. Steel cage with Styrofoam before concrete casting.

Reinforced concrete beam specimens measuring 15 cm × 15 cm in cross-section and 75-cm long were utilized for accelerated reinforcement corrosion studies and flexural strength determination. Steel cages consisting of four 12-mm diameter bars, 70 cm in length and held together with six stirrups of 9-mm diameter were fabricated. Only the top reinforcement with stirrups was exposed and the other portion was temporarily covered with Styrofoam. Fig. 1 shows the steel cage with the styrofoam before concrete casting. After casting, the specimens were cured by covering with wet burlap for 14 days. After curing, the styrofoam was removed and the exposed rebars were corroded by spraying saline water (5% NaCl) for about six months until a significant degree of reinforcement corrosion was evident. The rebars were then cleaned by the two methods, namely SB and with a wire brush (HT). After cleaning, a zinc-rich epoxy

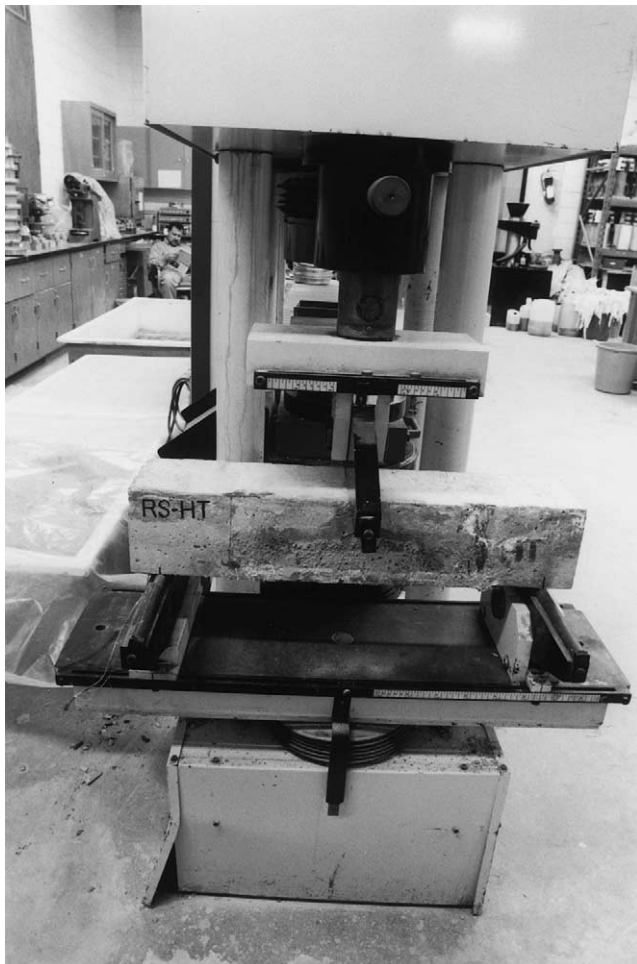
Fig. 2. Setup for determination of flexural strength.

procedure [11]. The specimens were placed on the testing machine with the repaired portion of the beam facing down and with a span length 65 cm. The beam supports were 5 cm away from the edge of the beam, as shown in Fig. 2. The load was applied at a rate of 0.5 kN/s. The specimens were loaded until failure, and the maximum load was recorded.

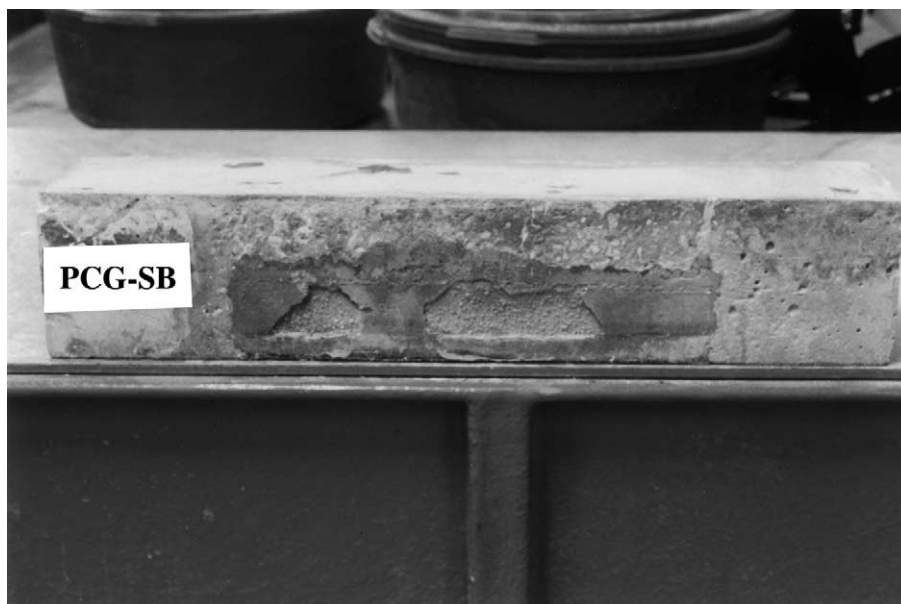
Fig. 6. PCG-SB-4 beam after accelerated reinforcement corrosion.

Figs. 6 and 7 show the PCG-SB-4 and CG-SB-4 beams, respectively, after accelerated corrosion exposure. The superiority of PCG over CG in the corrosion protection is clearly visible in these two plates. A similar conclusion can be derived from comparing Figs. 8 and 9, for PCG-HT-4 and CG-HT-4 beams, respectively. Moreover, by comparing Figs. 6 and 8, it can be noted that the corrosion product formed at the interface between the concrete and the repair mortar is more in the specimens repaired with CG than those repaired with PCG. This indicates that sand-blasted steel bar corroded at a lower rate than the hand tool cleaned steel bar. A similar argument can be put forward by comparing Fig. 7 with Fig. 9.

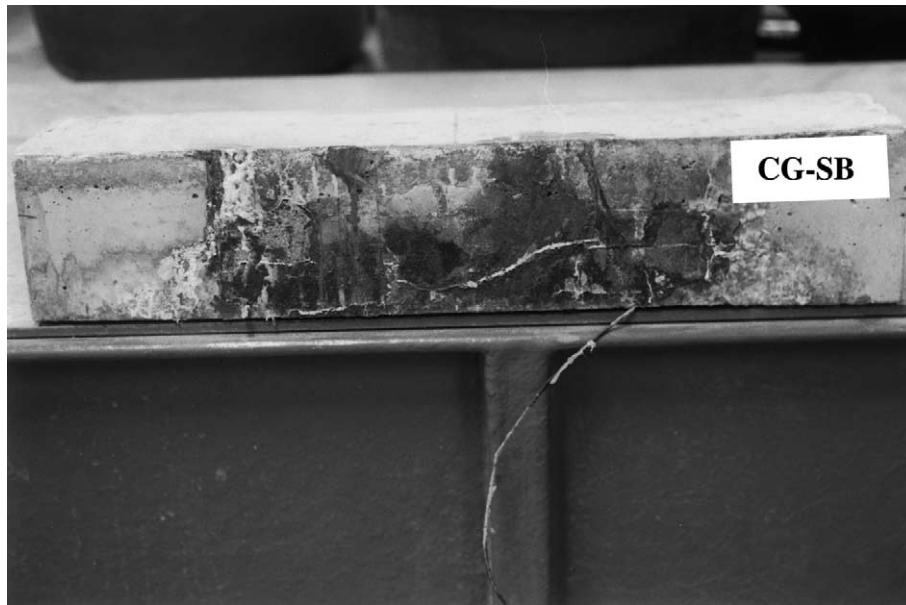
Fig. 7. CG–SB-4 beam after accelerated reinforcement corrosion.

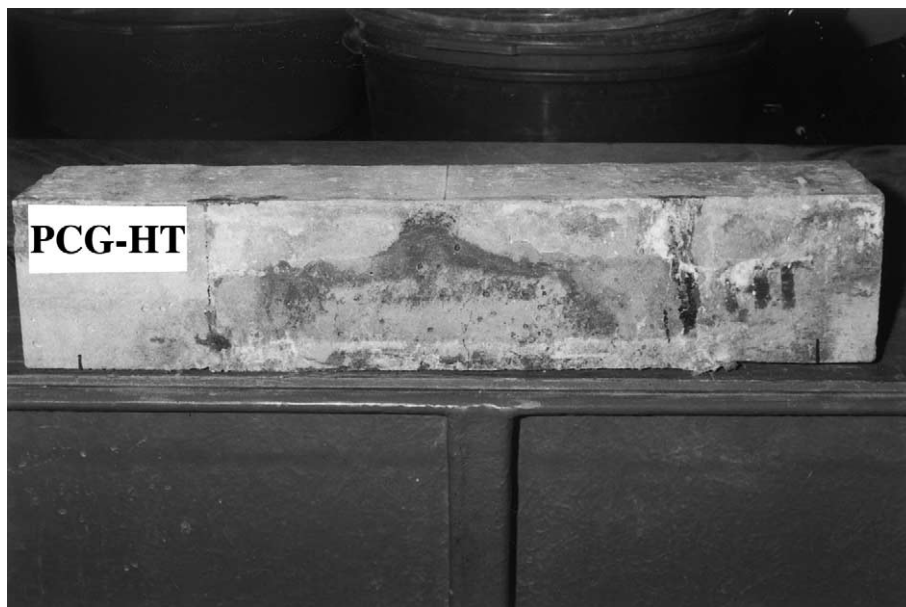
Fig. 8. PCG–HT-4 beam after accelerated reinforcement corrosion.

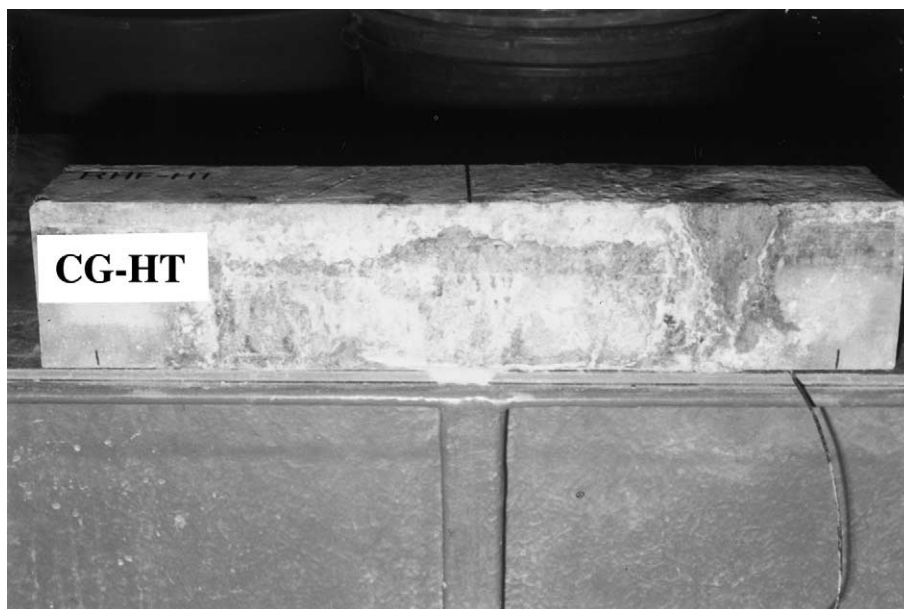
Fig. 9. CG-HT-4 beam after accelerated reinforcement corrosion.

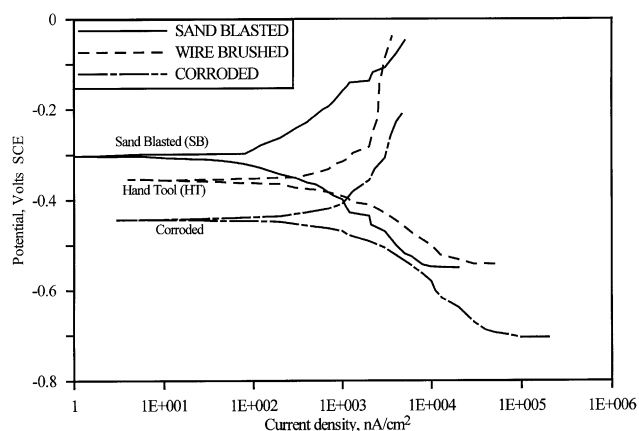
Fig. 10. Potentiodynamic curves for steel with varying surface conditions.

Fig. 10 shows the potentiodynamic curves for the corroded steel bars and those cleaned by SB and wire brushing. The corroded steel bars exhibited a more cathodic behavior compared to the bars cleaned by wire brushing and SB. Further, the sand-blasted steel bars exhibited a more anodic behavior than those cleaned by wire brushing. The current required for the transition from the cathodic to the anodic region was almost similar in the corroded steel bars and those cleaned by wire brushing, while it was marginally lower in the steel bars cleaned by SB. Fig. 11 shows the LPR curves for SB, HT, and corroded steel specimens. From these

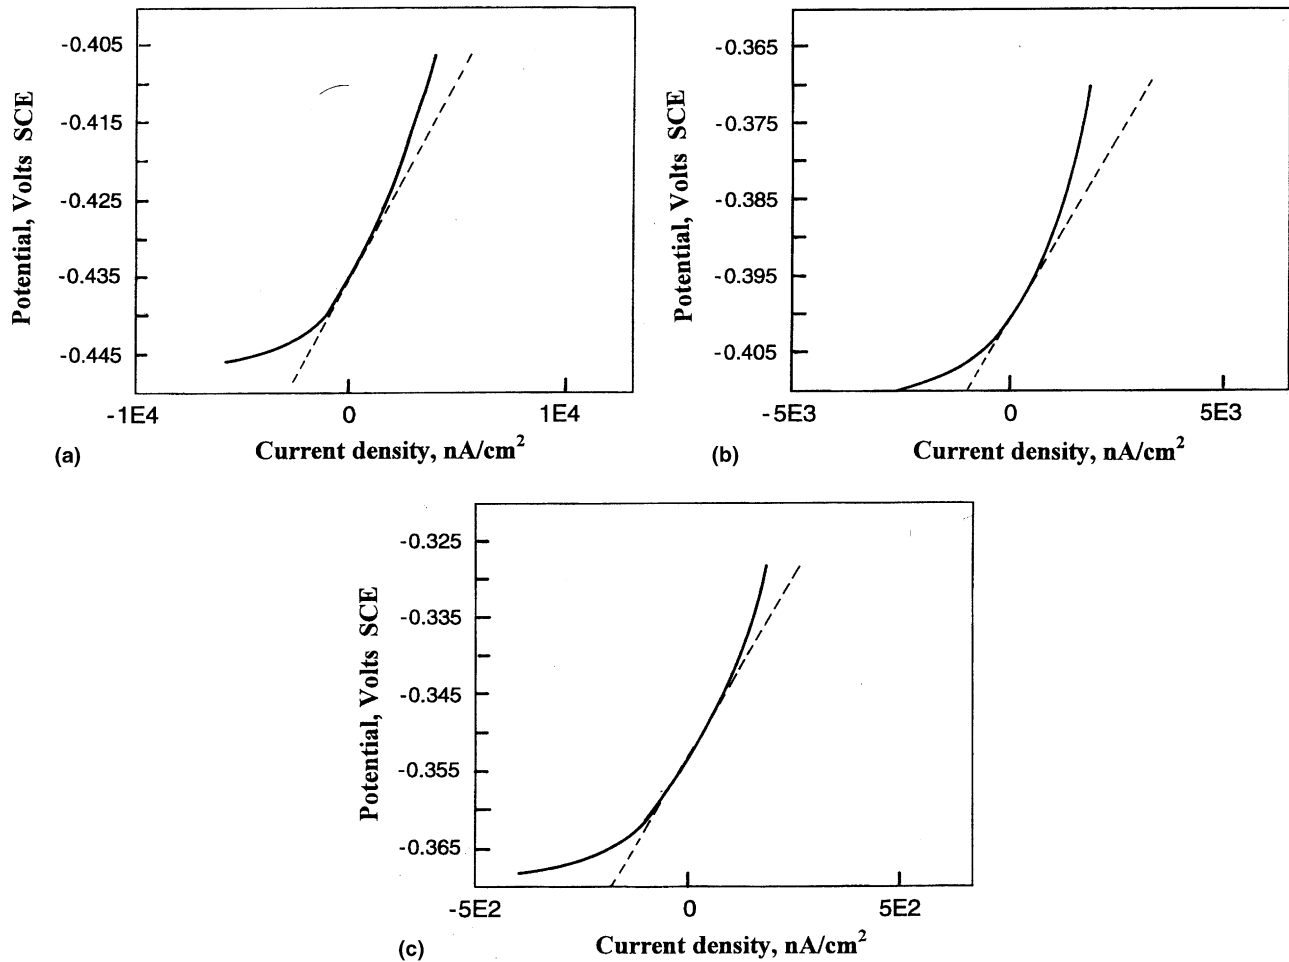
Fig. 11. Linear polarization resistance curves for steel with varying surface conditions (a) SB, (b) HT and (c) corroded.

curves, the values of E_{corr} , R_p , I_{corr} , and corrosion rate were evaluated and summarized in Table 9. The polarization resistance (R_p) of steel bars cleaned by SB was the highest followed by steel bars cleaned by hand tool. The R_p of the corroded bars was the lowest. Consequently, the average corrosion rate of sand-blasted steel was the lowest being 0.154 mils per year (mpy). The corrosion rate of wire brushed and corroded steels was 1.334 and 2.187 mpy, respectively.
