# The thaumasite form of sulfate attack in Portland-limestone cement mortars stored in magnesium sulfate solution

## Abstract

Mortar prisms ( $40 \times 40 \times 160 \text{ mm}^3$ ) made at a water:solids ratio of 0.5 and a cement:aggregate ratio of 1:2.5 from Portland cement with 0%, 5%, 15% and 35% limestone additions were cured in water at 20 °C for 28 days. They were subsequently stored in air and submerged in 1.8% magnesium sulfate solution at 5 and 20 °C for a year. The prisms were inspected visually every 28 days, the solution was changed every 84 days, and selected samples were examined by X-ray diffraction (XRD), differential scanning calorimetry (DSC) and scanning electron microscopy (SEM) after specified intervals. The thaumasite form of sulfate attack was readily identified in the ordinary Portland cement (OPC) – 35% limestone mortar after 126 days storage in magnesium sulfate solution. The surface layer of the prism had spalled and was mushy, while the core was still solid and sound. Gypsum, thaumasite and brucite were identified in the surface layer. Secondary electron images of polished sections of deteriorated Portland-limestone cement mortars revealed the micros

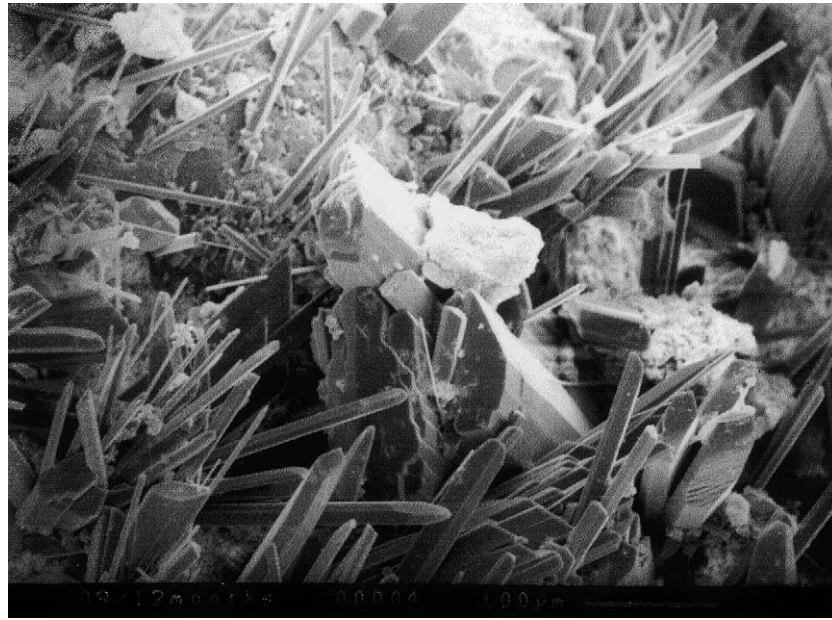
Sections of a deteriorated OPC – 35% limestone mortar stored in 1.8%  $\text{MgSO}_4$  solution at 5 °C for 364 days were examined by SEM, as stub samples, in order to assess the external morphology of the prisms. A relatively low magnification, secondary electron image of the surface is shown in Fig. 6. Large subhedral gypsum

Fig. 6. Secondary electron image of a deteriorated OPC – 35% limestone cement mortar stored in 1.8%  $\text{MgSO}_4$  solution at 5 °C for 364 days.

tabulae (~50 mm) can be seen in the centre of the micrograph, surrounded by a mixture of smaller gypsum crystals and long thin needles of epsomite (up to 200  $\mu\text{m}$  in length). Epsomite had formed as a result of direct precipitation from magnesium sulfate solution, whereas gypsum had formed from sulfate attack of the cement matrix. To the centre right of the micrograph is a phase with a different morphology. Further examination of

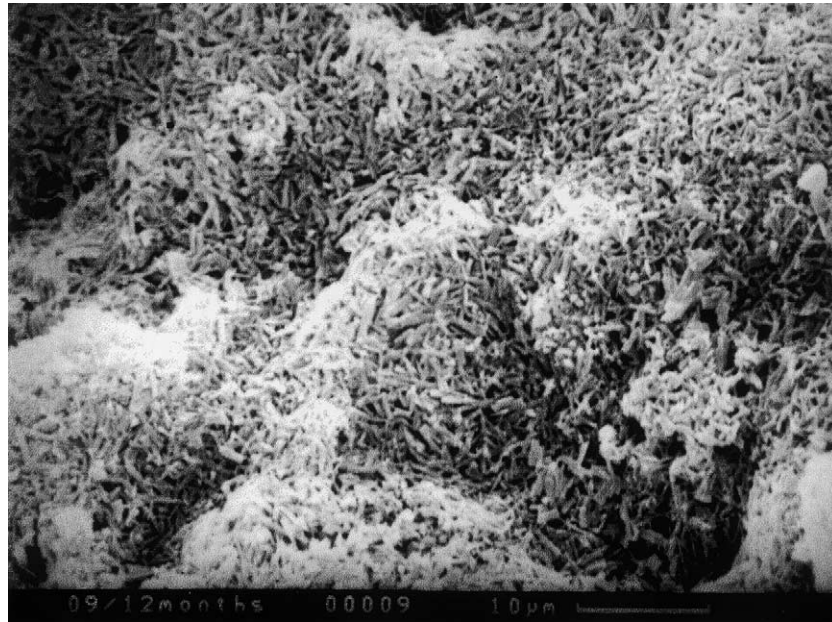
Fig. 8. Secondary electron image of the same mortar.

closer inspection. A cluster of these needles is shown in Fig. 8 at higher magnification. The needles were very fine ( $\ll 1 \mu\text{m}$ ) and up to  $3 \mu\text{m}$  in length. They appeared, in many cases, to taper and were joined together in a large, open felted mass. At still higher magnification, the needles sometimes appeared to have joined together to form platy rosettes (Fig. 9), where the edges of the rosettes had fused. EDS analysis of the needles showed large calcium and sulfur peaks, along with small silicon

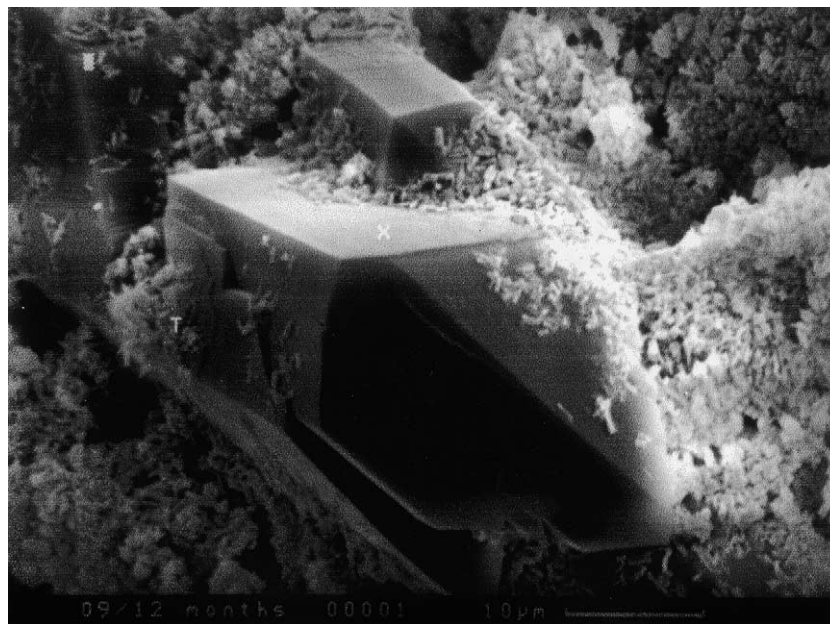
Fig. 10. Secondary electron image of the large tabular gypsum crystal surrounded by fine needles of thaumasite (T = thaumasite, X = gypsum).

Secondary electron image (Fig. 10) shows a large tabular gypsum crystal with fine interwoven needles of another phase. EDS analysis of the acicular phase (labelled T) showed large calcium and sulfur peaks, a smaller silicon peak and a trace of magnesium, but no evidence for aluminium. It was concluded that the phase was thaumasite rather than ettringite. EDS of the large tabular phase (labelled X) showed the presence of only calcium and sulfur, confirming the identification of gypsum. These conclusions are supported by XRD analysis of the specimen.
