Thaumasite as decay product of cement mortar in brick masonry of a church near Venice

Thaumasite has been recognized as constituent of salt efflorescences occurring within the cementitious mortar connecting the brick framework. It gives rise to swelling fissures and scaly detachments; furthermore, to heaving, curving and spalling of the perimeter walls.

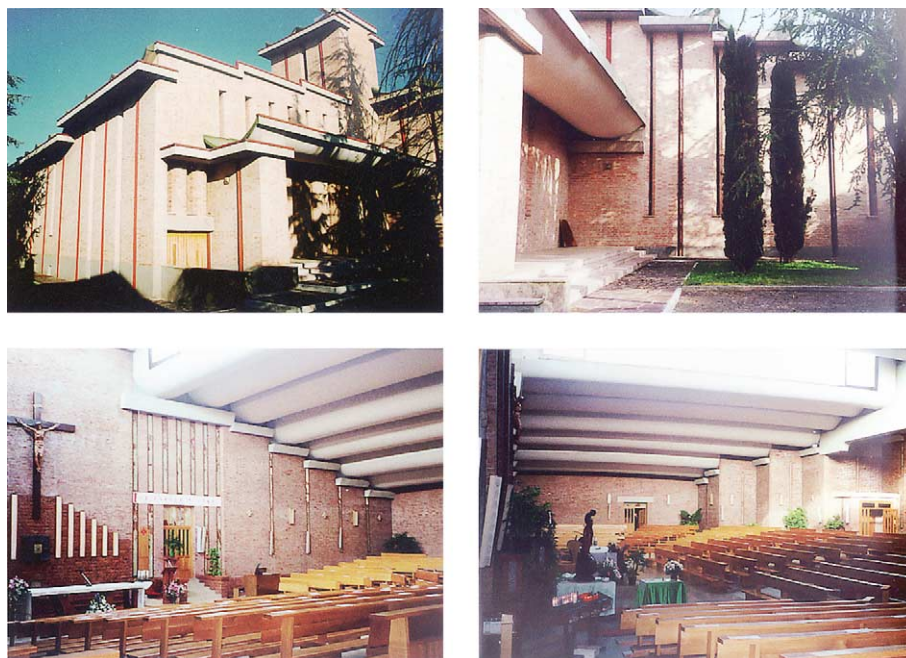
The parish church of Annone Veneto/VE, is a monumental basilica devoted to St. Victor Martyr (San Vittore Martire) by a legacy delivered on the occasion of the Vaticano II Council; it is serving a large catholic communion district. Its construction was completed in 1976: Fig. 1 shows external and internal views of the

Fig. 1. External and internal views of the church building.

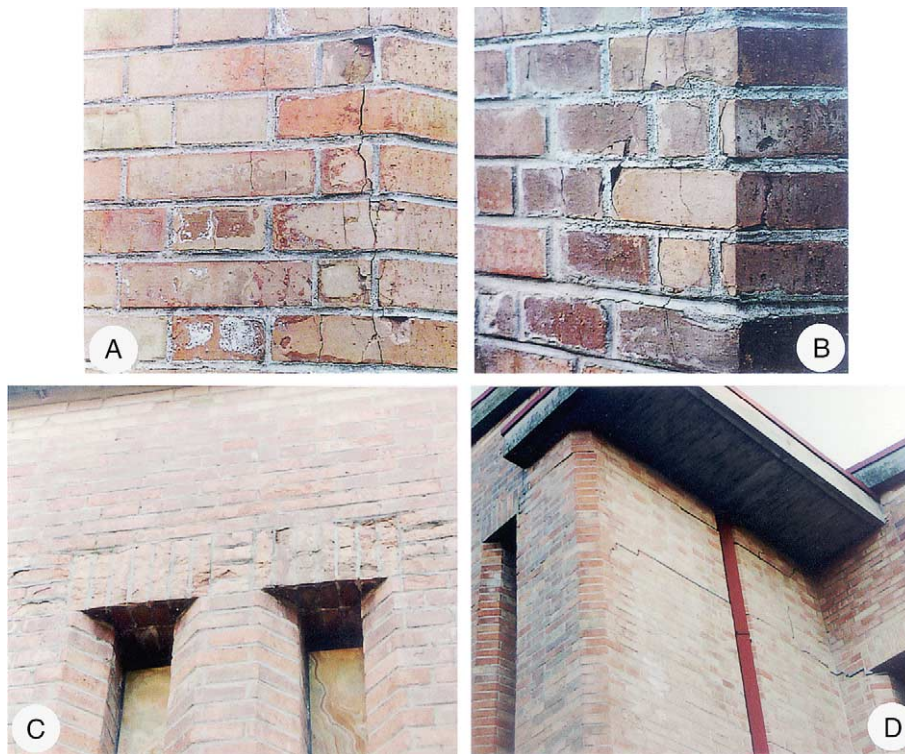
The brickwall frameworks show several damage aspects (Fig. 2): scaly detachments from the brick surface, fissures, cracks and salt efflorescences. Fissures are concentrating along brick–mortar joints (B, D), whereas cracks cut across the bricks themselves (A). Scaly detachments observable on the external brick surface (A, C), in some instances are accompanied by thin whitish salt efflorescences. The fissures are sometimes located along damaged mortar–brick joints (B) which become detached from each other (D). Heaving and spalling of brickwalls are the result of such decay.

Fig. 2. Decay aspects of the brickwalls (see text).

In some instances, the morphologies of thaumasite crystals observed on the masonry walls of the church of Annone Veneto/VE may indicate that crystal growth took place in conditions far from equilibrium (i.e. at different supersaturation values). Such morphologies and growth pathways resulted in high crystallization pressure which caused damages of the porous mortars and bricks (expansion, detachment and cracking), which caused curving, heaving and spalling of the brickwall frameworks.

The case of the church of Annone Veneto/VE, where the thaumasite occurs in an above-ground construction, is a peculiar one. Care was paid in selecting appropriate materials for correct repair and rebuilt interventions of the brickwall parts damaged by thaumasite efflorescences, using a mortar made up of a mix of siliceous inert aggregates and a hydraulic binding, thus suitable to avoid sulphate and alkali attack.

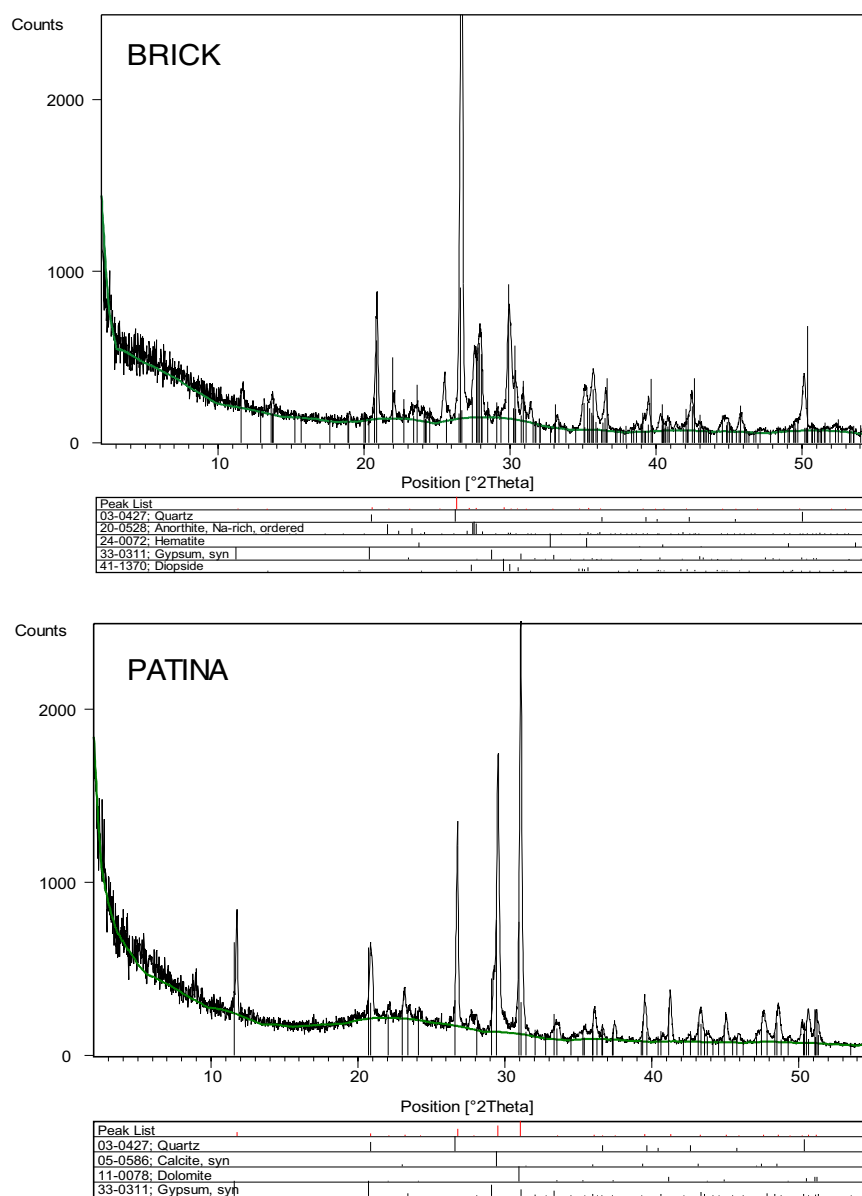
Fig. 6. XRD diffraction traces of a representative brick sample, and of a thin patina covering the brick surface.

X-ray diffraction trace (Fig. 6) indicate the presence of a very low amount of gypsum within the bricks itself, whereas higher amounts, together with Mg–calcite and dolomite (these carbonates are also constituting the mortar aggregate grains), are present in thin patinas covering the brick surface. Such kind of patinas seem to be precipitation products from solution percolating through the joint mortar.

Noteworthy the presence of gypsum and absence of thaumasite on brick surfaces at the southern exposure, where temperature ranges and moisture condition are quite different with respect to northern exposure (here thaumasite is the predominant constituent of efflorescences, especially developed on internal walls; its formation is due to the peculiar micro-environmental conditions as already mentioned above).
