Thaumasite sulphate attack at the concrete structures of the Ferenc Puskás stadium in Budapest

M. Révay, V. Gável *

Cemkut Research Development Co. Ltd for Cement Industry, P.O. Box 230, 1300 Budapest, Hungary

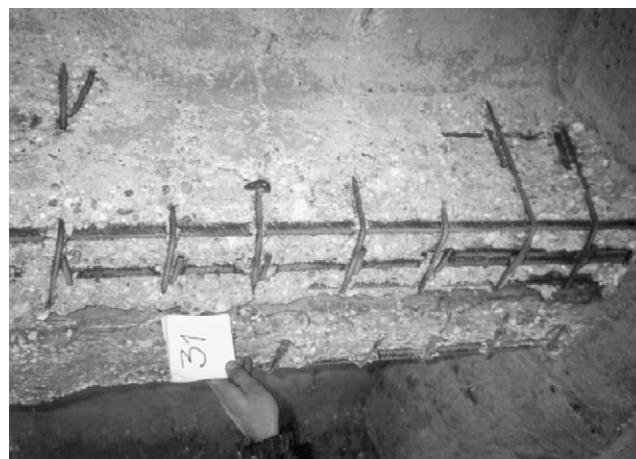
Fig. 4. A typical damage of the concrete—3.

The history of the reinforced concrete structure of the stadium, however, proved to be less successful. From the mid-sixties, the strength of the concrete started to gradually and significantly decrease, which is shown in the following figures (Figs. 2–4).

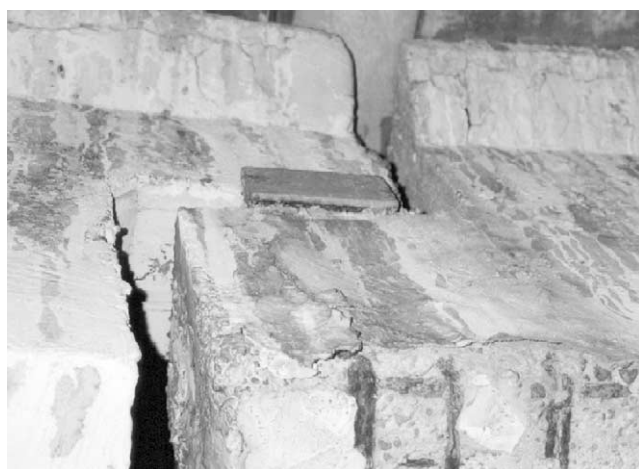
Fig. 2. A typical damage of the concrete—1.

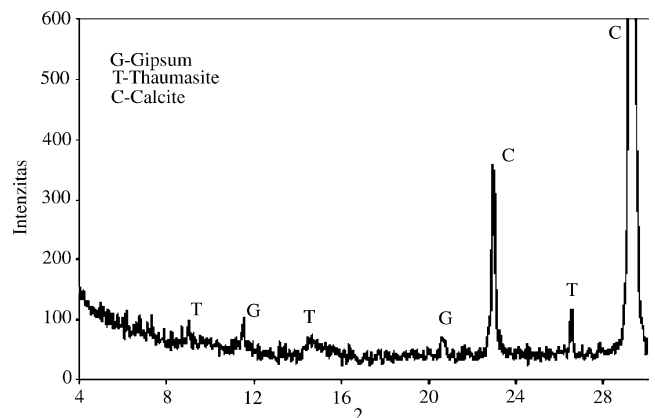
Fig. 9. XRD curves of the concrete in 2001.

In the XRD ($2\theta = 5\text{--}30^\circ$) besides gypsum and calcite some relatively low intensity thaumasite peaks can also be observed [15].
