The microscopical characterisation of thaumasite

R.G. Sibbick *, N.J. Crammond, D. Metcalf

Centre for Concrete Construction, BRE, Garston WD25 9XX, UK

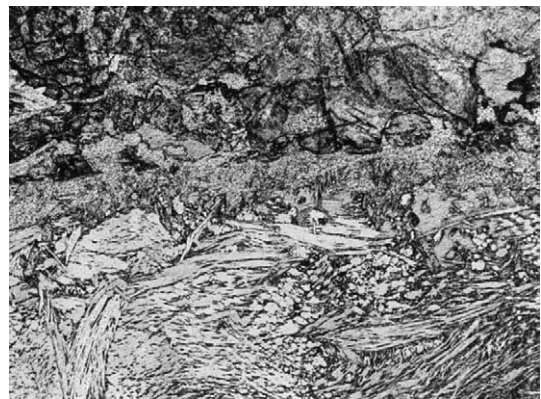
Fig. 3. Natural thaumasite sample showing the interface between the colourless well-formed acicular crystals (bottom) and the straw yellow, finely crystalline, and randomly orientated thaumasite mush typically observed within TSA-affected concretes (top). Magnification $\times 33$ (PPL).

It can also be observed optically as shown in Figs. 2 and 3 that the crystalline form of the natural thaumasite was indeed varied and showed increasingly well-structured crystal forms, without any detectable changes in its composition. Fig. 4 shows how the thaumasite deposits relate to the rest of the mineral types in the sample, which appears to include calcium aluminosilicates, calcium silicates, and calcium aluminates. XRD analysis detected small amounts of Afwillite ($\text{Ca}_3\text{Si}_2\text{O}_4(\text{OH})_6$), Grossular ($\text{Ca}_3\text{Al}_2(\text{SiO}_4)_3$), and Jennite ($\text{Ca}_9\text{H}_2\text{Si}_6\text{O} \cdot 18(\text{OH})_8 \cdot 6\text{H}_2\text{O}$) and possible traces of bredigite, ettringite, and gehlenite as well as an abun-

dance of thaumasite. The naturally occurring crystalline thaumasite was observed to be colourless or white in the plane polarised light mode of optical microscopy. The well ordered prismatic and acicular forms of thaumasite shown in Figs. 2 and 3, show a clear colourless appearance with a range of birefringence close to 0.018. Birefringence is the effect on polarised light of variations in the refractive index of different minerals. The difference between mineral types are often manifested by different levels of birefringence (refraction) and thus the associated polarisation colour when viewed with cross polars under a polarising microscope. This is a complex area and greater details are given in Optical Microscopy by Paul Kerr [3].

polarised light (Fig. 3). The range of birefringence observed within the natural thaumasite was also similar to the TSA thaumasite ranging between 0.000 and 0.027. The reason for the distinct straw yellow coloration was felt to relate to either minor impurities incorporated within the finer crystalline matrix, (after being expelled from the more well-formed and larger crystals), or differences in a constituent undetectable by SEM i.e. H_2O , CO_2 , CaCO_3 or unspecified carbon compounds.

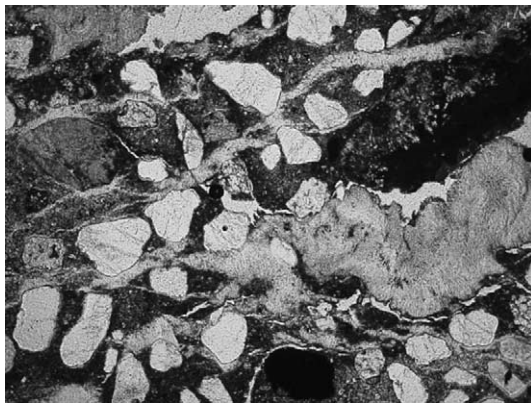
Fig. 6. Zone 3 and 4 TSA development within structural concrete. Thaumasite shown is light yellow coloured, quartz sand grains are white and the remaining cement paste matrix is brown. Image width 4 mm taken in plane polarised light.
