Sulfate attack and role of silica fume in resisting strength loss

S.T. Lee ^{a,*}, H.Y. Moon ^b, R.N. Swamy ^c

Abstract

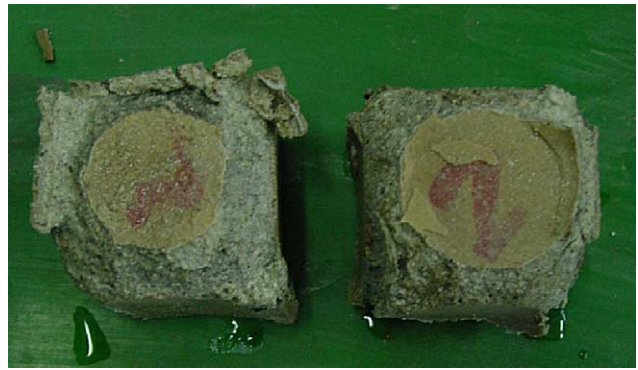
Fig. 1. OPC-45 mortar cubes immersed in 5% sodium sulfate solution for 510 days.

It was observed that initial deterioration invariably started from the corners of the mortar samples. For OPC-45 mortars immersed in sodium sulfate solution for 510 days, the loss of mortar mass was approximately 11%, and the wide cracks due to the expansive pressure on the cement matrix were significant, as seen in Fig. 1. Signs of visual deterioration of the OPC-45 mortar were first observed at 56 days with some visible cracks near the corners. On the other hand, SF5-45, SF10-45 and

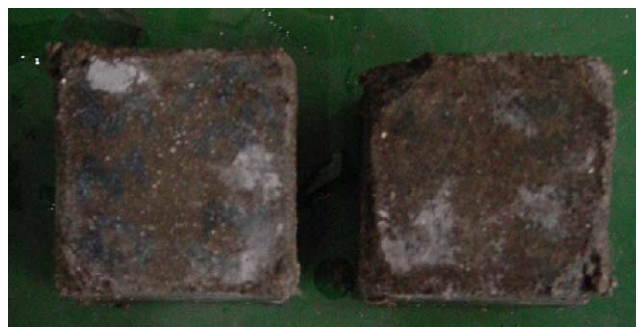
Fig. 3. OPC-45 mortar cubes immersed in 5% magnesium sulfate solution for 510 days.

In magnesium sulfate solution, some parts of the surfaces of OPC-45 mortars peeled off after 180 days of

immersion, due to loss of cohesiveness between the surface layer and the inner cement matrix. After 510 days of exposure, the corners of OPC-45 mortars had spalled off, and a layer of white material was found deposited on the faces of the mortars, as shown in Fig. 3. Furthermore, inside the cracks of the mortars, needle-shaped crystals (probably gypsum formation) were present. Fig. 4 shows the visual appearance of the deteriorated SF10-45 mortars immersed in magnesium sulfate solution for 510 days. It can be seen that the SF mortars show exposed aggregates and somewhat greater severity of deterioration compared to that of OPC-45 mortars, even though both mortars were exposed to magnesium sulfate attack for the same immersion period.

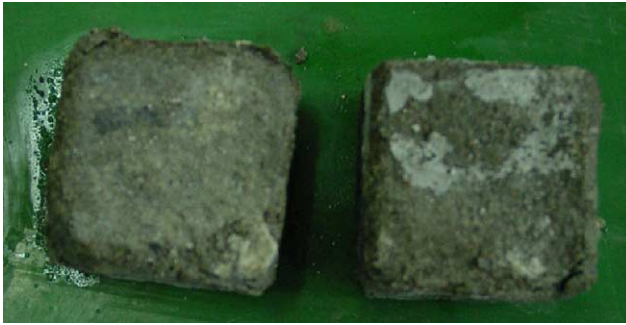
Fig. 4. SF10-45 mortar cubes immersed in 5% magnesium sulfate solution for 510 days.

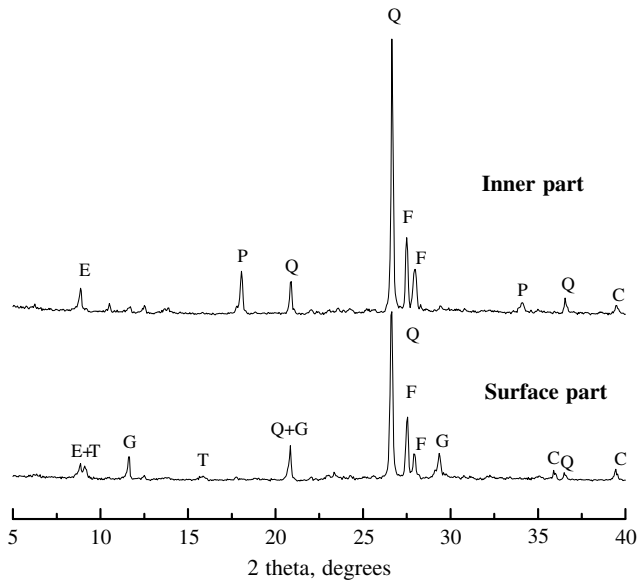
Fig. 11. XRD of OPC-45 mortar placed in 5% sodium sulfate solution for 510 days. (Note: E = ettringite, P = portlandite, Q = quartz, F = feldspar, C = calcite, T = thaumasite, G = gypsum).

Diffraction patterns shown in Fig. 11 indicate that the difference between the inner and the outer surface parts of OPC-45 mortar exposed to sodium sulfate solution is remarkable. Especially in the surface part of OPC-45 mortar, the peaks of thaumasite were detected at 9.2° and 15.0° 2θ in addition to gypsum peaks at 11.7° , 20.7° and 29.2° 2θ . On the other hand, as shown in Fig. 12, the XRD trace of powders from SF mortar sample (surface part) stored in the same solution showed no thaumasite peaks even after 510 days of immersion in 5% sodium sulfate solution, and only a somewhat weak gypsum peak at 29.2° 2θ was observed. The XRD traces on the deteriorated part of both OPC and SF mortar revealed the absence of portlandite due to sodium sulfate attack.
