Application of impulse-thermography for non-destructive assessment of concrete structures

Abstract

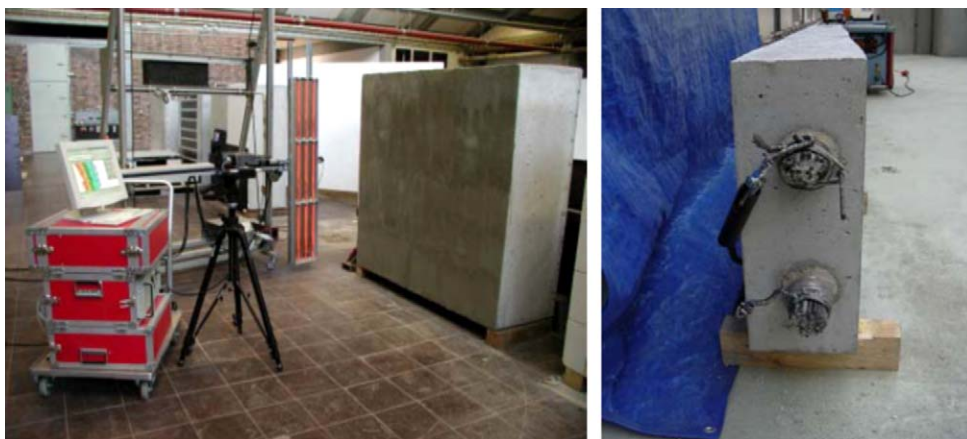
Fig. 1. Left: experimental set-up with infrared camera, computer and infrared radiator for direct heating of the surface. Right: electrical connections at the wires inside the tendon ducts for indirect heating by electric resistance.

One experimental set-up for the performance of impulse-thermography measurements in laboratory as well as on-site is shown in Fig. 1(left). It consists of a thermal radiator, an infrared camera and a computer system that enables digital data recording in real time. The thermal heating unit contains of three infrared radiators having a power of 2400 W each. The heating procedure is usually done dynamically by moving the radiators under computer

For the location of injection faults inside tendon ducts, the pre-stressing steel is heated up by a welding apparatus with electric currents between 15 A and 50 A, using the electric resistance of the pre-stressing wire as shown in Fig. 1(right). Inside the ducts, maximum temperatures of 25 °C were recorded with thermocouples.

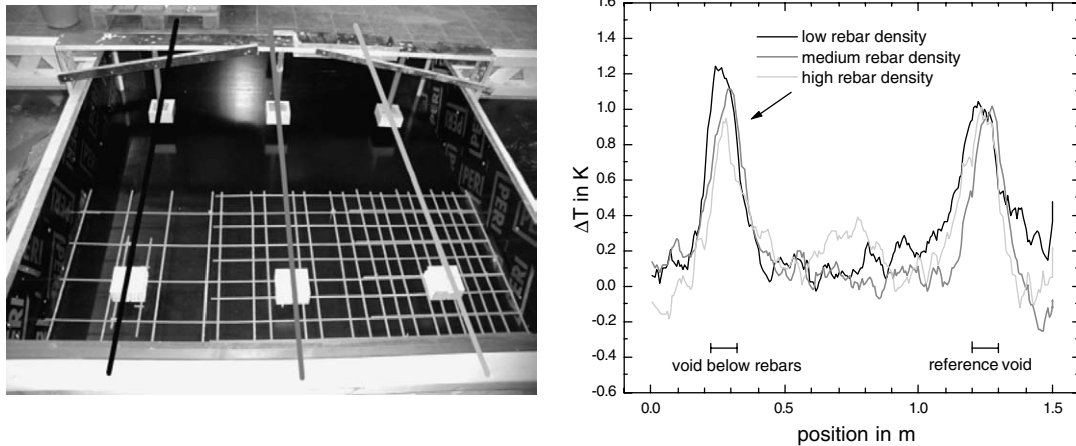
Fig. 6. Left: test specimen with voids and different number of reinforcement mats before concreting. Right: temperature distribution at the surface of the test specimen along the measurement lines depicted in the left image.

For the investigation of the influence of reinforcement density, a test specimen was constructed as displayed in Fig. 6(left). It has three voids with a size of $10 \times 10 \times 5 \text{ cm}^3$ (simulated by polystyrene) at a depth of 6 cm and located behind three different densities of reinforcement (one, two and three layers of reinforcement mats Q188, 1.88 cm^2 reinforcing steel per m). At the same height and depth, three further reference voids (also simulated by polystyrene and having the same size) without any reinforcement were included.

Data obtained from the observation of the cooling-down behaviour after a heating duration of 30 min are shown in Fig. 6(right). The thermograms showing the maximum temperature contrast above the voids were selected and three horizontal line scans were taken across the areas of different reinforcement density. Each of these scans included a void below the reinforcement and a reference void. Only a small influence of the rebar density could be

noticed: with increasing rebar density, the temperature contrast of the underneath voids decreases slightly.

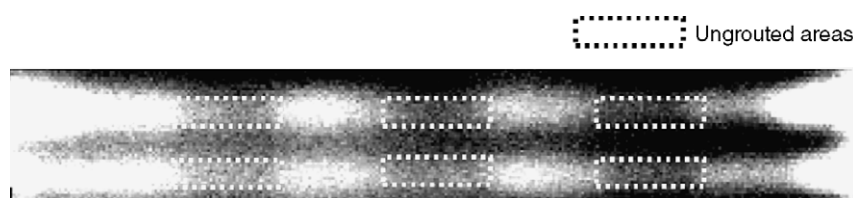
Fig. 11. Temperature distribution, 40 min after switching on of the heating source (white: temperature > 16.0 °C, black: temperature < 14.5 °C). The six ungrouted areas are colder than the grouted areas of the two horizontal tendons.

In the second case, the pre-stressed concrete test specimen was heated up to 15 min from the outside surface by infrared radiators with a total electrical connected load of 5200 W. Only from the side with small concrete covering ($c = 5$ cm) the grouting faults in the ducts could be detected clearly.
