Behaviour of patch repair of axially loaded reinforced concrete beams

Experimental investigation is conducted to assess structurally the effectiveness of patch repair in axially loaded columns. Two patch repair materials are selected with high and low modulus of elasticity. The concrete columns were patch repaired under loaded and unloaded conditions. The patch repair is structurally effective for concrete columns repaired in an unloaded state. While for concrete columns repaired in a loaded state, the patch repair is structurally effective only when additional loading is applied. The load distribution between the patch repair, concrete core and steel reinforcement depends on the modulus of elasticity and areas of these components in the composite section at the repaired zone. For patch repair to be structurally effective, it is recommended to relieve the loads before the patch repair is applied either partially or totally if constructionally possible.

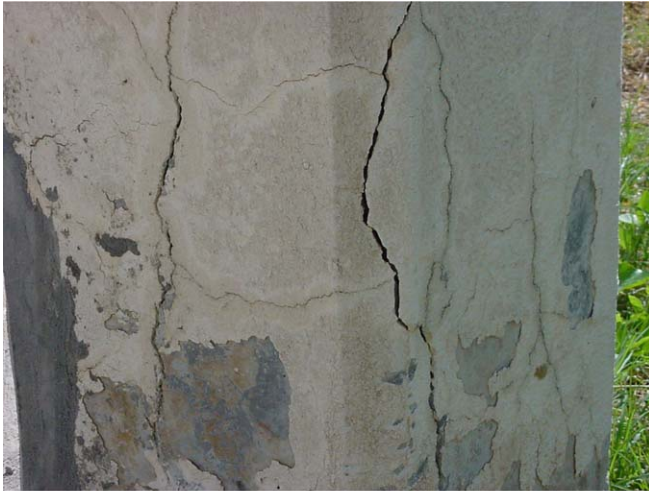
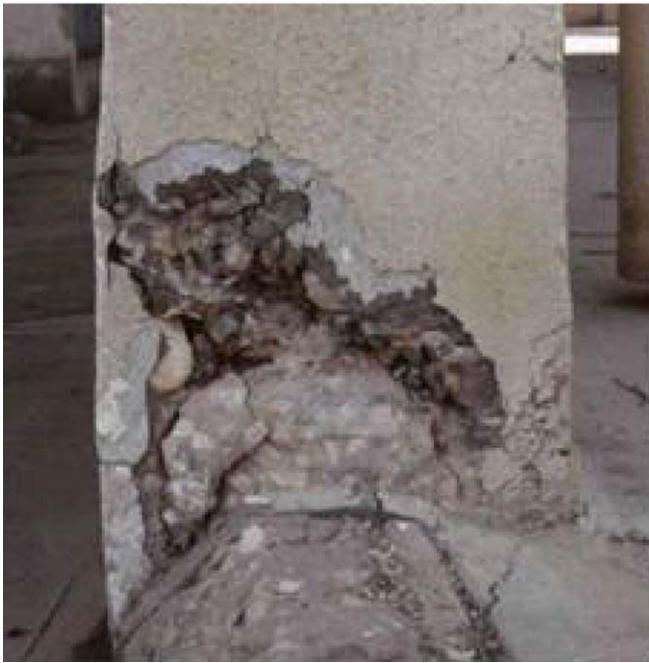
Fig. 1. Deterioration of columns in the Arabian Gulf region.

Deterioration of concrete columns in the Arabian Gulf area as shown in Fig. 1 is mainly attributed to the chloride induced corrosion of reinforcing steel. Moisture rises from the groundwater table in the concrete above ground level by capillary action followed by high evaporation rates due to high temperature. This leaves a heavy crest of chlorides in the zone above the ground level. Usually more salt penetrates than is leached out, thereby causing significant concentrations to develop within the concrete over the years. Chlorides dissolved in surface moisture are also deposited on the concrete surfaces and subsequently enter the pores of concrete by capillary action. Just above the

ground level, all conditions required for triggering corrosion action are met as the oxygen becomes available. It creates microclimates within the concrete pores that initiate corrosive action. As the corrosion of steel reinforcement progresses, deterioration in the form of cracking and spalling of concrete columns occurs at the ground level. If a significant amount of material at the compression zone is lost, loads are transferred to the intact core of the compression member resulting in substantially higher stresses and subsequently detrimental to the structural integrity and safety [1–3].

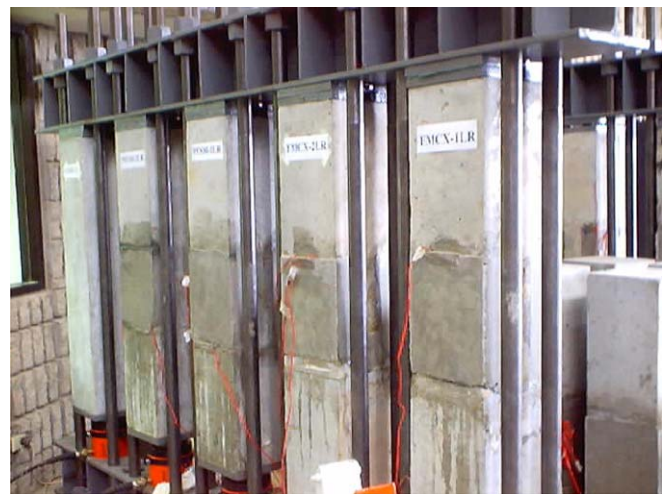
Fig. 4. Columns repaired in a loaded state left to cure.

the loaded state, the columns were mounted in a loading frame as shown in Fig. 3. The columns were maintained under loading equivalent to 20% of its ultimate capacity. The patch repair was applied to these stressed columns and left to cure as shown in Fig. 4.

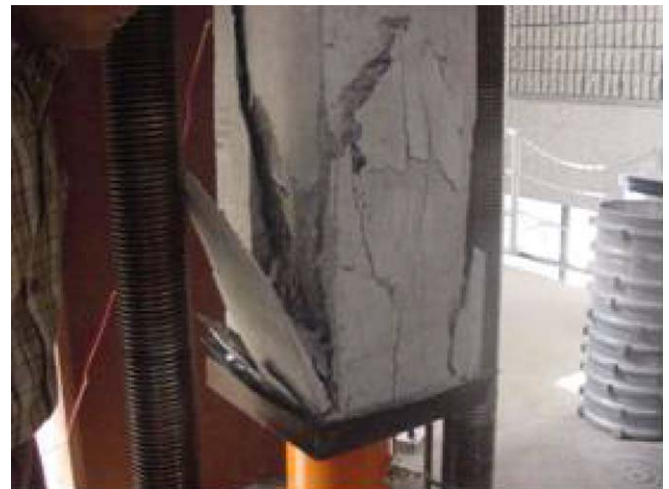
Fig. 7. Column failure of group I.

The columns of groups I and II represent undamaged and damaged columns, respectively. The load versus the average measured strain for columns (UC1, UC2 and UC3) and columns (RC1, RC2 and RC3) are shown in Figs. 5 and 6, respectively. The strain at the surface of concrete is higher than that at the concrete core and on the steel for both groups. For group II, the average measured strain in the exposed steel bars is less than that of the embedded steel bars. For group I, the columns failed by crushing and spalling of concrete at the lower end of the column as shown in Fig. 7. While for group II, the columns failed in the recess portion by buckling of the exposed steel as shown in Fig. 8.

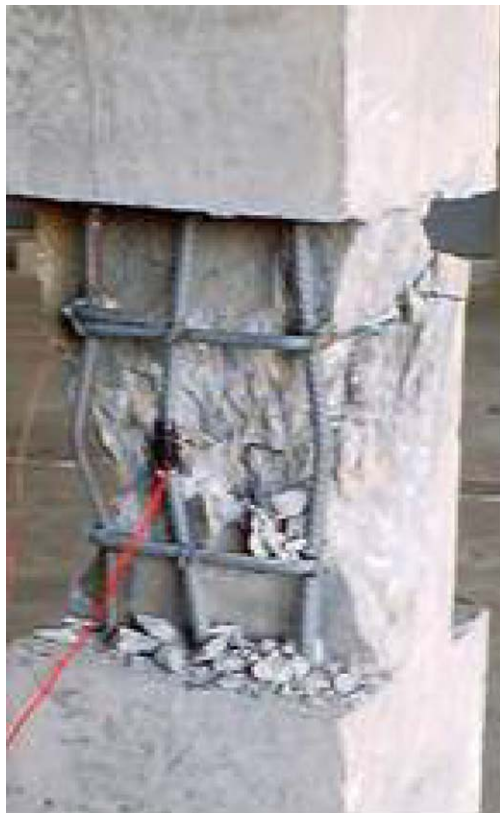
Fig. 8. Column failure of group II.

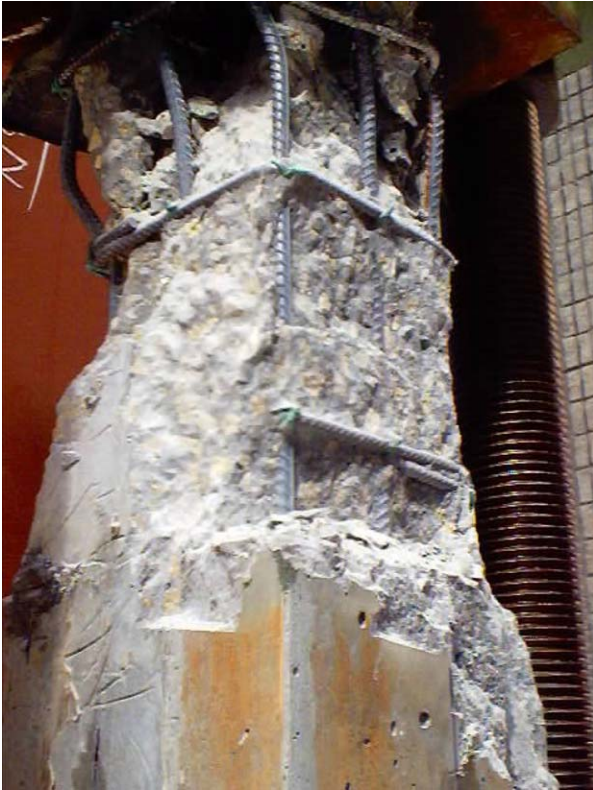
Fig. 11. Column failure of group III.

concrete core. The columns failed by crushing of concrete at the top portion of the column as shown in Fig. 11.
