A quantitative study on the plastic shrinkage cracking in high strength hybrid fibre reinforced concrete

A. Sivakumar, Manu Santhanam *

Department of Civil Engineering, Indian Institute of Technology, Madras, India

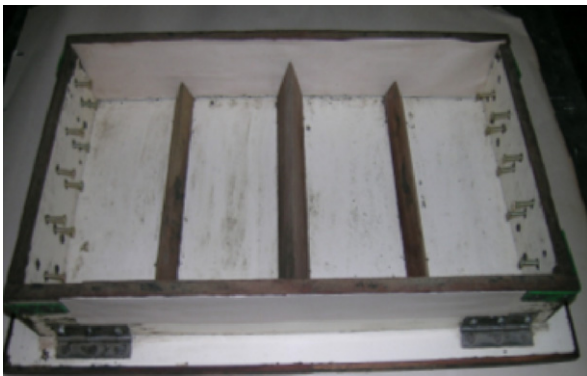
Fig. 1. Fabricated mould setup.

The slab mould (see Fig. 1) of dimension $500 \times 250 \times 75$ mm was made of laminated board. A thin polyethylene sheet was placed over the base to eliminate base friction between the concrete and laminated board. The slab was provided with a stress riser of 55 mm height at the center and two base restraints of 35 mm height at 35 mm from both ends, along the transverse direction. In addition to this, a bolt and nut arrangement was provided at the ends to restrict the longitudinal movement of the concrete slab from the edges and to provide additional restraint, increasing the potential of cracking at the notch. The concrete

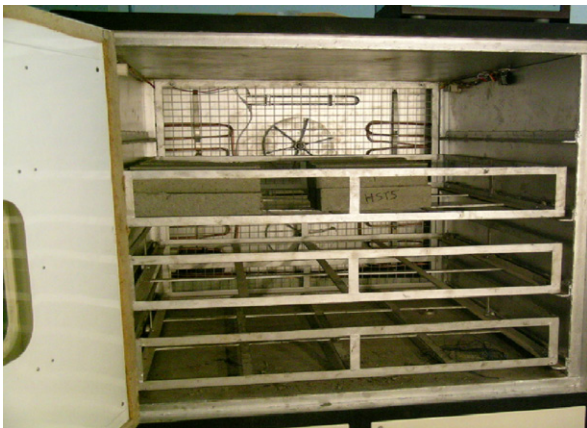
Fig. 2. Environmental chamber used for storage of specimens.

slabs were stored after casting in an environmental chamber with dimensions of $2.75 \times 0.9 \times 0.9$ m, as shown in Fig. 2. Apart from controlling temperature and humidity, this chamber was equipped with a high-speed fan of air velocity 3.8 m/s fixed on the walls of the chamber to accelerate drying of concrete. The slabs were exposed to a constant temperature of 35 ± 1 °C, a relative humidity of $40 \pm 1\%$, a wind velocity of 6 m/s. The evaporation rate, measured by detecting the loss of water from a porcelain bowl placed inside the chamber, was $0.62 \text{ kg/m}^2/\text{h}$. The slabs were checked visually for any signs of cracking at approximately 30-min intervals. The slabs (inside the moulds) were kept in the chamber for 24 h.

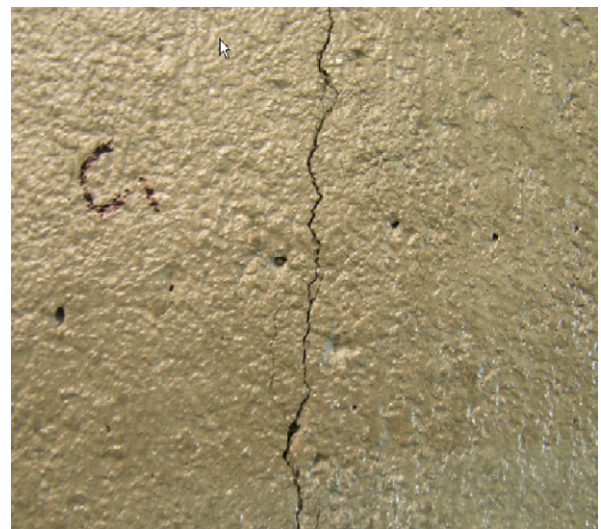
Fig. 3. Plastic shrinkage crack in the plain concrete (C1) slab (area 250×250 mm).

The time of occurrence of first crack was noted for all slabs during the experiments. In the case of plain concrete, approximately 160 min after mixing with water, a fine hair-line crack running throughout the width of the slab was observed above the central stress riser. This fine crack, which could have possibly been caused due to settlement, was found to widen upon further drying. In the case of fibre reinforced concrete specimens, the appearance of the first crack took a relatively longer time (more than 7 h). This could be attributed to the availability of bleed water on the top surface, which delays drying of the surface. Fibres in concrete have been reported to act as bleeding channels, which supply water to replenish the drying surface and reduce the magnitude of capillary stresses developed [25].

In the case of plain concrete, a single crack over the central stress riser was found to run almost straight throughout the width of the specimen. However, for fibre

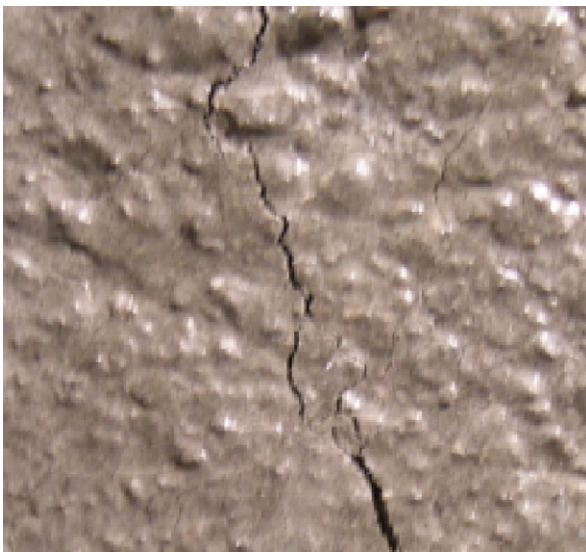
Fig. 4. Plastic shrinkage crack in the steel fibre concrete (HST2) slab (area 75×75 mm).

The crack measurements comprise of the crack length, crack width (maximum and average) and total crack area. Images of the crack were captured using an optimal zoom camera based on crack visibility; some captured images of different concrete specimens are shown in Figs. 3–7, and calibration of the image size using a ruler is shown in Fig. 8. Subsequently, the captured images were processed

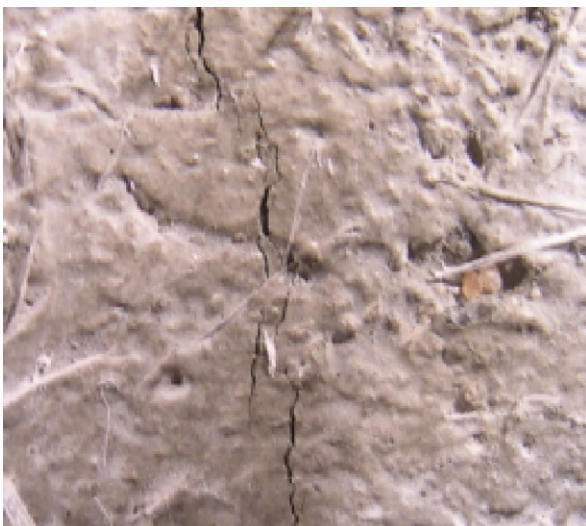
Fig. 5. Plastic shrinkage crack in the steel–polypropylene hybrid concrete (HSPP3) slab (area 35×35 mm).

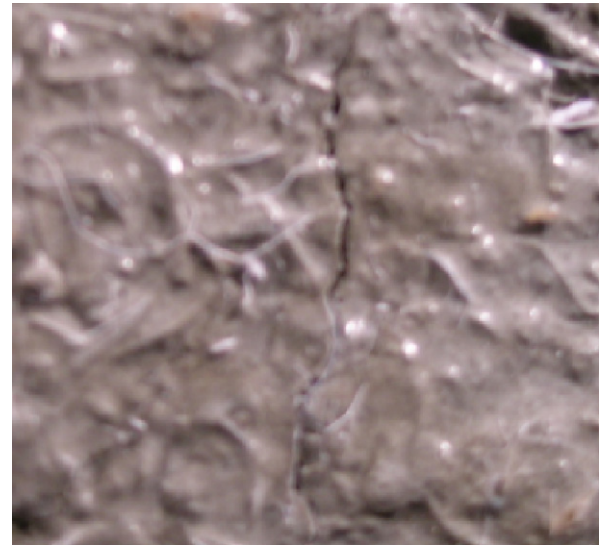
Fig. 6. Plastic shrinkage crack in the steel–polyester hybrid concrete (HSPO4) slab (area 18×18 mm).

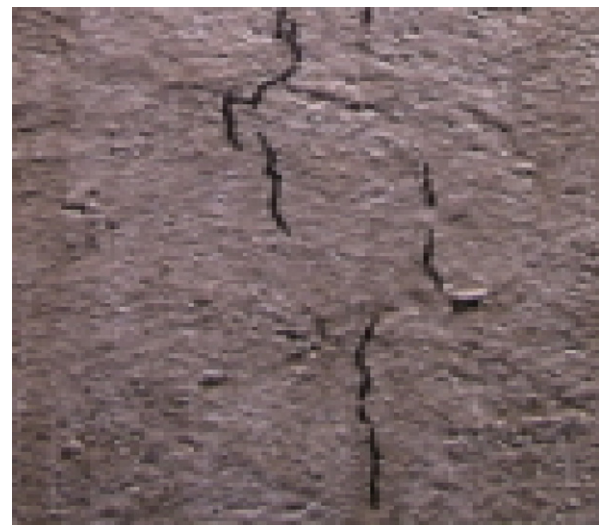
Fig. 7. Secondary crack observed in steel–glass hybrid concrete (HSGL5) slab (area 52×52 mm).

In the case of polyester and polypropylene hybrid fibre concretes, at high volume fractions of non-metallic fibres, secondary cracks were seen to appear branching out from the main crack. These secondary cracks were thinner than the main crack (crack widths were less than 0.035 mm). The total area of secondary cracks was calculated to be always less than 10% of main cracks. As the non-metallic fibre fraction increased to 0.38%, the main crack was neither continuous nor distinctive. This trend was slightly different for steel–glass fibre concretes, as the secondary crack widths were of the order of 0.075 mm.

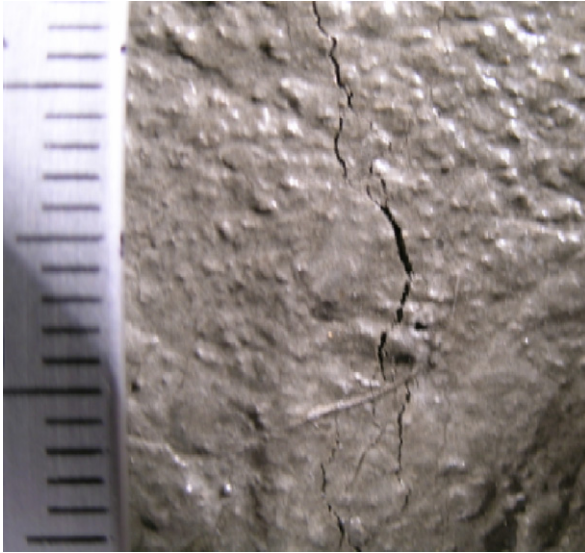
Fig. 8. Calibration of measurement using graduated scale.

The length of crack was determined by using a curve-tracing tool in the image analysis software to trace the crack. The length was then calculated in terms of pixels, which were converted to length units (mm) using the calibration scale. Similarly, using a linear scale tool in the image analysis software, the crack width was calculated at 180 equi-distant points along the crack. The actual image resolution varied due to variation in height at which pictures were taken based on the crack visibility. The total crack area was then calculated on the binarized image

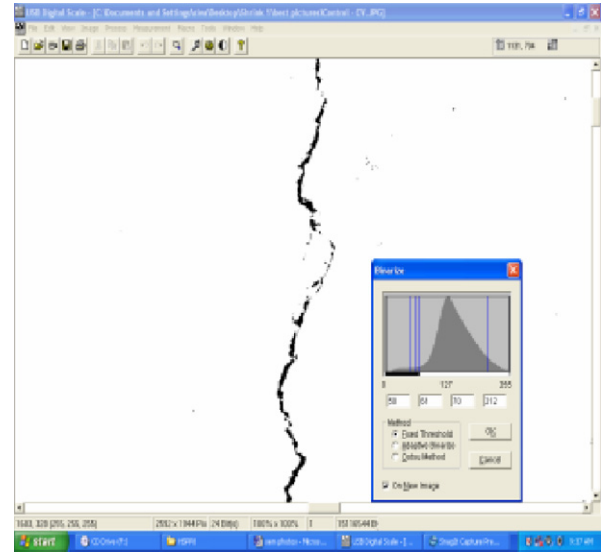
Fig. 9. Example of a processed image of controlled concrete.

and edited with image analysis software to get a clear crack profile using various mathematical operations such as binarization, thresholding, cleaning and filtering. An example of an image after the processing operations is given in Fig. 9.

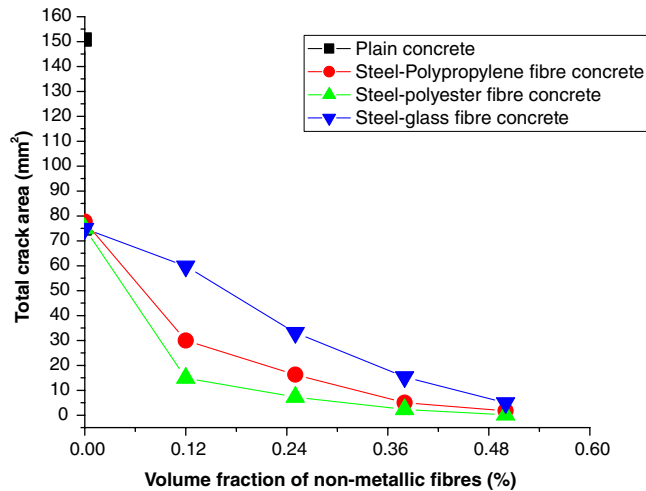
Fig. 10. Influence of dosage of non-metallic fibres on total crack area.

Experimental results given in Table 4 indicate that the maximum crack width was observed in the case of plain concrete; with fibre addition, the crack widths were reduced. Compared to steel fibre concrete, hybrid fibre concretes showed better crack control features. The total crack area reduced with increased addition of non-metallic fibres, as shown in Fig. 10. The reduction in crack width using hybrid fibre combinations (presented in Table 4) significantly contributed to the reduction of the overall crack
