Durability of concrete containing siderite-bearing microsyenite and trachyte aggregates

R.P. Khatri *, G.W. Quick, V. Sirivivatnanon

CSIRO Manufacturing and Infrastructure Technology, P.O. Box 310, North Ryde, New South Wales 1670, Australia

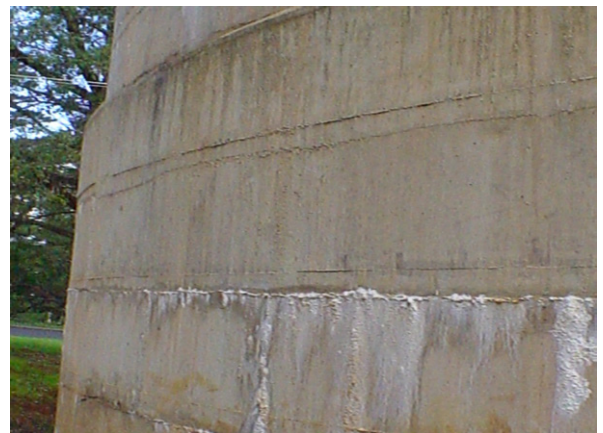
Fig. 6. General view of the Bowral water tank with efflorescence from a joint.

This tank was built in an exposed area possibly in the early 1900s, and appears to have been built in a series of horizontal rings using lift formwork. At the time of inspection, there were typical efflorescence patches appearing at numerous horizontal joints, as shown in Fig. 6. The exposed concrete appeared well compacted and the tank was functioning well without any damp patches. There were large patches of orange staining, of unknown origin, mostly running down from the construction joints. It was

quite clear that they did not originate from within the concrete. Overall the staining was no more than that expected on similar structures elsewhere.

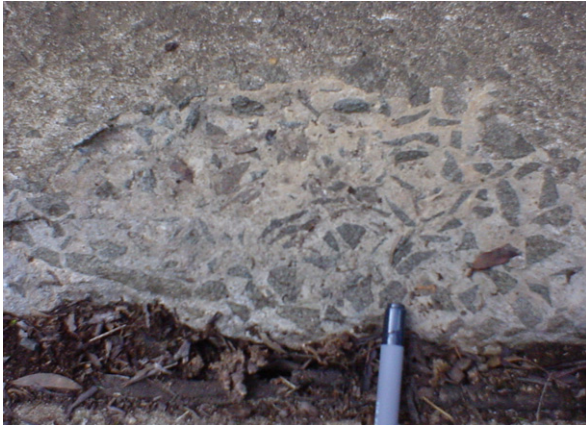
Fig. 7. Exposed aggregate at base of water tank.

There was some chipping-off around the edge of the base of the tank that had exposed the aggregate, as shown in Fig. 7. Visual observation of this fracture surface suggested that it had been built using aggregates from the disused quarry at Mt Gibraltar, located adjacent to the concrete tank. A subsequent examination of the sample confirmed that it was petrographically similar to the microsyenite rocks at Mt Gibraltar.

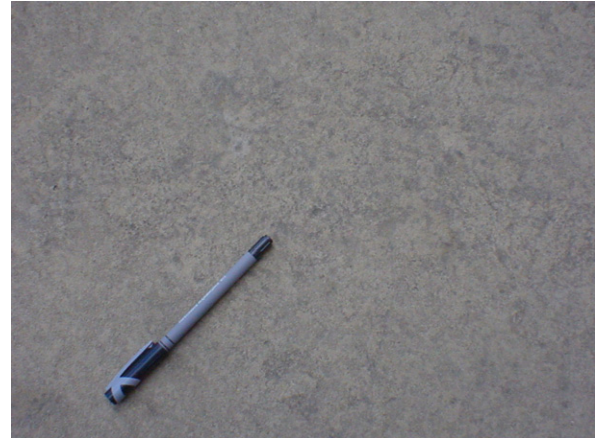
Fig. 9. Close-up of the office building slab near door.

An office building (ca 1930), believed to be built with concrete made with Mt Gibraltar aggregate was also examined. Aggregate particles collected showed similar features to rock sampled from Mt Gibraltar. As seen in Fig. 8, the top part of the walkway slab and its edge on the side of the building are well exposed to the weather. As shown in Fig. 9, no staining was observed.

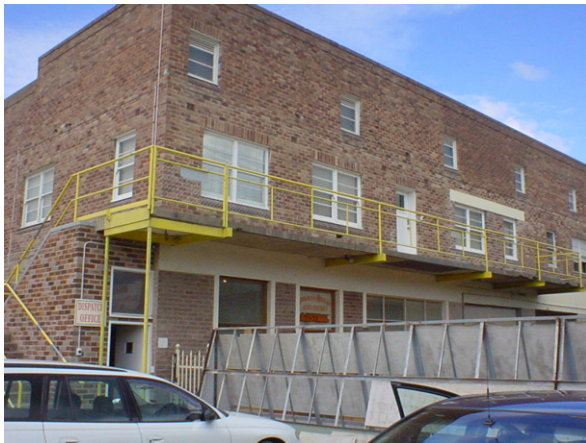
Fig. 8. Bowral Austral office building with external walkway (slab).

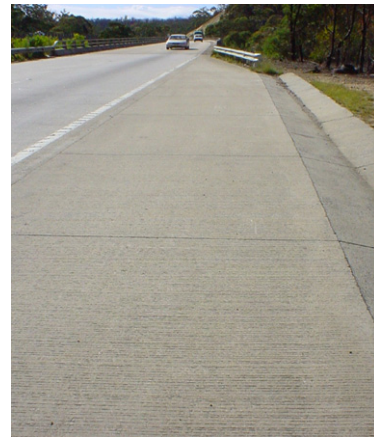
Fig. 10. Road shoulder of a section of Mittagong Bypass (built in the early 1990s).

The shoulder and the CRCP were constructed in the early 1990s (Fig. 10). The road shoulder is cast from concrete with a coarse siderite-bearing trachytic aggregate sourced from the nearby Nattai River Cut 5. At the time of inspection, the concrete of the road shoulder showed no visible cracks or staining (Fig. 11).

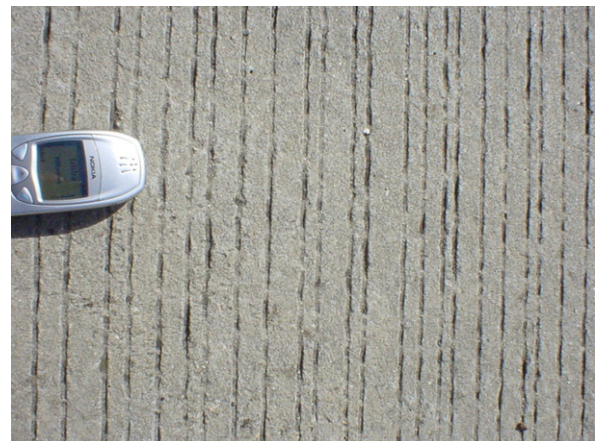
Fig. 11. Road shoulder built with Nattai River Cut 5 aggregate, free of cracks and staining.

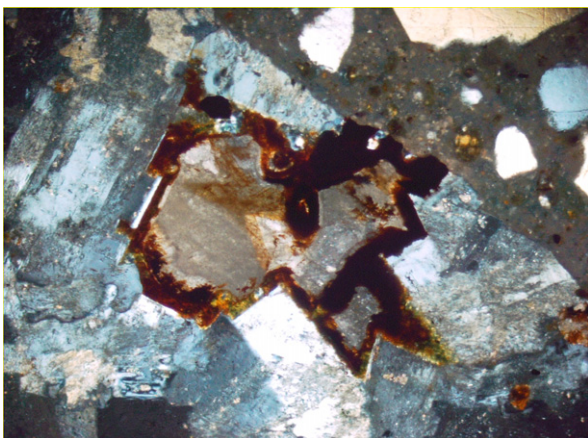
Fig. 12. Peripheral oxidation of siderite on outer surface of aggregate, WOF = 1.75 mm, XPL.

In addition to the visual examinations of the structures, detailed petrographic studies of an old (about 80 years old) concrete curb sampled from the Mt Gibraltar quarry were also carried out. Prepared polished thin sections were examined under the petrographic microscope in both polarised (XPL) and unpolarised light (UPL). The aggregate in the concrete was identified as an alkali feldspar microsyenite with interstitial pyroxene (aegirine–augite), siderite and plagioclase feldspar, identical to the rock sampled from the disused Mt Gibraltar quarry. The petrographic study also indicated that the oxidation of the siderite was varied, but most crystals showed a high degree of peripheral (Fig. 12) and internal (Fig. 13) alteration to iron oxides/hydroxides.

Figs. 12 and 13 are images from the petrographic study of the aggregate in concrete (or siderite in a high pH concrete environment), and they clearly show evidence of the oxidation of siderite. The performance of aggregate in a concrete environment or the oxidation of siderite in a con-

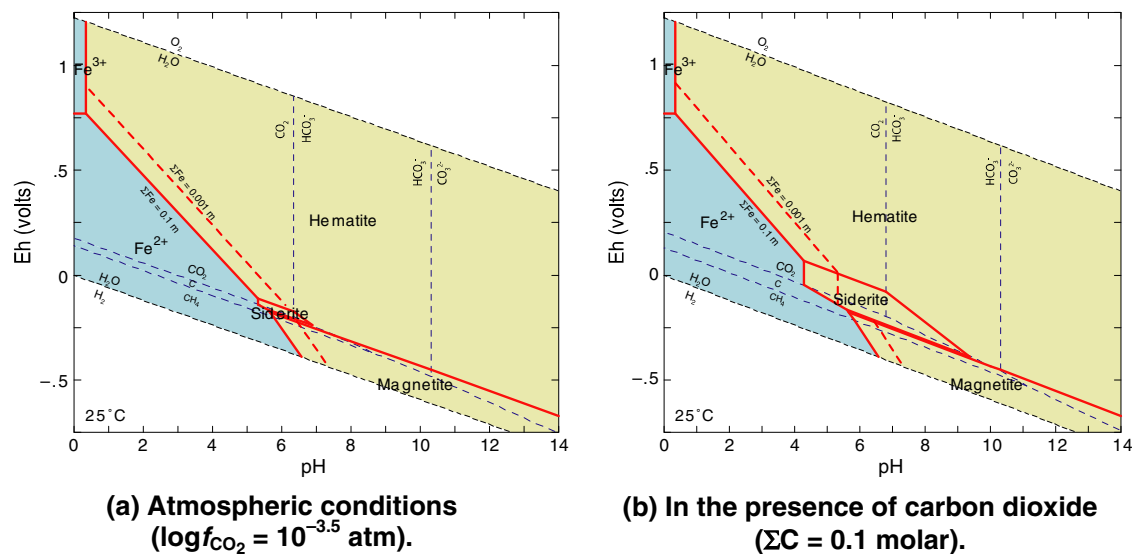
Fig. 14. Eh–pH diagram of Fe–CO₂–H₂O system at 25 °C. The thick solid lines show the boundary between Fe minerals and aqueous species at $\Sigma\text{Fe} = 0.1$ m, and the thick dashed lines show the boundary between Fe²⁺ and minerals at $\Sigma\text{Fe} = 0.001$ m. The fine dashed lines define the boundaries between carbon species and the stability field of water.

Under atmospheric conditions where the partial pressure of CO_2 is 0.0003 atm, siderite has a very small stability field (pH from 5 to 7, Eh from -0.25 to -0.1) (Fig. 14a), and thus will be oxidized to hematite (Fe_2O_3), goethite ($\text{FeO}(\text{OH})$) or $\text{Fe}(\text{OH})_3$, depending on the amount of water in the system and following equations give the chemical reactions. The thermodynamic data used for the calculation of the Eh–pH diagrams (Fig. 14) and the equilibrium constants for the following reactions are from Lawrence Livermore National Laboratory thermodynamic database [5]

If the pore water in the concrete contains a considerable amount of carbon (as HCO₃⁻ when pH 7–10), reactions (1)–(3) will favor the left-hand sides, and therefore enhance the stability of siderite. For example, the stability field of siderite in equilibrium with 0.1 m total dissolved carbon is in the range of pH from 4.5 to 9.5 and Eh from –0.4 to 0.1 (Fig. 14b) – much larger than in Fig. 14a.

Thus, it can be seen that in the presence of CO₂ there is a tendency for siderite to convert to metastable iron oxides/hydroxides under the Eh–pH conditions of a typical concrete environment, where pH is approximately 10–14. However, it should be noted that these theoretical calculations do not give any information about the kinetics of the reaction nor the rate of oxidation of the siderite; clues to the rate of reaction can be inferred from the field or from accelerated weathering studies. The study also established that the stability of siderite will not change in the presence of 3% NaCl solutions.
