# Effect of FRP bar degradation on interface bond with high strength concrete

Julio F. Davalos, Yi Chen \*, Indrajit Ray

Department of Civil and Environmental Engineering, West Virginia University, Morgantown, WV 26506-6103, USA

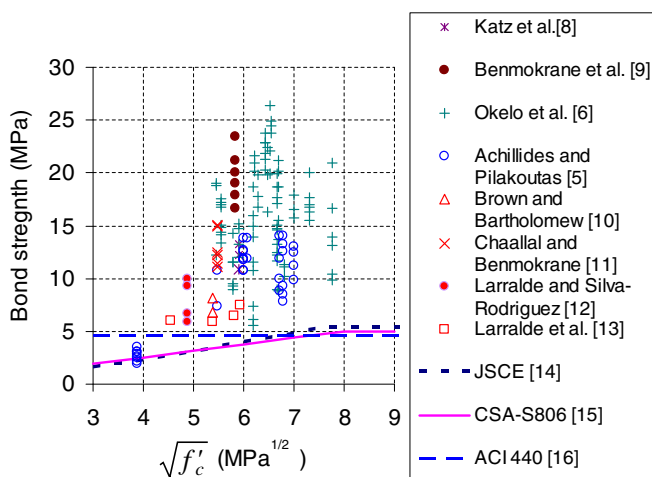
Fig. 1. Bond strengths vs. square root of concrete compressive strength. (See above-mentioned references for further information).

It is well established that the bond strength of steel bars is proportional to the square root of concrete compressive strength ( $\sqrt{f'_c}$ ). But this may not be true for FRP bars. The pullout failure mode of FRP bars is usually different from that of deformed steel bars. The bond strengths from several pullout tests of FRP bars vs.  $\sqrt{f'_c}$  were collected from the literature as shown in Fig. 1. These data are based on FRP bars with glass or carbon fibers, diameters of 6–19 mm, and embedment lengths of 4–18 bar diameters. For comparison purpose, the bond strengths used in design guides are also plotted in the figure. It can be seen from Fig. 1 that bond strengths adopted in CSA-S806 [15] and JSCE [14] are conservative, while the constant limit given in ACI 440 [16] may not be conservative when concrete strength is low. As shown in Fig. 1, when concrete compressive strength is relatively low, bond strengths are proportional to concrete strength, but for strength approxi-

mately above 30 MPa, this correlation is not apparent. The explanation for this behavior may be as follows. Generally, for concrete compressive strength below 20 MPa, the bond strength is primarily governed by interface concrete failure due to induced cracking and tensile stresses as in the case of steel bars. For concrete with higher strength beyond about 30 MPa, the interface mode of failure is due to a combined effect of concrete and surface FRP material degradation, with failure being increasingly dominated mainly by FRP bar surface damage as concrete strength increases. The surface of FRP bars generally includes a resin-rich layer and the interface of this layer with fibers inside. Therefore, the pullout resistance characterized by bond failure mainly occurring within the bar surface can be treated as a possible upper-limit bond capacity of FRP bar-concrete.

Test results in terms of bond strength values are summarized in Table 3. Compared to the test results of other studies as shown in Fig. 1 (Okelo and Yuan [6]; Achillides and Pilakoutas [5]), the bond

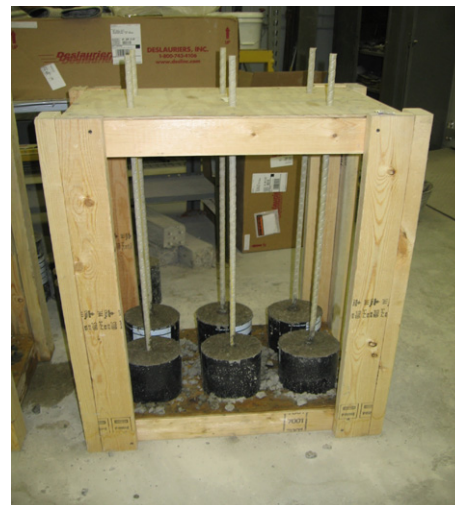
For pullout test specimens, the FRP bars were cut into 900 mm lengths, and the encasing concrete cylinders had dimension of 150 mm height and 150 mm diameter. The FRP bars were concentrically embedded in the concrete cylinders with bond lengths of five bar diameters. In order to control the bond length, the FRP bar was prepared with a bond breaker, which consisted of soft plastic tubing inserted around the bar to prevent contact of FRP with concrete. These specimens were fabricated by positioning the bars vertically through a wood alignment guiding frame as shown in Fig. 3. The concrete cylinder specimens, with embedded FRP, were removed from the plastic molds one day after casting, and then placed in a curing tank for 27 days before they were subjected to the environmental conditioning as described in the next section.

Fig. 3. Setup for fabrication of pullout specimens.

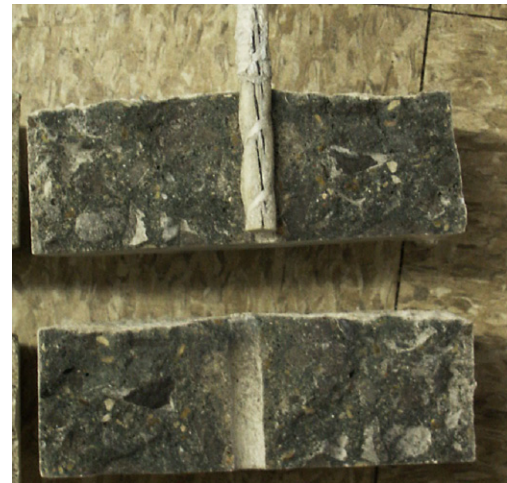
**Fig. 7.** Concrete bond failure of pullout test [2].

faces of the sand coating layer (sand embedded in resin-rich layer) and core-bar. The bond failure for GFRP bar specimens occurred consistently at the bar surface as expected. For CFRP bar specimens, the bond failure observed was minor and occurred both in concrete and bar surface. The bond failure modes for both control and conditioned specimens were nearly the same. In contrast to the results of this study, tests performed previously by the present authors [2] showed that the pullout failure mainly occurred in concrete while the bar surface appeared to be intact as shown in Fig. 7; in that case, the GFRP bar was similar to GFRP1 bar described in this paper, but the concrete compressive strength was only about 20 MPa, as opposed to an average of 60 MPa used in the present research.

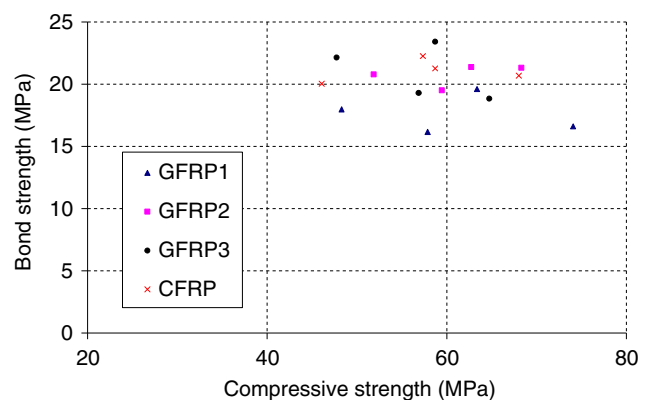
**Fig. 11.** FRP bar bond strengths vs. Concrete strengths.

Concrete cylinders were also tested for compressive strengths after exposures. The test results are listed in Table 3. There was obvious strength increase for concrete exposed to environment W. The conditioning of environment T resulted in about 20% compressive strength reduction for concrete. The bond strength vs. concrete compressive strength of companion specimens is plotted in Fig. 11. As expected, no apparent dependence of bond strength on concrete compressive strength can be found, as was purposely planned to primarily induce and study FRP-bar damage effect on bond strength with concrete.
