Long term behavior of Portland limestone cement mortars exposed to magnesium sulfate attack

A. Skaropoulou^a, S. Tsivilis^{a,*}, G. Kakali^a, J.H. Sharp^b, R.N. Swamy^c

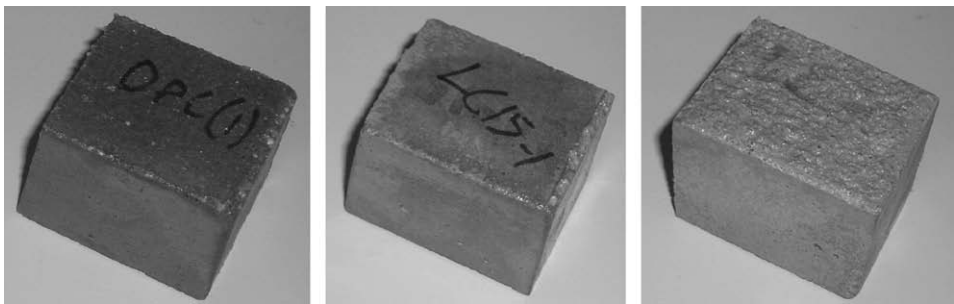
Fig. 3. Specimens with siliceous sand cured for 60 months in a 1.8% MgSO_4 solution at 25 °C.

No damage whatsoever was observed in the specimens exposed to sulfate solution at 25 °C (Figs. 3 and 4), nor was there any evidence of thaumasite formation at the higher temperature. It can be stated that “conventional” sulfate attack of well made mortars, at ambient temperature, is very slow, much slower than TSA at low

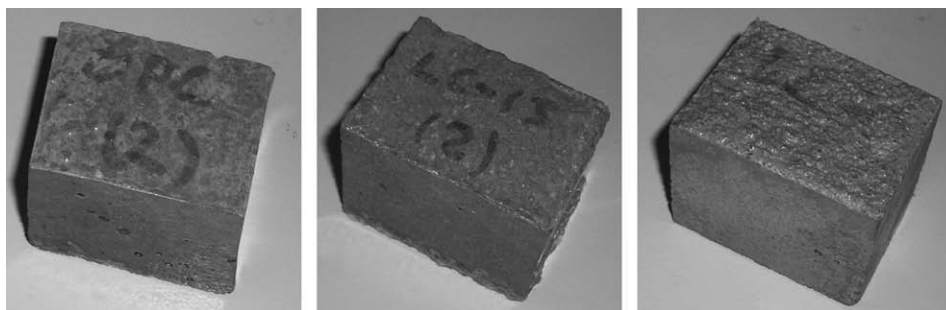
Fig. 4. Specimens with calcreous sand cured for 60 months in a 1.8% MgSO_4 solution at 25 °C.

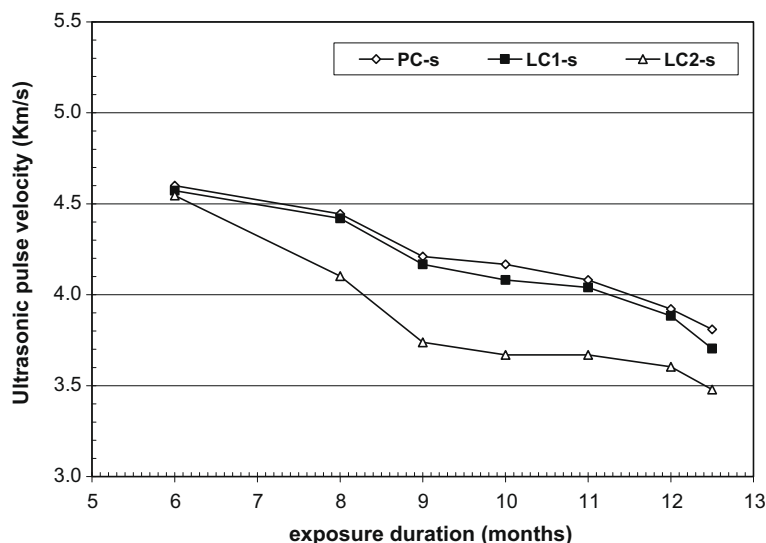
Fig. 6. Ultrasonic pulse velocity of specimens with siliceous sand (5 °C, 1.8% MgSO₄ solution).

The ultrasonic pulse velocity was measured periodically, after the first signs of damage were observed in the samples. The results for specimens cured at 5 °C are presented in Figs. 6 and 7 for siliceous and calcreous sand, respectively. In the case of siliceous sand (Fig. 6) although the decrease in velocity is small, it is clearly observed that LC2-s shows the worst behavior. In the case of calcreous sand (Fig. 7), samples LC1-c and LC2-c seem to have an almost similar behavior, worse than PC. After 13 months the specimens were too damaged to continue the measurement of ultrasonic pulse velocity.

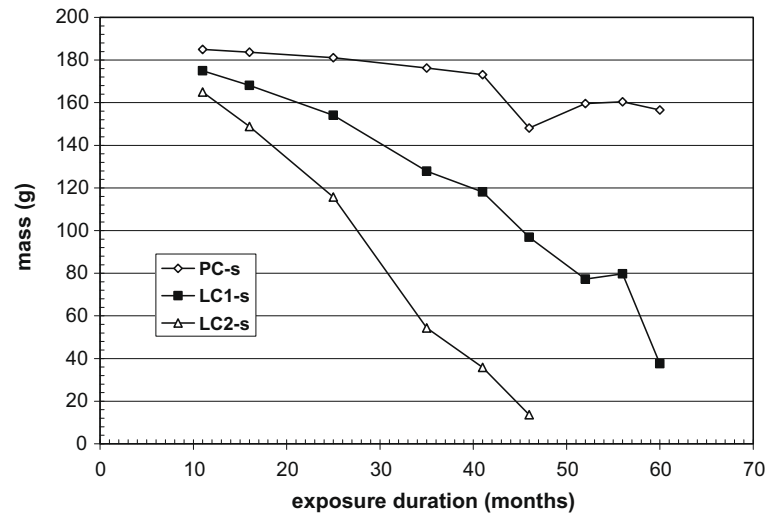
Fig. 8. Changes in mass of specimens with siliceous sand (5 °C, 1.8% MgSO₄ solution).

The mass loss of specimens is presented in Figs. 8 and 9 for siliceous and calcreous sand, respectively. LC2 showed the worst

behavior. In case of siliceous sand (Fig. 8), LC2-s lost 92% of its mass after 46 months of exposure in the sulfate solution. In case of calcreous sand (Fig. 9), LC2-c lost 80% of its mass after 60 months of exposure in the sulfate solution.
