# Flexural and shear strengthening of RC beams with composite materials – The influence of cutting steel stirrups to install CFRP strips

Inês G. Costa, Joaquim A.O. Barros \*

Department of Civil Engineering, University of Minho, 4800-058 Guimarães, Portugal

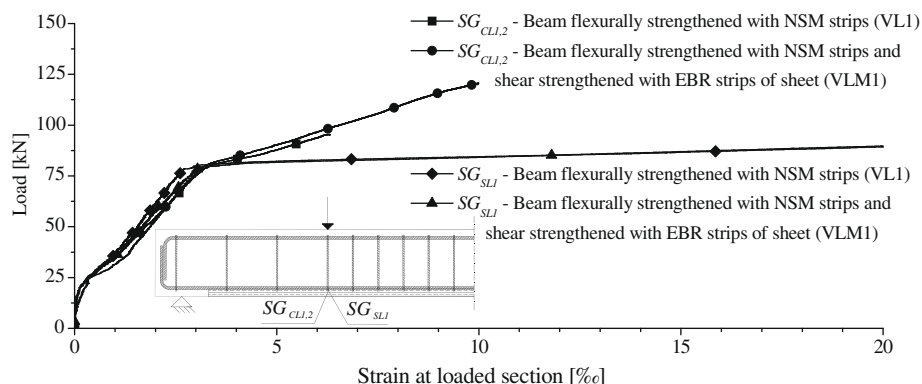
Fig. 9. Relationship between the applied load and the strains in both the longitudinal steel bars ( $SG_{SL1}$ ) and NSM strips ( $SG_{CL1,2}$ ).

In spite of having supported a load level significantly higher than its VR1 reference beam, the potential duplication of the load carrying capacity that NSM strips applied in VL1 beam could provide was not attained due to the occurrence of a shear failure mode in VL1 beam, as expected. However, it is quite notable that, at the moment of the shear failure, the longitudinal steel bars were already yielded in all the beams of Series 1 (Fig. 7). In fact, the longitudinal steel bars started yielding at a beam deflection of 3.3 mm, for a load of 79 kN when the maximum strain in the CFRP strips was 3.2‰ (Fig. 9).

Fig. 9 compares the evolution of the strains in the NSM strips (average of the two monitored strips) and in the longitudinal steel bars for the VL1 and VLM1 beams. It can be concluded that, up to the yielding of the longitudinal steel bars the variation of the strains in steel bars and CFRP strips was similar, revealing a perfect bond conditions between these strips and surrounding concrete. It is also visible that the shear strengthening system allowed the mobilization of a maximum strain of 10.0‰ in the NSM strips, which is 56% of the ultimate strain registered experimentally in this material (Table 4), while in VL1 beam the occurrence of the shear failure mode limited the maximum strain in the NSM strips to 6.4‰.

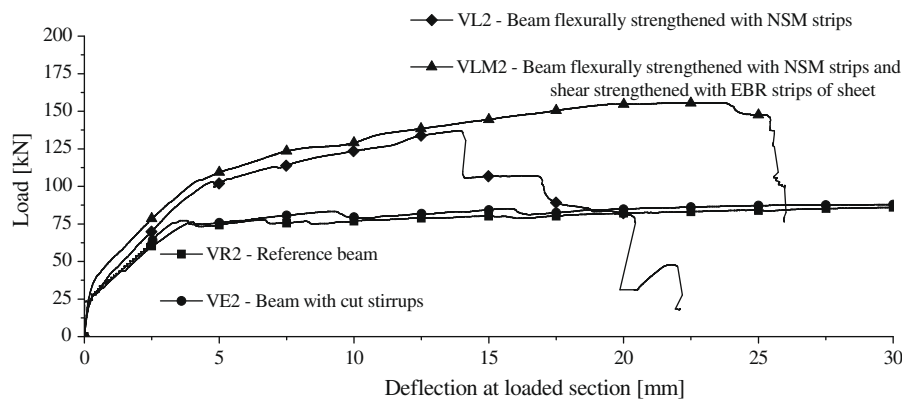
**Fig. 13.** Deflection-load relationship for the beams of Series 2.

The relationship between the applied load and the deflection at the loaded beam section is represented in Fig. 13 for the four beams of Series 2. Table 6 includes the most significant results obtained the tests of this series. From Table 6 it is visible that the increase in terms of beam's load carrying capacity provided by the strengthening of two laminates ( $\rho_f = 0.090\%$ ) was 55%, while combining the flexural and shear strengthening systems (VLM2) assured an increase of about 77%. It is also observed that the loss of load carrying capacity due to the cut of the bottom arm of the stirrups was again very small.

Similar to what happened in the beams of Series 1, when the beams of Series 2 failed, their longitudinal steel bars had already yielded. Furthermore, when shear failure crack formed in VL2 beam the longitudinal steel bars had already yielded (Fig. 13).

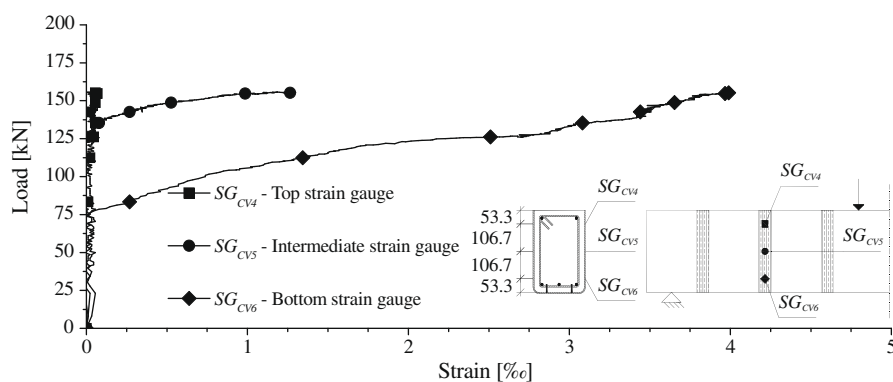
**Fig. 14.** Relationship between the strains in the EBR strip of sheet ( $SG_{CV4}$ ,  $SG_{CV5}$ ,  $SG_{CV6}$ ) and the applied load, in VLM2 beam (dimensions in mm).

On the other hand, the strain field registered by the strain gauges installed on the strip of sheet of VLM2 beam (Fig. 14) was distinct of the one recorded in VLM1 (Fig. 10). Since in VLM2 beam a shear failure crack was not formed in the  $L_1$  span where EBR strips of sheet were applied, the maximum strains registered in the monitored strip were lower than the corresponding ones measured in the strip of sheet of VLM1 beam.

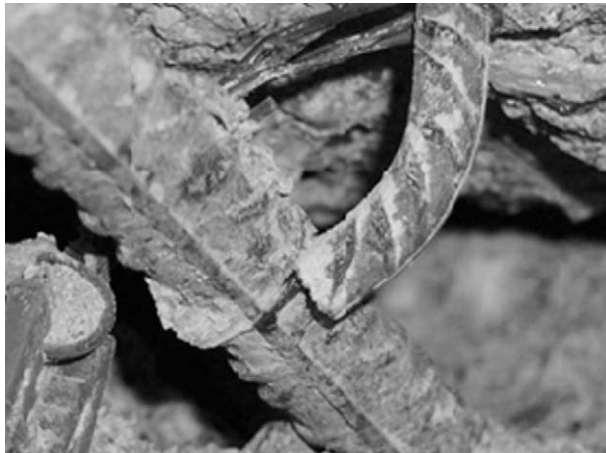
Fig. 17. Sliding of the central stirrup in the  $L_1$  span (VL3 beam).

Fig. 16 shows that the steel stirrup of the VL3 beam, closest of the loaded section in the  $L_1$  span, has ruptured, while the other stirrups loss their capability of embracing the longitudinal steel bars (Fig. 17). This suggests that if beams with bottom arm steel stirrups cut for the installation of NSM strips are subjected to cyclic loadings, such as in the case of a seismic occurrence, the steel stirrups can lose their capacity to provide shear resistance. In fact, in this case the applicability of the truss Mörsh approach, currently used for the evaluation of the contribution of tie stirrups and concrete compressive struts for the shear resistance of RC beams, is no longer applicable. Furthermore, concrete confinement might be also affected, which can have a detrimental effect, mainly when beams are also subjected to axial compressive force. These concerns advise additional research in the behaviour of RC beams with cut steel stirrups for the installation of NSM strips, subjected to cyclic loadings. The influence of fatigue loadings should also be investigated, since the load repetitions can significantly decrease the anchorage conditions of the cut arm branches of the stirrups, with the consequent adverse repercussions in terms of shear resistance and concrete confinement that steel stirrups can guaranty.

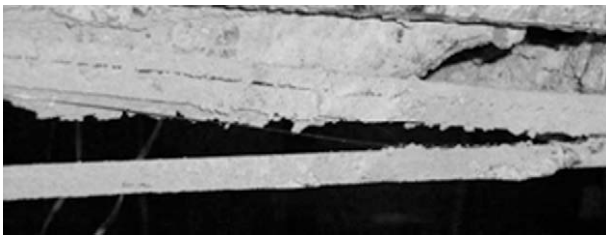
Fig. 18. Appearance of the NSM strips at the end of the test.

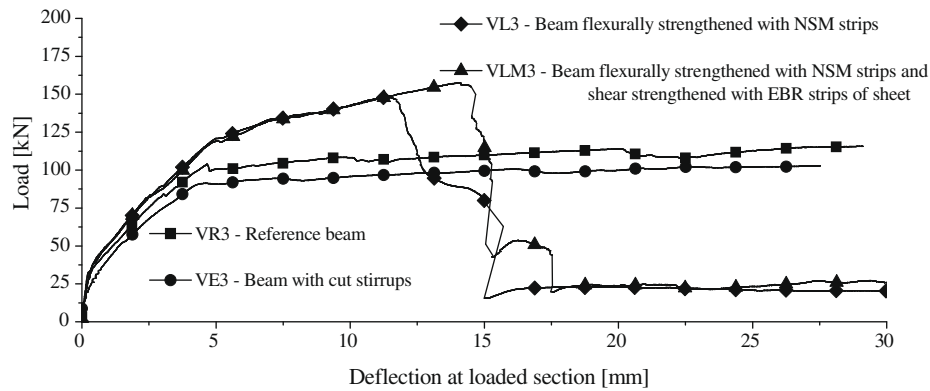
Fig. 19. Deflection-load relationship for the beams of Series 3.

When designing the CFRP shear strengthening system for VLM3 beam, the recommendation [12] for a distance between consecutive strips of sheet ( $s_f$ , Fig. 2) less than  $0.9d_s - w_f/2$  ( $w_f$  is the width of the strip of sheet,  $d_s$  is the effective depth of the beam's cross section,  $s_f = 296$  mm) was disregarded. In this beam the distance between strips of sheet ( $s_f = 325$  mm) was higher than the maximum value of  $s_f$  recommended by [12], which contributed for the occurrence of a shear failure mode (Fig. 19).

From Table 7 and Fig. 19 it is verified that the increase in term of load carrying capacity provided by two NSM CFRP strips applied in VL3 beam ( $\rho_f = 0.076\%$ ) was 28%, while the flexural and shear strengthening strategy adopted in VLM3 beam allowed an increase of 36%. The results in this table also show that cutting the bottom arm of the steel stirrups of the beam of this series led to a decrease of 11% in terms of beam's load carrying capacity. Although VLM3 beam has failed in shear, at the maximum load the strain on the CFRP strip was 10‰, which is 56% of the material ultimate strain, similar to the value recorded in the corresponding beam of Series 1. The strain fields in the longitudinal steel bars and NSM CFRP strips were similar to those measured in the homologous beams of the previous series.
