Size effect of concrete samples on the kinetics of external sulfate attack

Xavier Brunetaud^{a,*}, Mohammed-Rissel Khelifa^{a,b}, Muzahim Al-Mukhtar^a

^a University of Orléans, CRMD UMR 6619, 1 B rue de la Férollerie, 45071 Orléans Cedex 2, France

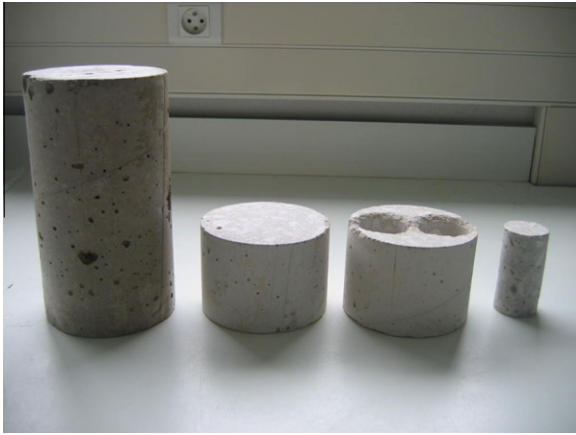
Fig. 2. Coring of 4 × 8 cm cylinders from 11 × 22 cm cylindrical concrete specimens.

Concrete cylinders (4×8 cm), obtained by coring into 11×22 concrete cylinders, were an original sample type. When submitted to the sulfate, the specimens showed macroscopic signs of ESA almost immediately for $W/C = 0.59$ and after 2–3 months for $W/C = 0.49$. This type of specimen was not equipped with measurement pins, it was not possible to simply and rigorously measure the expansion, only visual assessment was used to estimate swelling of around 10% located at the ends of the samples. Dynamic modulus measurements were very sensitive since the core of the 4×8 cm cylindrical sample quickly became damaged.

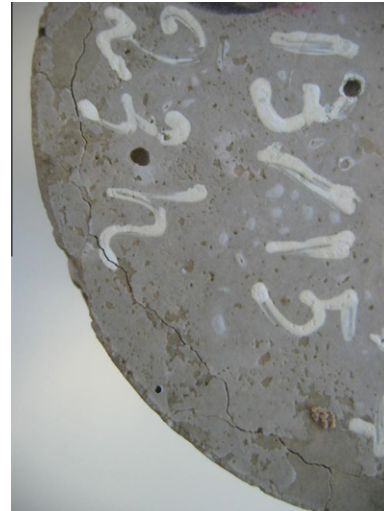
Cylinders (11 × 22 cm) subjected to complete immersion showed no sign of degradation until the 5th month. From the 6th month, CEM II/59 and CEM II/49 samples underwent significant cracking along their circular ridge. For the same CEM II/A cement, the cracking of CEM II/59 (i.e. W/C = 0.59) was more pronounced compared to those of CEM II/49 (i.e. W/C = 0.49). Cracking was always located near the edges (see Fig. 3). The 11 × 22 cm cylinders of the concretes made with CEM I 42.5 PM-ES cement remained intact, regardless of the W/C, and no cracking was observed.

Fig. 3. Visual inspection of CEM II/59 11 × 22 cm cylinders after 5 months.

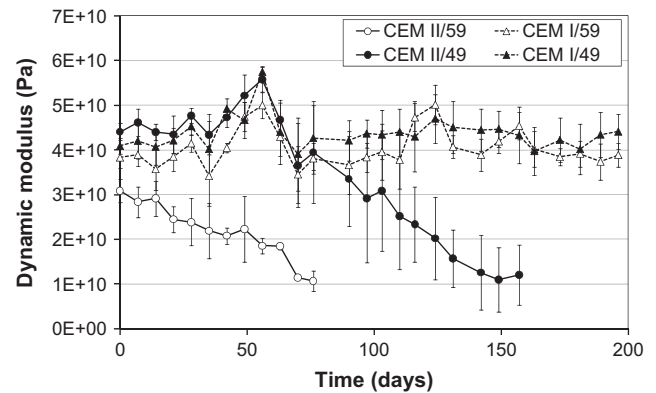
Samples of CEM II/59 and II/49 were damaged until rupture, while samples of CEM I/59 and I/49 remained intact. For CEM II specimens, there was a significant decrease in the dynamic modulus with a significant increase in the mass and a visible swelling of the most exposed surface of the samples (Figs. 7 and 8). These symptoms were similar to those involved in a swelling reaction [1]. As aggregates are exclusively limestone, we could not determine any alkali-aggregate reaction (AAR).

Fig. 8. Dynamic modulus of the 4 × 8 cm cylinders.

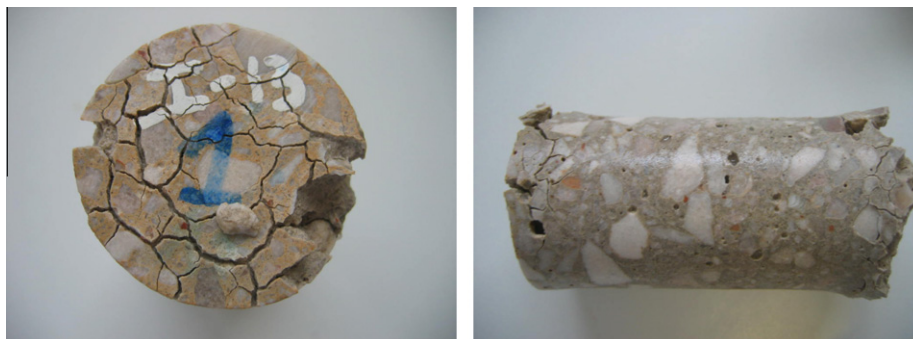
Fig. 6 shows the macroscopic consequences of immersion applied to the 4 × 8 cm cylinders of CEM II/59 concrete. From the third month, the visual aspect of the samples of CEM II/59 concrete

revealed surface cracking corresponding to large cracks at the paste/aggregate interfaces, with particular swelling located at the ends of the samples, which is the most exposed area. The 4 × 8 cm cylinders of CEM II/49 concrete also suffered cracks, but in a less pronounced manner. For CEM II/49 specimens, 5 months were required to obtain the same level of degradation as with CEM II/59 specimens at 3 months.

Fig. 6. Visual inspection of CEM II/59 4 × 8 cm concrete cylinders after 3 months.

The accelerating effect of the 4×8 cm cylinders with respect to the 11×22 cylinders can be apportioned to the higher surface to volume ratio, since this ratio is twice as high for 4×8 cm as compared to 11×22 cm cylinders. Beyond this general effect, an interesting point is to take into account the actual surface in contact between the external sulfate solution and the cement matrix. Although calcareous aggregates are slightly porous (5%) and may contribute to the transport of sulfate solution, they do not react with sulfates and could be considered as non-reactive surfaces. The volumetric fraction of the calcareous aggregates (including sand) is about 67%. The resulting surface fraction of the cored specimens related to aggregate is quite high (see Fig. 6). As a

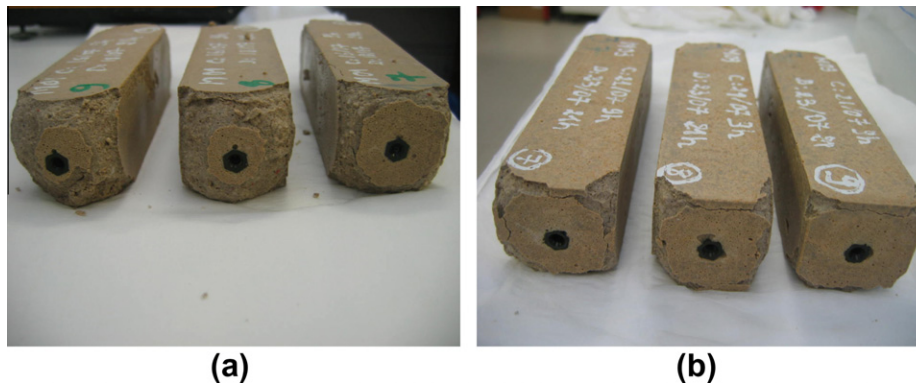
The mortars that were damaged by immersion were also the CEM II/49 and CEM II/59 specimens. The damage started at the 4th month for the CEM II/59 mortar and the 5th month for the CEM I/49 mortar (see Fig. 9).

Fig. 9. Visual inspection of CEM II/49 mortar at the 4th month (a) and CEM II/49 mortar at the 5th month (b).

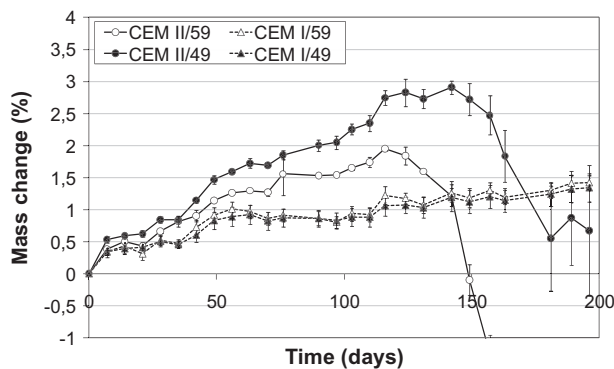
Changes in mass and expansion (see Figs. 10 and 11) confirmed that there was a weight increase and a significant expansion for both mortars made from CEM II, particularly that with a high W/C (i.e. CEM II/59). The sharp falls of material were a bit smaller

Fig. 10. Mass change of the $4 \times 4 \times 16$ cm prismatic mortars.
