Self-healing of surface cracks in mortars with expansive additive and crystalline additive

K. Sisomphon^{a,*}, O. Copuroglu^a, E.A.B. Koenders^{a,b}

^a Faculty of Civil Engineering and Geosciences, Delft University of Technology, Stevinweg 1, 2628 CN, Delft, The Netherlands

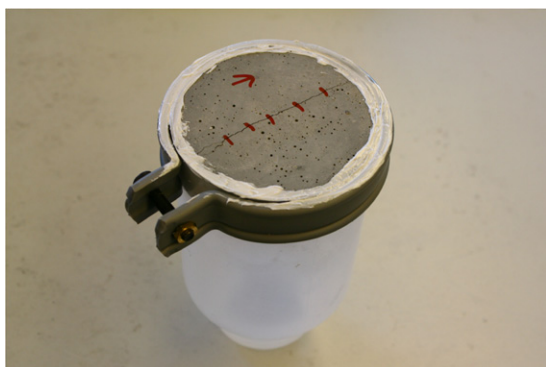
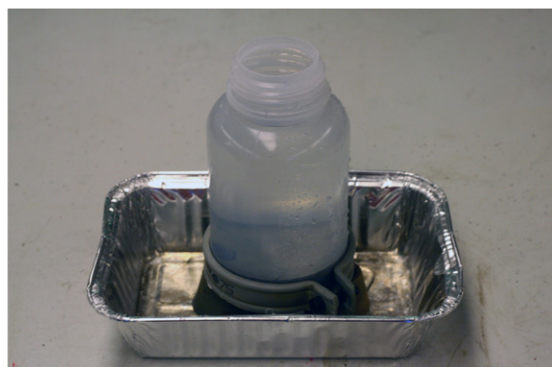
Water passing test was conducted on pre-cracked mortars to investigate the permeability of specimens due to crack progression. The specimen was attached to a plastic cylinder, and tightly fastened with a PVC bracket. Silicone sealant was applied along the seam to prevent water leakage (Fig. 3a). A constant water head of 100 ± 5 mm was controlled throughout the experiment by adding water (Fig. 3b). The specimen was placed on supports to allow free movement of water. The water passing rates were measured at 4, 7, 8, 14, 15 and 28 days wetting periods. The duration of each measurement was 10 min.

(a) Specimen for water passing test

(b) Set-up of the water passing test

Fig. 3. Water passing test.

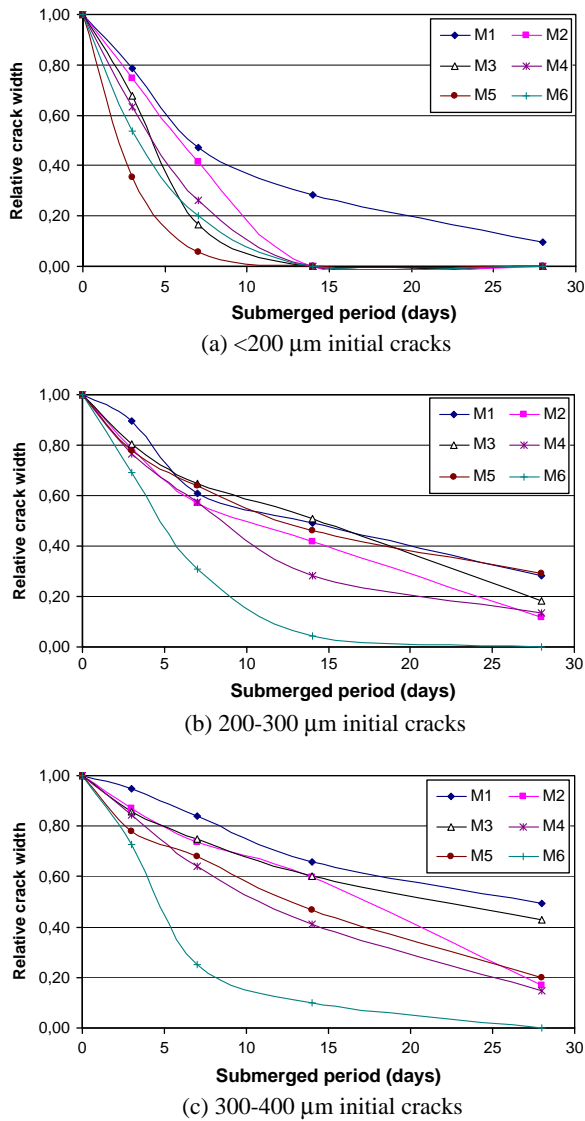
As demonstrated in Fig. 6a–c, the surface cracks were categorized into three groups of crack width which were for the initial width of $<200\ \mu\text{m}$, $200\text{--}300\ \mu\text{m}$ and $300\text{--}400\ \mu\text{m}$, respectively. The results were obtained from the average values of each crack range, and presented in term of relative crack width to the initial values. For small initial cracks ($<200\ \mu\text{m}$), the residual crack width of the control mortar was about 10% of the initial width after 28 days wetting. It can be seen that all mortars with additives can close the small cracks within 14 days. However, only M6 mix has a potential to completely seal medium ($200\text{--}300\ \mu\text{m}$) and large cracks ($>300\ \mu\text{m}$) within about 28 days. In this view, it can be

Fig. 6. Relative crack width of mortars.

obviously seen that M4 mix has a higher healing potential than M2 and M5 mixes at the first 14 days. At 28 days wetting, however, there was almost no difference between M2, M4 and M5 mixes, particularly for large crack healing. However, a more rapid healing ability would be more preferable in practice. Hence, the ability of surface crack closing could be ranked in the order of $M1 < M3 < M2 < M5 < M4 < M6$. While M6 was completely healed within 28 days, it has to be noted that the surface cracks on M4 and M5 mortars were completely sealed at 56 days wetting period.

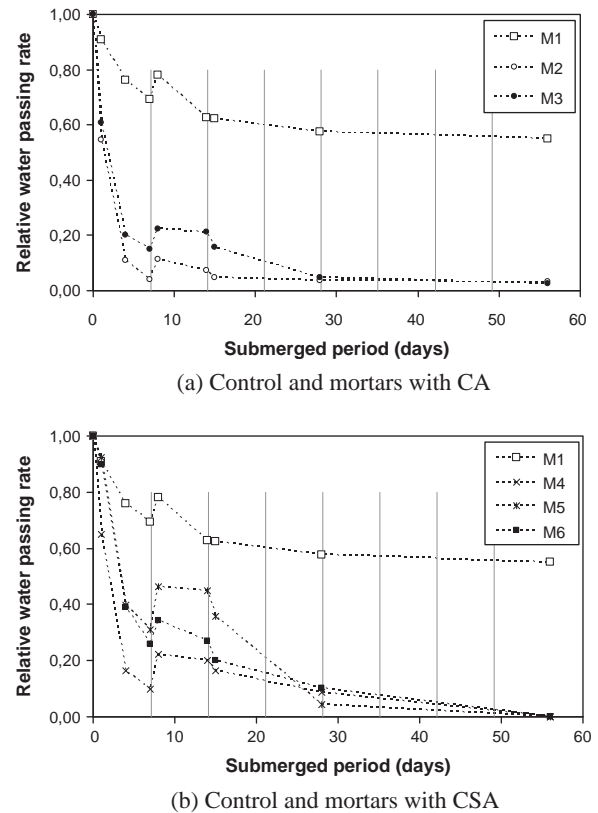
Fig. 7a and b shows the result of water passing rate of pre-cracked mortars corresponding to wetting period. At the beginning of the test, the initial water passing rates were measured. The initial rates were found in the range between 22 and 35 g/min. Thereafter, the reduction of water passing rate was presented in relative values to the initial water passing rate. For the control mortar (M1), slight reduction of water passing rate can be observed in the early period, while those mortars with CA or CSA showed rapid reduction of water passing ability during the first 5 days. The rates of reduction were gradually decreased between 5 and 7 days. However, after the water renewal at 7 days, the water passing rates of all mortars expectedly rebounded. From this observation, it can be hypothesized that some healing products formed at early period can be dissolved or decomposed under fresh water exposure. While most concretes in practice are usually exposed to fresh water, it is important to note that the specimens continuously released Ca^{2+} and OH^- to the curing water. Owing to the restricted environment of curing containers in laboratory, the rather high alkalinity of curing water in laboratory experiment may cause the misleading evaluation of concrete self-healing phenomenon, particularly the surface crack closing ability. On the contrary, the dissolved CO_2 in curing containers were consumed and continuously depleted. This may retard the precipitation of calcium carbonate which is a major product of self healing process. Therefore, it is essential that the water in curing containers is frequently replaced in laboratory experiments. It has to be noted that no rebound of water passing rate was observed after water renewal at 14 days and beyond. As healing products became denser, the decomposition rate might be substantially reduced, while the precipitation of calcium carbonate was still continuing.

Fig. 7. Relative water passing rate of mortars.

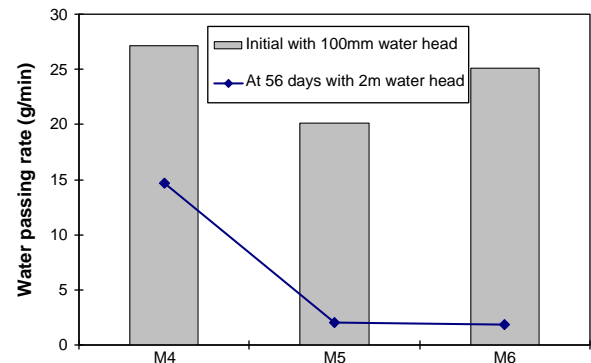
After 56 days, the surface cracks of M4–M6 specimens were completely sealed, and their water permeability rates with 100 mm water head were zero. Therefore, the water passing test was conducted at a higher water pressure. Fig. 8 shows the results of water passing test with a water head of 2000 ± 5 mm compared to the original water passing rates with a water head of 100 mm. As seen in Fig. 7, in the beginning period, it was clearly seen that M4 mortar had a more rapid crack closing ability compared to the M5 mortar. A similar tendency has been obtained from the surface crack closing ability investigated by stereomicroscope. After 28 days wetting, however, it seems that M5 had a slightly lower relative water passing rate than that M4. In addition to surface crack sealing, it seems that matrix swelling and further hydration of cementitious materials would play a role on the reduction of internal crack width and water passing ability. An explanation to this finding could be the slower hydration of free-CaO and consequent expansion compared with the formation of ettringite. The mass fraction among three oxides (CaO , Al_2O_3 and SO_3) indicate that ettringite would be the sole major product of CSA- α reaction. The limited amount of $\text{C}_4\text{A}_3\text{S}$ in CSA- β would cause a lower amount of ettringite formation compared with that from CSA- α . It can be hypothesized that the formation of ettringite plays a major role on early healing period, while the presence of excess free-CaO in CSA- β would react at later ages. At 56 days with a higher water head, it is clearly seen that M5 had significantly lower water permeability than M4.

Fig. 8. Water passing rate through cracked mortars.

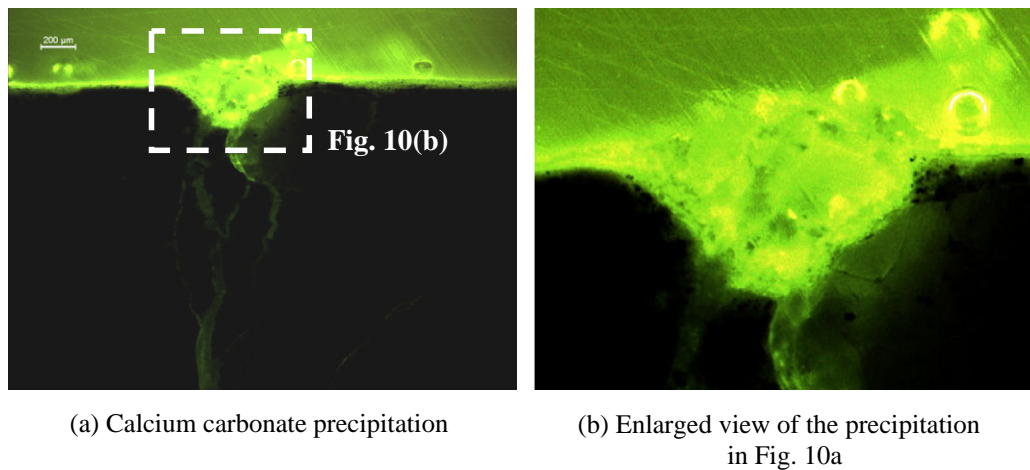
The appearance of surface crack closing products seen on the surface would be majority due to the precipitation of calcium carbonate which deposited on the surface of specimens (Fig. 10). In a previous work [8], the microstructures of crack were also observed on petrographic thin-sections through a polarized light microscope, by which excess formation of calcium carbonate on

Fig. 10. Precipitation of calcium carbonate (M6 specimen).
