THE MICROSTRUCTURE OF CONCRETE CURED AT ELEVATED TEMPERATURES

H H Patel, C H Bland and A B Poole

ABSTRACT

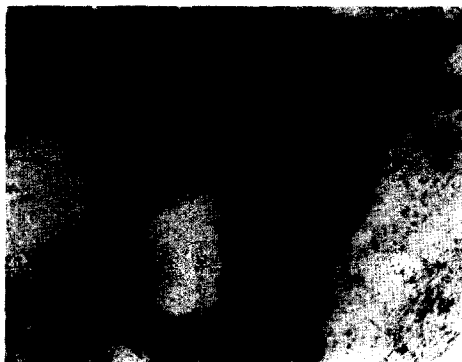
PLATE 3
Sample F: Backscattered
electron image

revealed limited residual clinker compatible with their age and hydration histories (Plates 1-3). The concretes cured at elevated temperatures (B, C, E & F) showed some development of hollow shells, particularly close to the largest aggregate particles, the result of the complete hydration of clinker grains and the migration of ions away from the site of hydration (Plate 3).
