ANCIENT GYPSUM MORTARS FROM St. ENGRACIA (ZARAGOZA, SPAIN): CHARACTERIZATION. IDENTIFICATION OF ADDITIVES AND TREATMENTS

M.P. Luxán*, F. Dorrego and A. Laborde**

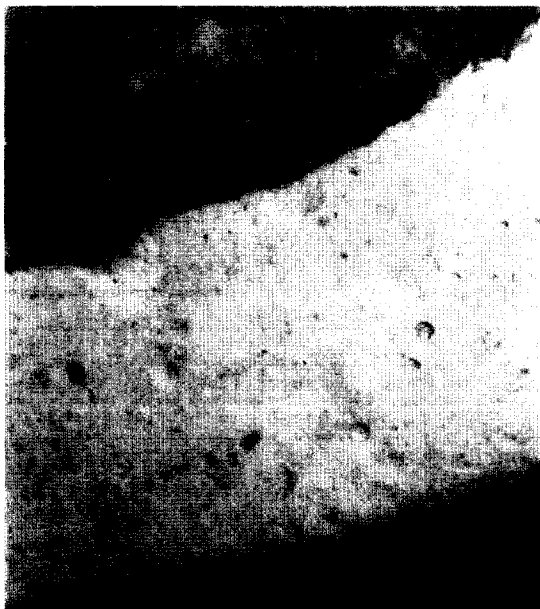
FIG. 2.- Reconstitution Mortar of the Re-carved T Piece (x 10,7)

the S mortar, later to the building, presents a similar appearance to that of the reconstitution mortar of the re-carved T piece (FIG. 2), that presents a good conservation state and good adherence with the alabaster, and it is like G mortar. In the W sample, extracted as coming from the Palao restoration period, two areas can clearly be distinguish: the inner one which contains small wood particles constituting part of the mortar mass and conferring more resistance to it and the outer coat formed by a gypsum base without aggregate and a protecting coat covered by dirtiness.

T sample : T mortar was part of an alabaster piece re-engraving its original shape (FIG. 2). Its look is similar to that of S mortar. Its IR spectrum is constituted almost in the whole by gypsum with presence of nitrates.

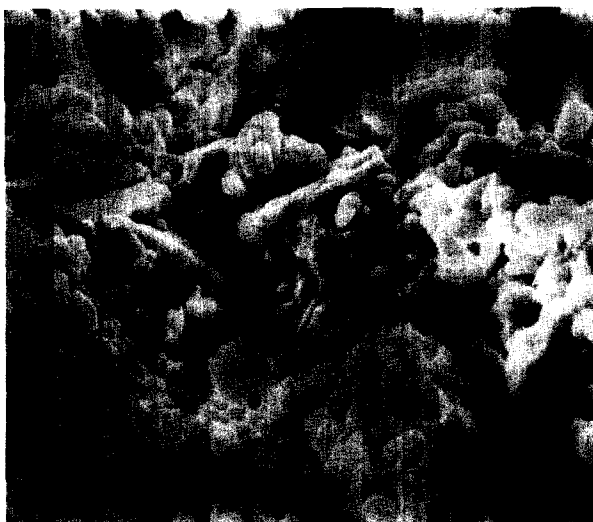
FIG. 4.- SEM Micrograph of J Mortar
(P Group) (x3000)

Through SEM/EDX the same results are corroborated. In the FIG. 4 it can be observed as an example a microphotograph of the old F mortar in which the gypsum and the calcium carbonate crystals are present.

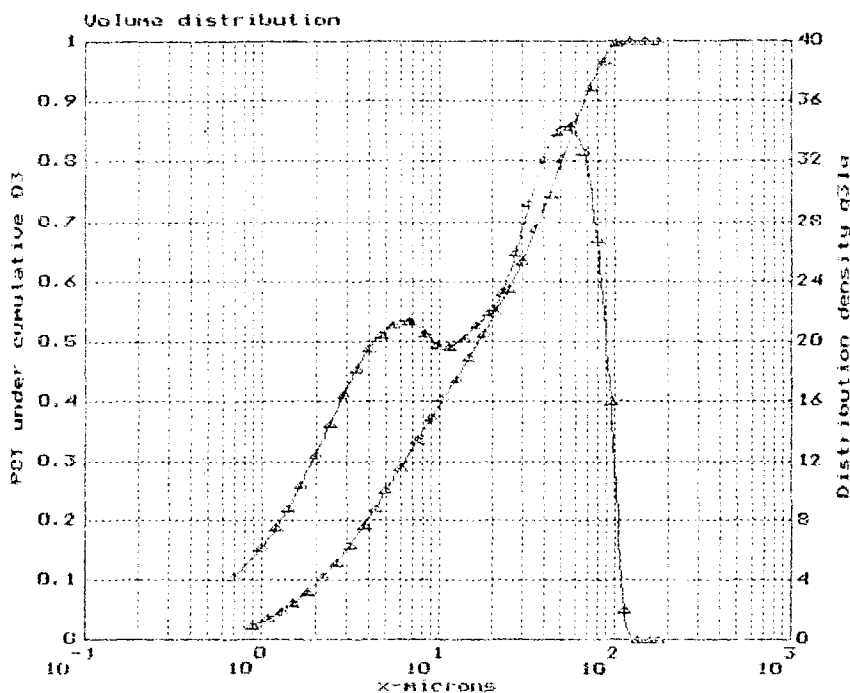
FIG. 8
Granulometric Analysis by Laser Ray
Diffraction of the Binder of O Mortar

O and J samples have a similar fineness although J sample is a bit smaller. The maximum of distribution density curve corresponds to particles around 50 μm. In this curve they reflect more than a maximum, sign of the existence of a components mixture

within the binder of O mortar (FIG. 8).
