INVESTIGATIONS ON CONCRETE RAILWAY TIES SUFFERING FROM ALKALI-SILICA REACTION

Jin Qinhua and Liu Weiqing

This paper investigated the railway ties affected by alkali-silica reaction in Shanghai and Zhengjiang railway stations. All these ties were produced by a plant in Beijing. The results showed that about 30% ties produced in 1980~1981 are damaged when used in the stations, while 61~85% ties manufactured in 1985-1987 were cracked now. It was found that load and wet and dry recycles could enhance the ASR cracking processes. Although compressive strength of concrete cubes cut from severely cracked ties are reduced 25%, static crack load of ties met the standard of class II. *Copyright © 1997 Elsevier Science Ltd*

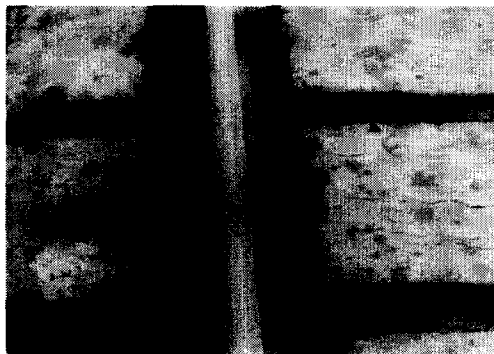
A survey was made in August 1988 on 13200 concrete ties placed in Shanghai railroad station. No. 82 and No. 76 ties were used. After 13~27 months in service, 4623 ties showed longitudinal cracks between the rail seats and map cracks at both ends with varying degrees of damage as shown in Fig. 1. In 1995, the number of damaged ties had increased to 9387 and the cracks were increased considerably wider. The extent of damage varied from different lines and locations. In Shanghai, there were three lines in which 85% ties were severely damaged showing map cracking in the middle (FIG. 2) while in Zhengjiang station, a small station near Nanjing, only 30% of the ties (No. 76) showed noticeable cracking.

FIG. 1.
Longitudinal cracks between the rail seats with map cracks in the both ends.

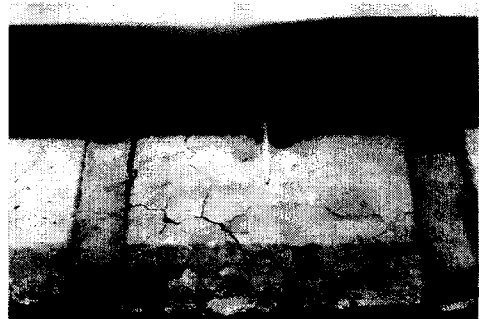
FIG. 4.

Cracks on the ends of a tie far away from the platform roof.

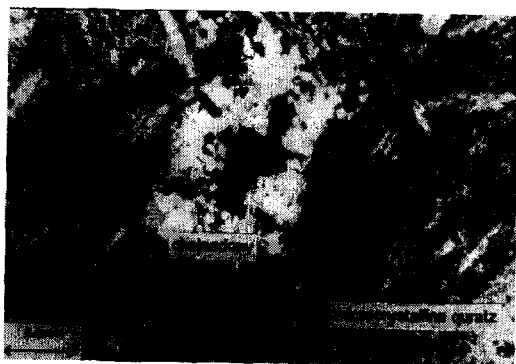
FIG. 8.

As mentioned previously (3), we found considerable amount of reactive aggregates in severely cracked concrete. The main reactive part was chalcedony and microcrystalline quartz as shown in Fig. 8. In the interface of cement and reactive aggregate particles, large amount of silica gel was observed. Figure 9 shows a typical EDAX result of silica gel found in cracked concrete. However, no abnormal amount of ettringite was found in cement paste. Therefore, the observed cracks in ties was most likely due to alkali-silica reaction rather than delay ettringite formation attack.

The texture of a reactive aggregate particle (thin section, crossed polarized light).

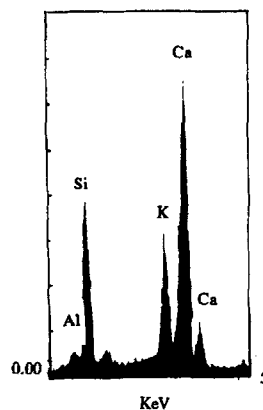
FIG. 9.

EDAX result of the typical silica gel.

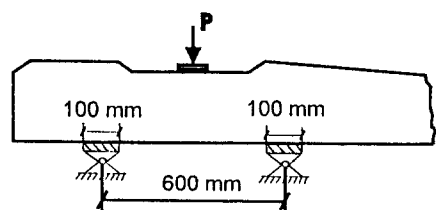
FIG. 10.

Crack tests were carried out according to Chinese standard TB 1879-87 "Crazing-resistance test method of static load for prestressed concrete ties". The tests were grouped into two parts: static load on the location where the rail is laid (back section crack test); (Fig. 10) and in the middle part of the ties (middle section crack test) (Fig. 11). The expansion of the ties was estimated by measuring the width of cracks. The results of the test are listed in Table 3.

According to the standard, if the tie cracks under a load on the back section +M of a tie are beyond 215 KN or 180 KN, it can be categorized into class I or II respectively. The corresponding values for the middle section are ≥ 180 KN or ≥ 160 KN for the class I or II. The results (Table 3) show that the average crack loads for three levels of damage meet the requirement of class I. However, two ties cracked at loads of only 200 KN in the back section test. These two ties had to be categorized as class II.

Back section crack test (static load on the location where the rail is laid).

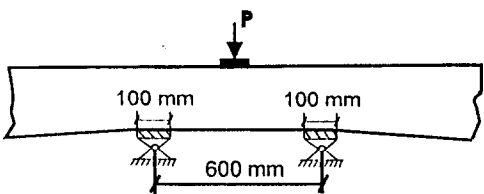
FIG. 11.

Middle section crack test (static load on the middle of the back surface).
