## PHYSICO-CHEMICAL AND PETROGRAPHICAL STUDIES OF OLD MORTARS AND PLASTERS OF ANATOLIA

Ahmet Güleş\* and Tülay Tulun\*\*

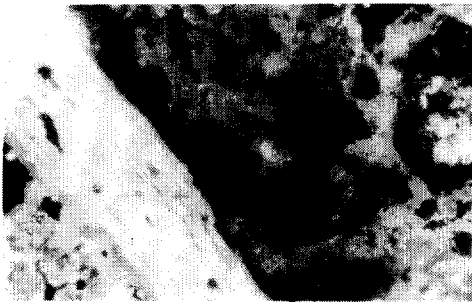
FIG. 3.  
TSA.TBP No:10, Fiber Additives.

Thin Section analysis of mortar and plaster samples of RB showed that they were quite homogenous with most of the mass made up of quartz, calcite and very little plagioclase and feldspar. The quartz content was rather large as it was seen in Fig.13. The aggregate content was over 65% and were very close to each other (Fig.12). Quartz and calcite grain sizes ranged from 0.1 mm to several mm. and their shapes were angular with low spherical property. Just a few samples of RB had crushed and ground brick pieces (Fig.14). Mortars and plasters samples of TB and EK had very different characteristics from those of RB samples. Mortar samples mostly consisted of little amount of quartz, carbonates, calcites (Fig.7), plagioclase and feldspar (Fig.2). The appearance of carbonate and broken shells indicated that these aggregates were prepared by crushing the "Küfeki" stone, which is a kind of calcareous sedimentary local stone. The mortar samples of domes (outside) were different from the wall samples. They did not contain any crushed bricks and stone pieces, but large amounts of (over 65%) pebble like aggregates where their size ranged from 0.3 to 3 mm. Although the trows included mostly in the inner plaster layer (Figures 3, 9), some of mortar samples had also these kind of additives.

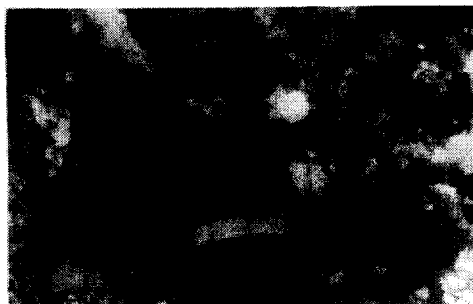
FIG. 7.

TSA.EKM No:19, Quartz, Carbonate and Calcite Minerals.

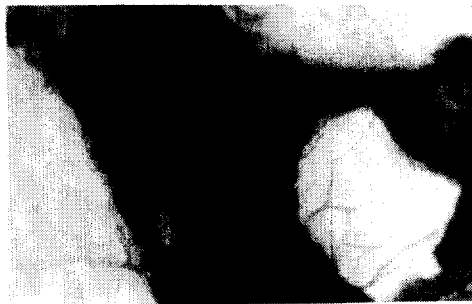
FIG. 8.

TSA.EKM No:8, From Dome, Pebble like Aggregates.
