**A CASE STUDY OF TWO AIRPORT RUNWAYS AFFECTED BY  
ALKALI-CARBONATE REACTION.  
PART ONE: EVIDENCE OF DETERIORATION AND EVALUATION  
OF AGGREGATES**

Through the inspection of field concrete and detailed petrographic examinations of concrete cores collected from two airport runways, it was found that the main reason of the damages in the concrete structures was alkali-carbonate reaction. The test results of the newly developed autoclave method agreed well with the field performance of the aggregates used. It is suggested that the autoclave method is an effective method to evaluate the reactivity of carbonate aggregates though its general validity should be widely inspected.

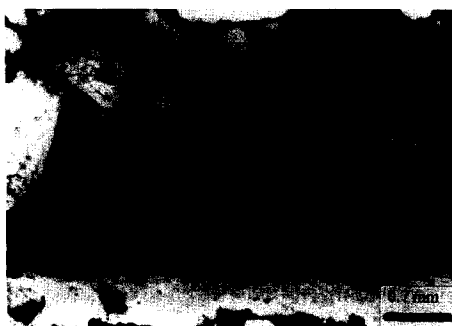
FIG. 9.

Cracks around an aggregate JN-3 particle in the heavily damaged concrete core of JN airport (thin section, plane polarized light).

For cores of the runway in JN airport, the typical feature of the reactive aggregate, i.e., cracks began within the aggregate particles and stretched out into the surrounding paste, was observed for the aggregate JN-2 and JN-3. FIG. 9 shows a crack around aggregate JN3. It was also noted that these aggregates JN-2 and JN-3 containing very little amount of clay. For aggregate JN-1, no visible cracks were recognized. However, surrounding cracks or debonding between the aggregate particle and paste were observed. This feature also presented for JN-2 and JN-3.
