# Experimental study of micro/macro crack development and stress–strain relations of cement-based composite materials at elevated temperatures

Yu-Fang Fu<sup>a</sup>, Yuk-Lung Wong<sup>a,\*</sup>, Chi-Sun Poon<sup>a</sup>, Chun-An Tang<sup>b</sup>, Peng Lin<sup>c</sup>

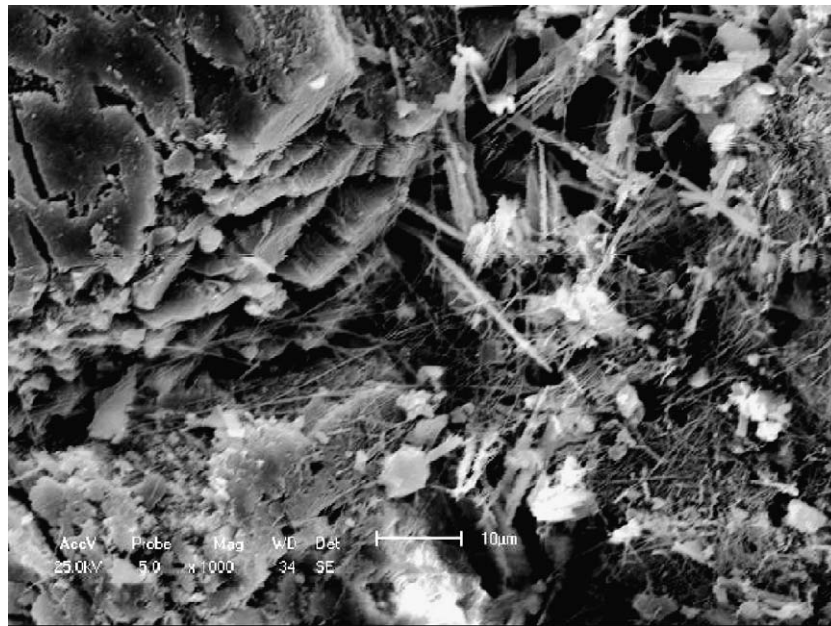
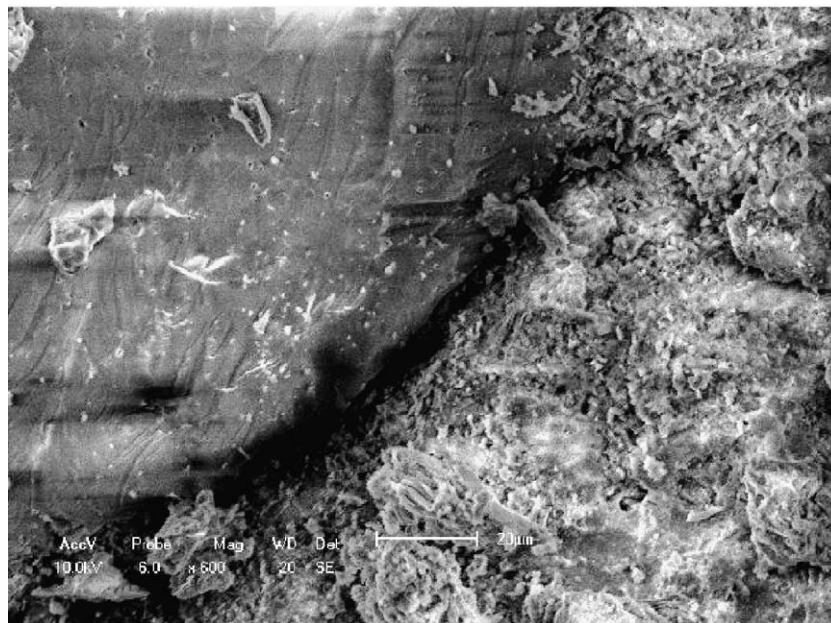
(a) Hardened cement paste,  $\times 1000$

(b) Mortar,  $\times 600$

Fig. 3. Morphology of typical HCP and mortar at room temperature.

Fig. 3 shows two representative micrographs of the microstructures of the HCP and the mortar specimens at the age of 28 days before heating. Their compressive strengths were 76 and 66 MPa, respectively. The HCP specimen had a good framework of platelike calcium hydroxide crystals, needle- or fiberlike C-S-H and crystals of ettringite and pores. In the mortar specimen, no transition zone was observed between the cement paste and the sand.

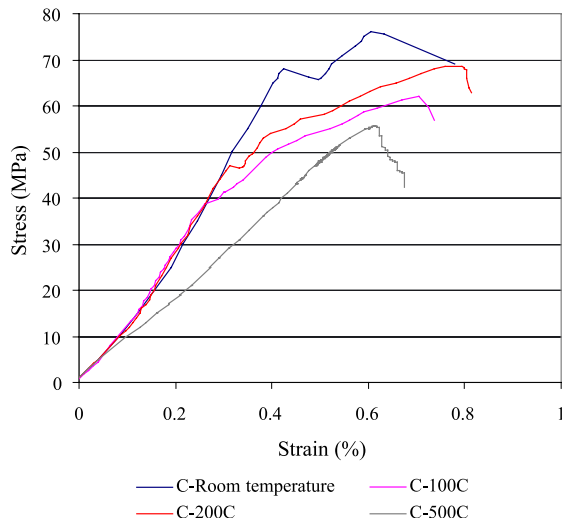
Fig. 7. Compressive stress–strain curves of HCP specimens at different temperature levels.

The compressive stress–strain relations of the HCP and mortar specimens determined under a thermal steady and displacement-rate conditions are shown in Figs. 7 and 8 respectively. From these measurements, the peak strengths and the secant modulus calculated at one third of the peak strength of the specimens are plotted in Fig. 9. The peak strengths and secant modulus decreased with increasing

Within the temperature range (from room temperature to 500 °C) studied in this research, the strains corresponding to the peak-strength of the HCP specimens were around 0.6% at 500 °C. However, for the mortar specimens, these strain values increased from 0.2% at the room temperature to 0.65% at 500 °C. This observation was consistent with the

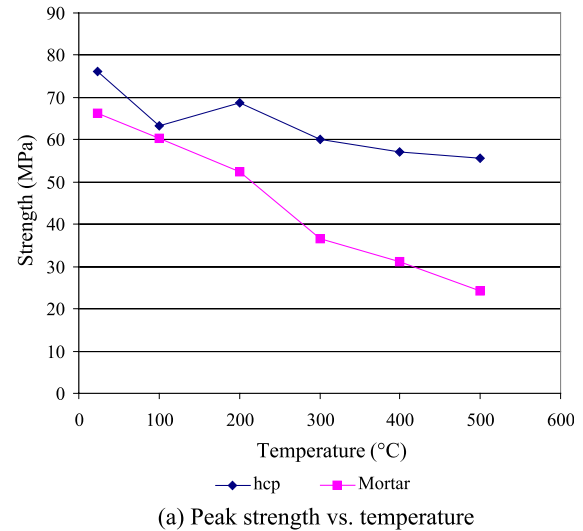
(a) Peak strength vs. temperature

(b) Secant modulus vs. temperature

Fig. 9. Compressive peak strength and secant modulus of HCP and mortar at elevated temperatures up to 500 °C.

temperatures. As compared with the respective peak strengths at the room temperature, the peak strength loss of the HCP specimens was about 27% at 500 °C, and that of the mortar specimens was about 66%. Similarly, the reductions of the secant modulus of the HCP and the mortar specimens were about 43% and 89% respectively. The deterioration of the mechanical properties of the HCP specimens basically was due to the thermal decomposition of hydrates and the occurrence of dehydration-induced cracks. The consistent poorer mechanical performance of the mortar specimens than the HCP specimens was attributed to the development and accumulation of macrocracks, derived from the thermal mismatch between the HCP and the sand aggregates.
