Corrosion of steel fibre reinforced concrete from the cracks

Jean-Louis Granju*, Sana Ullah Balouch

Laboratoire Matériaux et Durabilité des Constructions, INSA-UPS, 135 Avenue de Rangueil, 31077 Toulouse Cedex 4, France

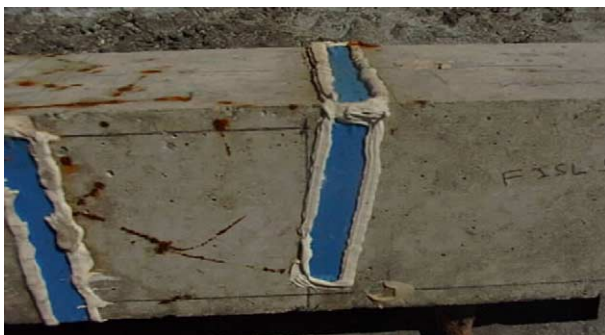
Fig. 4. Cracks protection.

The prisms were cracked at three positions, as shown in Fig. 1. In the fog room, they were positioned in such a manner that the cracks remain in vertical position, as shown in Fig. 2. In this way, during the periods of salted fog, the water could penetrate in the cracks, and during the periods of dryness, the water accumulated in the cracks could drain by gravity, allowing air, and its oxygen, to arrive in quantity on the corrosion sites. It results in one of the most severe conditions in regard with corrosion. Half of the prisms had their cracks sealed, and for the other half, the cracks were kept open to corrosive environment. The sealing was assured by plastic adhesive tape, 1.5 cm wide, on all the length of the crack. Moreover, the protection was reinforced by marine silicon mastic, as presented in Figs. 3 and 4. Both types of prisms, opened and sealed ones, were placed simultaneously in the fog room.

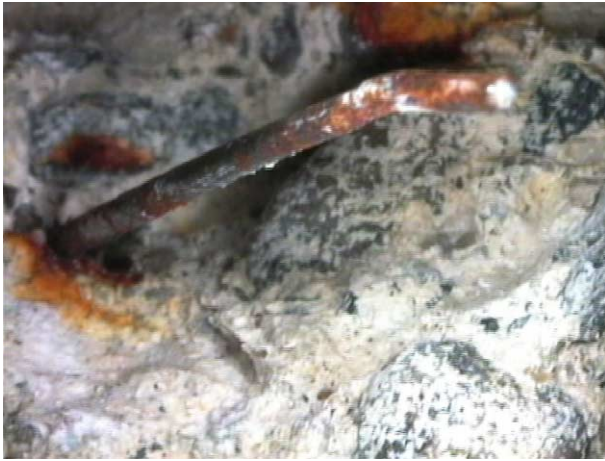
Fig. 12. Photograph of the corroded fibre in the crack.

After the flexure test, each prism has been carefully broken following the path of each investigated crack. Each face of these cracks and emerging fibres was examined visually and with a magnifying glass. The following features, illustrated in the sketches and photographs of Figs. 10–12, were observed:
