Occurrence of thaumasite in gypsum lime mortars for restoration

V. Tesch^{a,*}, B. Middendorf^b

Abstract

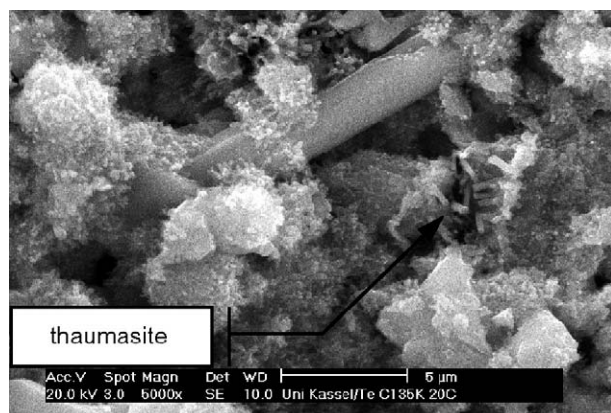
Fig. 11. SEM pictures of mortar sample C135K stored at 20/65.

Furthermore, the results of mortar samples with higher amounts of hydraulic components show that there is a high potential of thaumasite formation at low temperature. Looking to the results of the OPC containing mortar sample C253 or to sample 135 K with the high amount of CL 70, it can be seen that both samples show high expansion and a decrease in compressive strength, which can be indicative of thaumasite formation. In mortar samples with a small amount of hydraulic phases, thaumasite cannot be detected by SEM/EDX (Figs. 6 and 7). On the contrary, in samples with high amounts of hydraulic components, thaumasite is easily detectable by using SEM/EDX as shown in Figs. 8–14, as well as by XRD (Fig. 15).
