Influence of the intermixed interfacial layers on the thermal cycling behaviour of atmospheric plasma sprayed lanthanum zirconate based coatings

Abstract

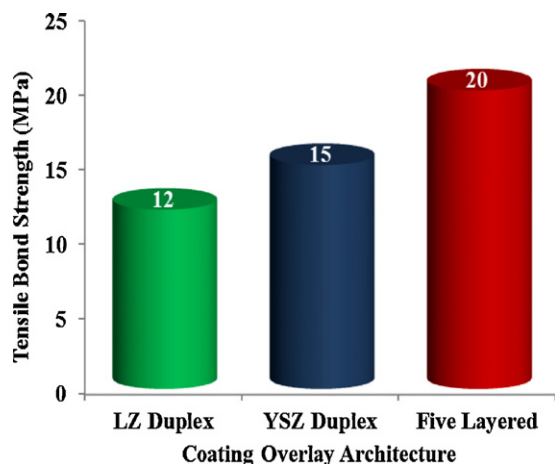
Fig. 15. Tensile bond strength of coatings.

layers. The tensile bond strengths of the LZ, YSZ and the five layered coatings are shown in Fig. 15. The tensile bond strength of 12 MPa was recorded in the case of the LZ duplex coating; 15 MPa and 20 MPa were the bond strengths of YSZ duplex and five layered coatings, respectively.

The tensile bond strength comparison chart for the LZ, YSZ and five layered coatings is shown in Fig. 15. According to previous studies, the residual stress levels present in the coatings can affect their thermal cycling life [32]. During the tensile bond strength test, the internal residual tensile stresses in the coating might get superimposed with the tensile loading, resulting in rapid separation or bond failure of the coatings. For the duplex coatings, because of the large difference of the thermal expansion coefficient of the top coat (LZ/YSZ) and the NiCrAlY BC, the residual stress must be quite high. The high residual stresses and the sharp interface between the ceramic layer and the bond layer cause the earlier bond failure between the ceramic layer and the metallic layer. The thermal stresses can be decreased significantly by using intermixed interfacial layers and therefore, the bond strength can be improved significantly. The increase of bond strength is also because of the gradual change of the microstructure without sharp interface between different layers.

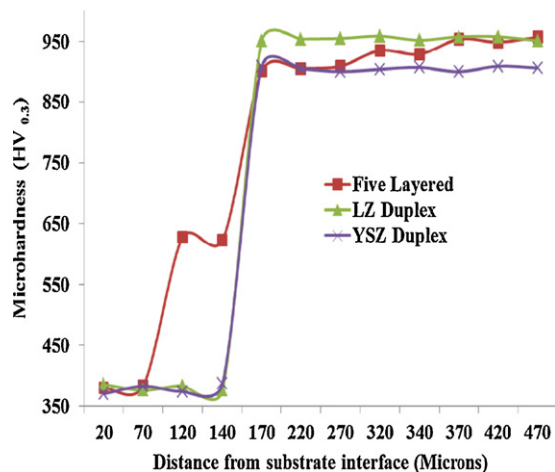
Fig. 16. Microhardness distribution in coatings.

The hardness distribution of the LZ, YSZ and five layered coatings are shown in Fig. 16. An average microhardness value of 954 HV_{0.3} was recorded in the case of LZ coating and an average hardness value of 907 HV_{0.3} was recorded in the case of YSZ coating. The average hardness values of the LZ–YSZ interface layer and the YSZ–BC interlayer of the five layered coating were 932 HV_{0.3} and 625 HV_{0.3}, respectively. The thermal cyclic lifetimes of the coatings with various architectures are shown in Fig. 17. From the figure it can be said that the LZ duplex coatings exhibited the lowest thermal

The microhardness distributions of the duplex coatings and the five layered coating are displayed in Fig. 16. It can be observed from the figure that the microhardness changes gradually through the five layered coating, while a significant difference exists for the duplex coatings. The gradual variation of the microhardness for five layered coatings can reduce the large difference of the elastic modulus between ceramic and metal layers. The high bond strength and the gradual variation of the microhardness between the top ceramic coating and the substrate are beneficial to maintain the coating integrity under the strain generated by the alternating compressive and tensile stresses generated during the thermal cycling test.

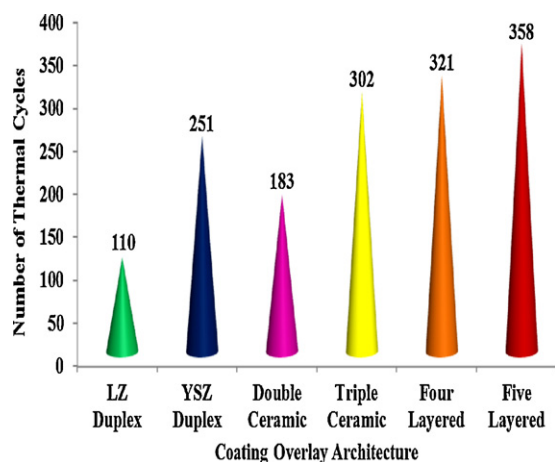
Fig. 17. Effect of coating architecture on number of thermal cycles.

cycling life of 110 cycles and the five layered coating exhibited the highest thermal cycling life of 358 cycles. The specific weight gain of the YSZ coating was the highest, with a peak weight gain of 2.45 mg/cm² and the weight gain of the five layered coating was the lowest with a peak weight gain of 1.2 mg/cm² with respect to the number of thermal cycles as is shown in Fig. 18.

was not due to sintering, but due to a different attribute. The XRD pattern (Fig. 28) of the LZ coating before and after thermal cycling did not show any significant variation and the cubic pyrochlore phase was maintained well without any phase transformation. The LZ coating survived the least number of cycles as illustrated in Fig. 17.

viewed in the graphical illustration shown in Fig. 17. The top surface of the thermally cycled double ceramic layered (Fig. 30) coating has a lot of cracks and the widths of the cracks are also large. The possible reason for the formation of microcracks is that the top ceramic layer is subjected to a tensile stress during heating [24]. The micrograph taken at the cross-section of the coating is shown in Fig. 31. The double ceramic layered coating shows cracks that have propagated from the surface and ended up in the interface between LZ and YSZ coatings. One can see extensive cracking right at the interface of the ceramic coatings (Fig. 31). This extensive cracking might have taken place due to thermal expansion mismatch, the high thickness of the coatings and the stress that occur due to TGO formation.

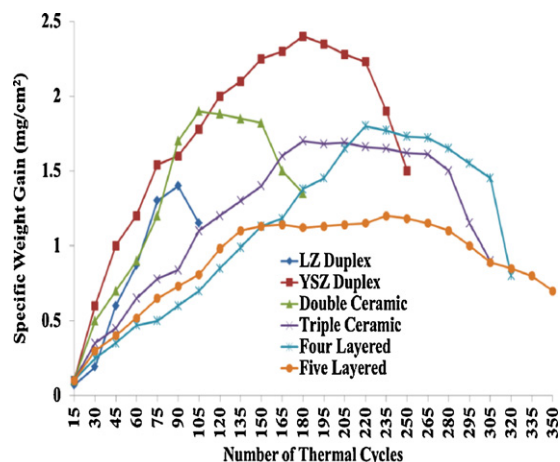
Fig. 18. Specific weight gain of coatings with respect to number of thermal cycles.

after 251 thermal cycles (Fig. 17). The specific weight gain due to oxidation of the coatings is shown in Fig. 18, which shows that the YSZ duplex coating has gained the highest specific weight. It is a known fact that the YSZ material is oxygen transparent [17]. Hence, the diffusivity of the oxygen atoms is

The oxidation behaviour of the LZ coating could be seen in Fig. 18, which displays that after 40 thermal cycles the LZ coating undergoes rapid weight gain. The oxygen non-transparent nature of LZ material is a very well established phenomenon [22]. Despite the aforementioned property, the oxidative weight gain of the LZ duplex was due to the heavy cracking of the coating. The evolution of cracks led to lots of opening in the coating, leading to rapid oxidation of the BC at the ceramic coat-BC interface. It can be seen from Fig. 27 that a transverse crack is also observed above the TGO layer after thermal cycling, which implies that BC oxidation is one of the important factors for coating failure. The EDS mapping results

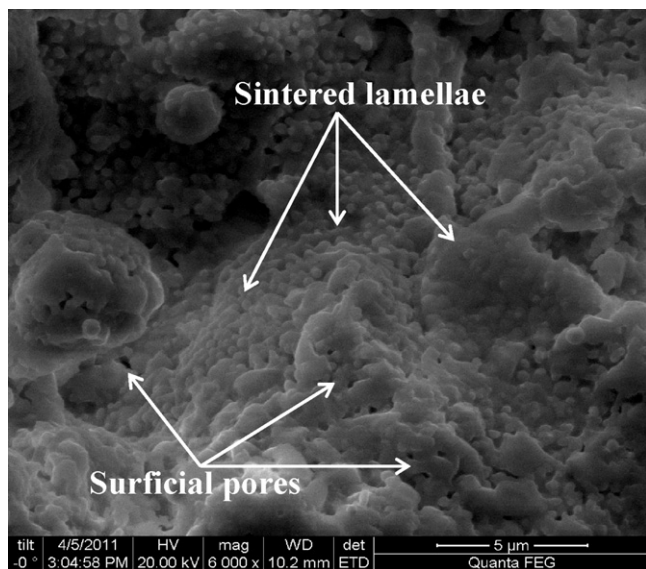
Fig. 20. High magnification image of top surface of YSZ duplex coating after thermal cycling.

morphology of the thermal cycled and spalled YSZ duplex coating is shown in Figs. 19 and 20. Fig. 19 displays longitudinal branched cracks, which have got propagated throughout the coating surface. The high magnification image (Fig. 20) displays extensive sintering of splats and closure of open porosities.

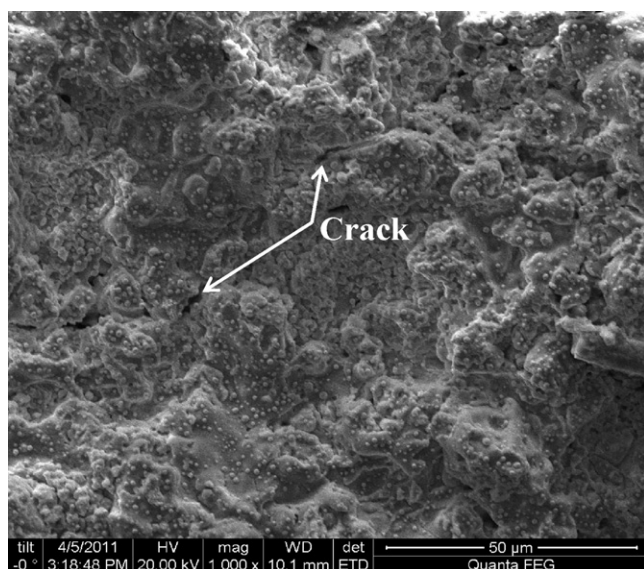
Fig. 34. Top surface of four layered coating after thermal cycling.

The top and cross-sectional views of the four layered coating are shown in Figs. 34 and 35. In this coating architecture an
