# Fractography of Fatigued and Fractured Regions in a Silicon Carbide Whisker Reinforced Alumina Composite

*Fatigue cracked and fast fractured regions in four point bend specimens prepared from 25 wt% silicon carbide whisker reinforced alumina composites were examined by Scanning Electron Microscopy. In the fatigue cracked region, the alumina matrix failed mainly in a transgranular mode and the whiskers failed mainly with a flat fracture surface but without pullout. On the other hand, in the fast fractured region, the whiskers failed predominantly by pullout and the alumina matrix failed in a mixed mode with about half in transgranular and the other half in intergranular fracture. Thus, to improve the fracture toughness of the material, the grain boundary strength of alumina and the matrix whisker interfacial bonding should be improved. To increase the resistance to fatigue, the fracture strength of the alumina grains should be improved by using finer  $\alpha$ -alumina particles and the fatigue strength of the whisker has to be increased by improving the uniformity in distribution of  $\beta$ -SiC whiskers during hot pressing.*

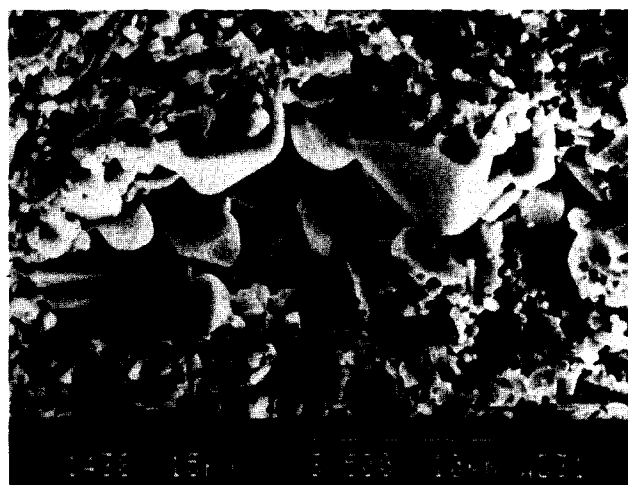
Fig. 2. Fracture surface of the composite showing the size and shape of the alumina matrix.

The SEM (Scanning Electron Microscope) examination of the fractured surface of the specimens which failed due to premature crack extension during precracking in the conventional bridge fixture,<sup>1,3</sup> showed that the alumina grain size after fabrication varied between 1 and 6  $\mu\text{m}$ . This confirms that during hot pressing, the alumina underwent substantial grain coarsening. In areas where either whiskers were absent or there was evidence of pores (Fig. 2), the grain size was as high as 6  $\mu\text{m}$ . However, in other areas, the majority of the alumina grain size was in the range of 2–4  $\mu\text{m}$ .

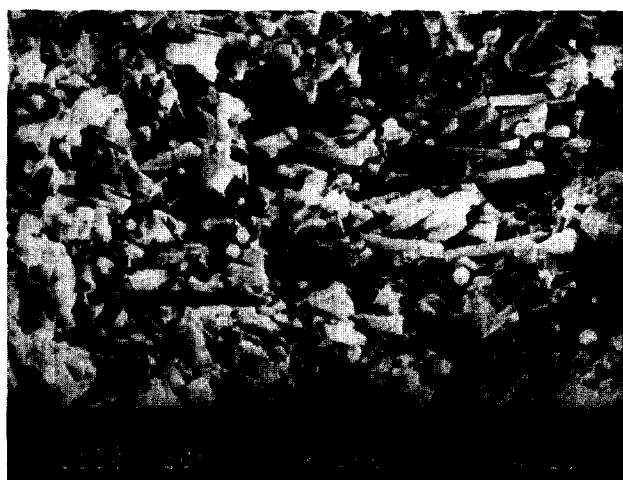
Fig. 7. At high  $\Delta K$  (2.8–3 MPa  $\sqrt{m}$ ) region the whiskers failed in a mixed mode, i.e. both with a square fracture and also by pullout.

$\sqrt{m}$ ), the whisker failed in two different ways: that is about 60% of the whiskers failed with a flat fracture and the balance failed by pullout (Fig. 7). On the other hand, in the fast fracture region, the whiskers failed predominantly by pullout (Fig. 8).

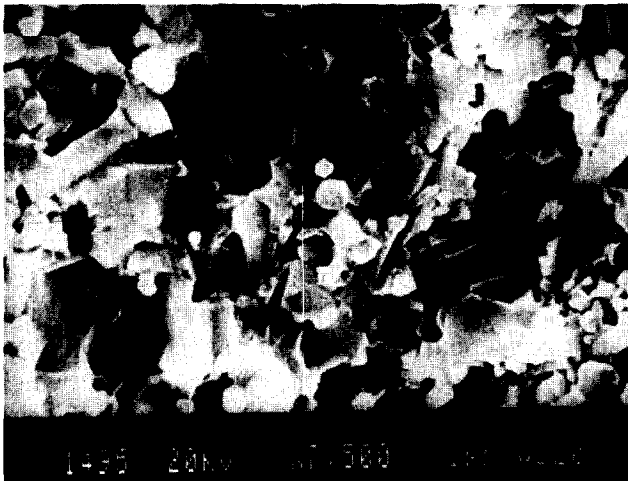
Fig. 9. At low  $\Delta K$  region, the alumina matrix failed predominantly through transgranular fracture.

Table 1 also reports that the matrix alumina grains failed predominantly through transgranular fracture (Fig. 9) at low  $\Delta K$  (0.8–1.8 MPa $\sqrt{m}$ ). In the high  $\Delta K$  (2.8–3 MPa $\sqrt{m}$ ) region, the matrix failed in a mixed mode wherein about 45% of the alumina grains failed by intergranular and the balance by the transgranular mode, as shown in Fig. 10. During monotonic loading, the alumina grains in the fast fracture region also failed in a mixed mode with a slightly increased percentage of intergranular (~55%) and the balance by transgranular mode—as shown in Fig. 11.

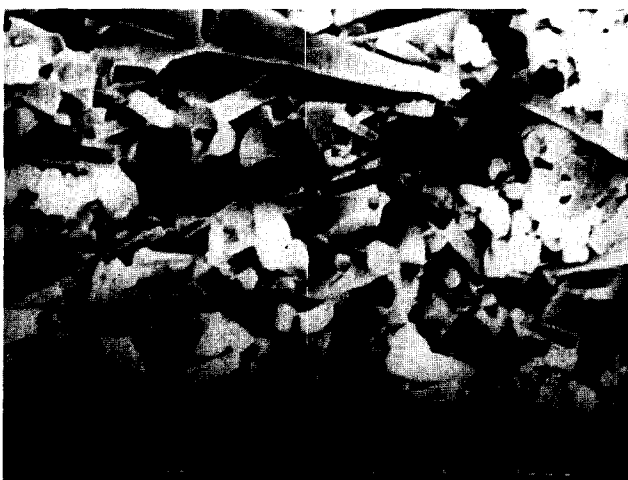
Fig. 10. At high  $\Delta K$  region, the alumina grains failed in a mixed mode, i.e. intergranular (~45%) and transgranular (~55%).

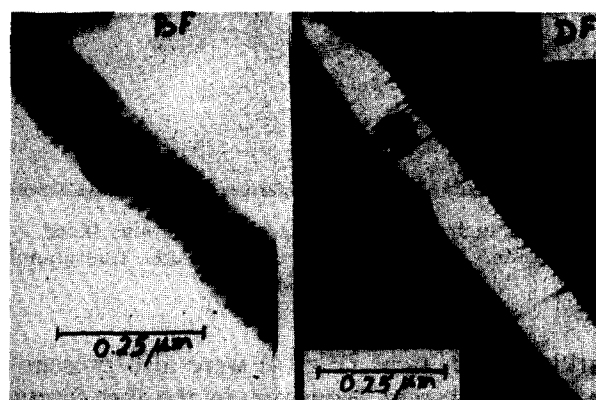
Fig. 15. TEM of  $\beta$ -SiC whisker showing stacking fault by dark field and bright field techniques.

Since the possibility of large scale failure by pullout or tensile fracture was discounted, whiskers were most likely to fail by fatigue. At low  $\Delta K$ , the whiskers which had bridged the crack after the surrounding alumina grains had failed by cleavage, would continue to experience fatigue loading, then failed with a square fracture which is typical of fatigue. The fatigue failure of the silicon carbide whisker under such circumstances, could be significantly influenced by the stacking fault such as is reported Ref. 11 in Fig. 15, since such fault could be responsible for nucleating the fatigue crack. However, this aspect needs careful study.
