Transmission Electron Microscopy of Intergranular Regions of Corroded Silicon Nitride

Abstract

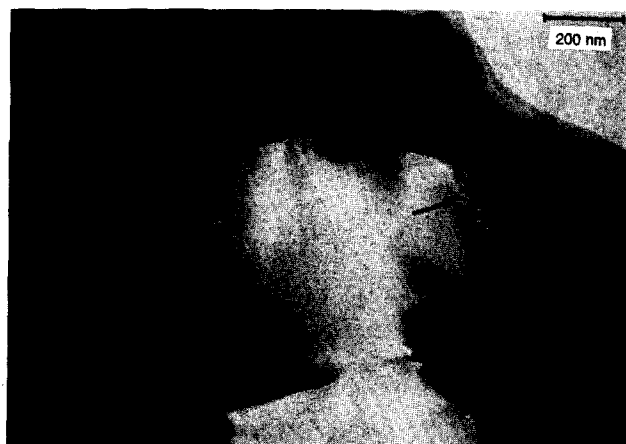
Fig. 3. Corroded SN1: 100 to 200 nm regions of foamed intergranular glass at a Si_3N_4 grain, and (smaller arrows) indications of general intergranular attack.

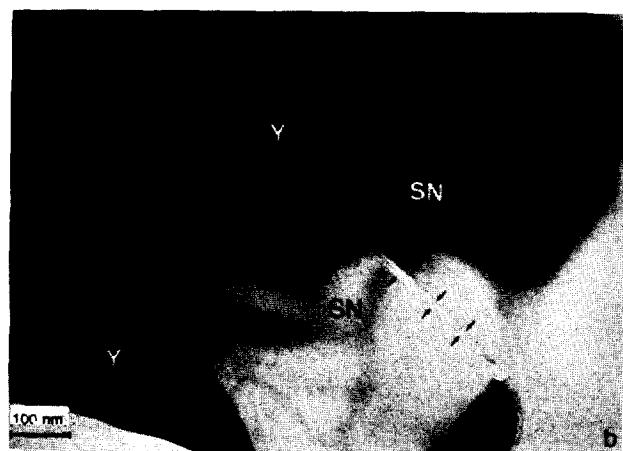
boundary (both features arrowed). At higher magnification (Fig. 4(a)) ~10 nm dimension micro-void formation at a silicon nitride-silicon nitride grain boundary can be seen, leading in extreme cases to the complete grain face separation in Fig. 4(b). On the basis of the lighter colour of the void regions of Fig. 4(b) it is believed that they do not contain glass: whether the nm dimension, more spherical, regions of Fig. 4(a) are voids or glass

Fig. 4. (a) Nano-void formation at a silicon nitride-silicon nitride grain boundary; (b) complete grain face separation.

microspheres is not so certain, but it is assumed that they are again gas-filled bubbles. The very fine scale of all these regions made reliable XMS analyses impossible.

The localised, uniform 10–15 nm dimension intergranular spherical features shown in Fig. 4(a) seem most probably to be nitrogen-filled bubbles generated by oxidation of the silicon nitride by

oxygen diffusing through an intergranular film. At this bubble dimension, and assuming a liquid-gas interfacial energy of $\sim 300 \text{ mJ m}^{-2}$, the equilibrium internal gas pressure would be of the order of 600 bar. This is high, but is still insignificant by comparison with the theoretical nitrogen pressure in equilibrium with silicon dioxide and oxygen at 0.2 bar pressure at this temperature, which, on the basis of a standard Gibbs function of reaction at 1400 K of $\sim -1703 \text{ kJ mol}^{-1}$, would theoretically be of the order of 10^{30} bar. This pressure is clearly an unrealistic one from any practical point of view; the value is of interest in that it serves to indicate the marked tendency for nitrogen to be generated in these regions, and for it to be able to build up a considerable pressures. The internal gas pressure might then be able, in effect, to prise grains apart. This interpretation is, however, clouded by the possibility that internal stresses will be generated also by the considerable volume expansion ($\sim 86\%$) caused by oxidation of silicon nitride to SiO_2 , and these stresses will add to those caused by nitrogen generation. The larger voids seen in Fig. 4(b) suggest that with time individual bubbles have indeed linked to form continuous cavities, from which liquid silicate has been expelled by the continuing generation of nitrogen. In the case of the more glassy SN2 material, giving on corrosion much larger liquid-free regions, the process appears to have occurred more extensively. That liquid mobility on this scale should occur at the relatively low temperature of 1100°C would require a very low viscosity, but this would be readily attained by the incorporation of K_2O into the intergranular phase.

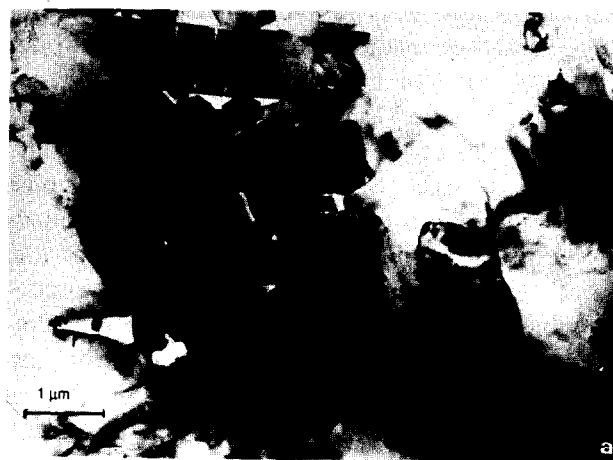
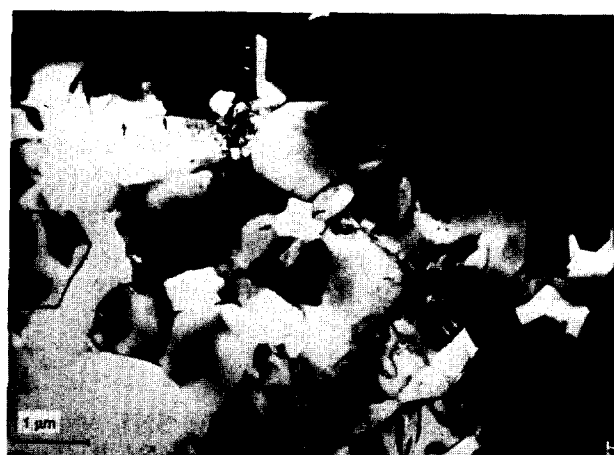
The more heavily iron-contaminated and glassy SN2 silicon nitride also contained predominantly $\beta\text{-Si}_3\text{N}_4$, together with intergranular FeSi , FeSi_2 , $\text{Si}_2\text{N}_2\text{O}$, and the Olivine $(\text{Mg,Fe})\text{SiO}_4$ forsterite structure solid solution; glass was present at many three grain junctions, and identification of the Mg-containing secondary phase was assisted by XMS analysis. Figs 5(a) and (b) show typical regions of material at the corrosion zone interface after corrosion for 800 h. The MgO-containing silicon nitride was more severely degraded during corrosion than the SN1, Y_2O_3 -densified silicon nitride. A marked feature of the microstructure of this material (arrowed) is the regions which appear to be completely depleted of glass, bounded by silicon nitride grains. These are not seen in uncorroded material and suggest the large-scale loss of a liquid (of lowered viscosity) from these regions. Figure 6 shows (arrowed) a crystalline

Fig. 5. Corroded SN2: typical planar view regions at the corrosion zone interface after corrosion for 800 h; arrows indicate intergranular voids foreign to the uncorroded microstructure.
