Microstructure and Thermal Stability of a Glass-Coated SiC/SiC Composite

M. Li & F. Guiu*

Department of Materials, Queen Mary and Westfield College, University of London, Mile End Road, London E1 4NS, UK

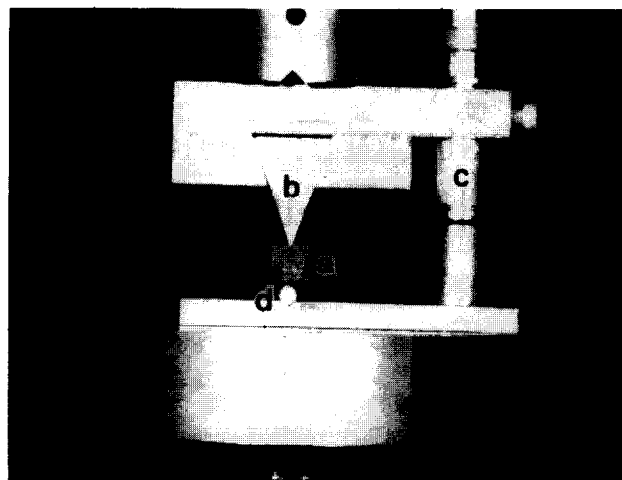
Fig. 1. Set-up for the wedge opening test showing (a) specimen, (b) wedge, (c) displacement transducer and (d) supporting roller.

cloth layers. By forcing a wedge into the notch, a crack was made to propagate across the specimen using the experimental set-up shown in Fig. 1. The loading wedge is made of a hard steel and the wedge angle is 40° . The specimen was supported by a steel roller of 3 mm in diameter. The wedge opening tests were performed under position control mode at a crosshead speed of 0.2 mm min^{-1} . The wedge displacement (vertical displacement) was measured by a capacitance transducer with a sensitivity of 1 mm V^{-1} and the applied load vs. wedge displacement curve was recorded on an X-Y plotter. During the wedge opening test, a travelling microscope was mounted close to the specimen to observe the crack propagation.

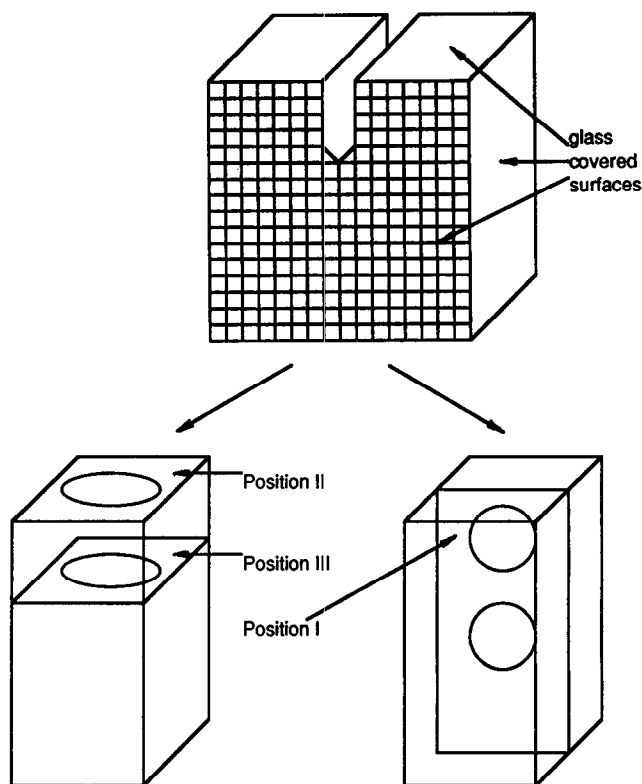
Fig. 2. Schematic diagram showing the sectioning of the SiC/SiC tablet after mechanical test for the preparation of TEM specimens.

After the wedge opening tests, the crack paths and fracture surfaces were examined under a scanning electron microscope (Jeol JSM-35 CF). After the specimens were split into two pieces, thin foils were prepared from different positions and orientations as shown in Fig. 2 for structural examination under a transmission electron microscope (TEM) (Jeol 200 CX). The compositions of various areas such as interphase, Nicalon fibres and CVI SiC matrix were analysed using the energy dispersive X-ray spectrometer (EDS) attached to the SEM and TEM.

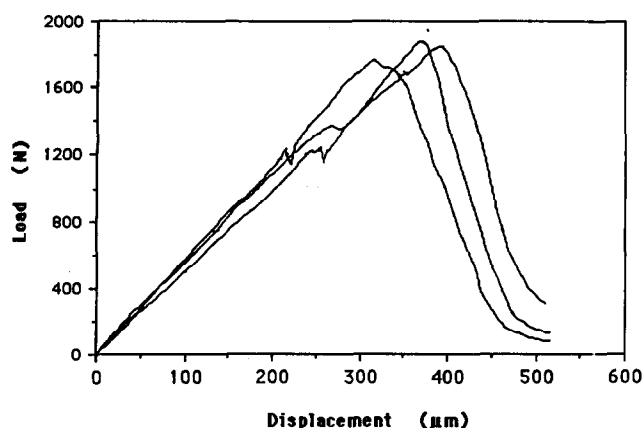
Fig. 6. Applied load vs. wedge displacement curves for as-received SiC/SiC specimens.

To investigate the effect of heat treatment on the mechanical integrity of the material, three as-received composite tablets were tested by the wedge opening method to obtain reference curves. The results showed good repeatability of the technique. The three specimens gave almost identical load-displacement curves as shown in Fig. 6, with a variation of maximum applied load between 1.75 and 1.88 kN. The composite exhibited an initial linear elastic behaviour followed by a non-linear load-displacement relationship until the maximum load was reached (Fig. 6). The first load drop terminated the linearity and a sound was heard coincidentally with this load drop. No crack was observed on the specimen surface, but sign of

debris jumping from the notch tip was noted. From the first load drop to the maximum load, there was no evident main crack on the specimen surface and emission of particles from the notch front continued. The non-linearity towards maximum load is probably due to the progressive cracking of both matrix and fibres which are inside a limited damage zone just at the notch tip. It is possible that the resolution of the observation method used was not sufficient to obtain detailed image of what was happening at the notch tip before the maximum load was reached. After the maximum load, a dominant crack started to be gradually revealed, which propagated from the notch tip through the middle of the specimen to the contacting point of the supporting roller. For the SiC/SiC composite, the fracture by wedge opening test is non-catastrophic, and hence some load-bearing ability is still retained beyond the maximum load because fibres bridge the crack.

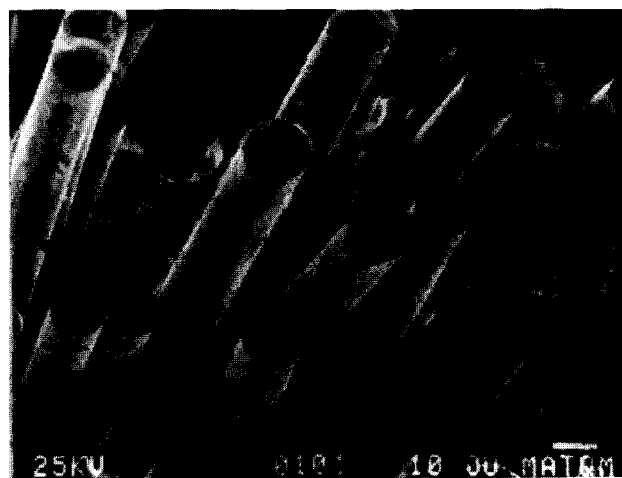
Fig. 9. Fracture surface of the as-received material showing various degree of fibre pull-out.

After crack path examination, the tested specimens were manually pulled apart so that fracture surfaces could be studied under the microscope. Fracture surfaces of as-received specimens were characterized by fibre pull-out (Fig. 9) and debonding between the fibre and the matrix.

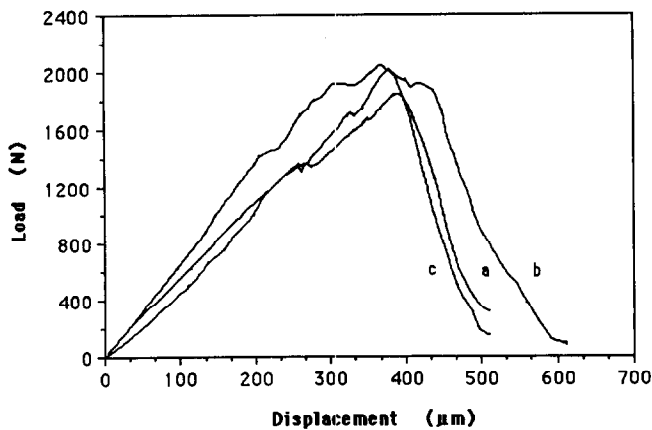
Fig. 10. Applied load vs. wedge displacement curves for SiC/SiC specimens: (a) as-received, (b) heat-treated at 1000°C for 50 h, (c) heat-treated at 1150°C for 50 h.

It could be seen from the recorded load-displacement curves (Fig. 10) that heat treatment up to 1150°C for 50 h did not significantly change the mechanical properties of the composite. The microstructures observed under SEM and TEM of the heat-treated specimens showed similar features to those of the as-received material.

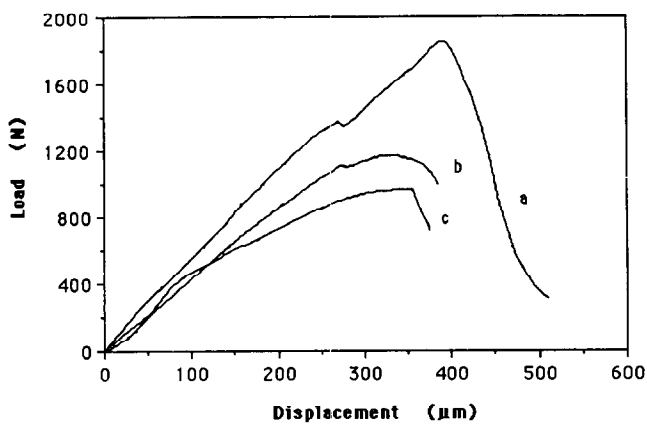
Fig. 11. Applied load vs. wedge displacement curves for SiC/SiC specimens: (a) as-received, (b) heat-treated at 1300°C for 50 h, (c) heat-treated at 1400°C for 50 h.

A heat treatment for 50 h at both 1300 and 1400°C produces a drastic degradation of the composite's mechanical properties (Fig. 11). In the wedge opening tests the specimens did not fail by the propagation of a single main crack, as observed for the material heat-treated below 1150°C, but by massive delamination of the fibre layers (Fig. 12) and severe damage at supporting points. The frac-

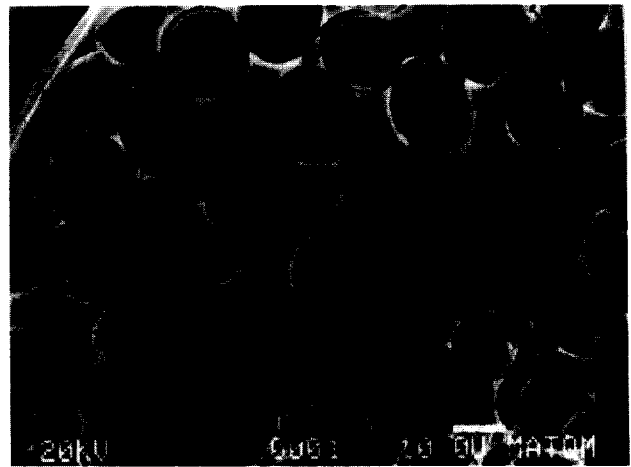
Fig. 14. Extensive debonding between the fibre and the matrix in a specimen heat-treated at 1400°C for 50 h.

ture surfaces of these specimens showed extensive fibre pull-out with segmental patches of interphase adhered to the fibre surface (Fig. 13). All these observations are clear evidence that the strength of the fibre-matrix interface has been severely degraded. It can be seen in Fig. 14 that delamination

of the material has taken place not only between the fibre layers, but also within the fibre bundles.

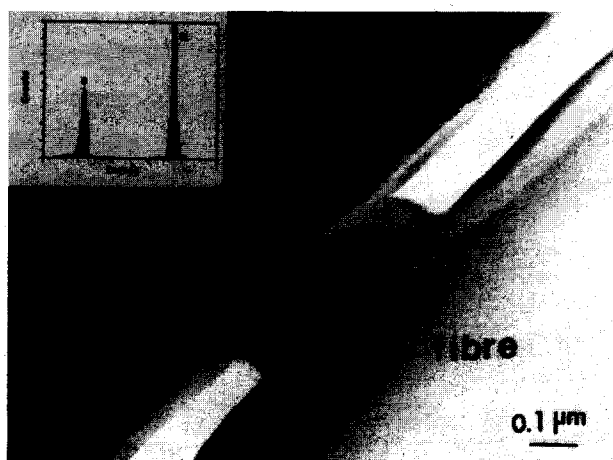
Fig. 17. TEM image and EDS spectrum of the new interphase (silica) in the oxidized specimen heat-treated at 800°C for 100 h.

Some composite tablets were polished on one surface to remove the glass layer. They were subsequently heat-treated at 800°C for 100 h. TEM specimens were prepared after the heat treatment from different positions of the tablet. Important structural changes were observed to have taken place to a depth of 0.5 mm from the uncovered surface. The original interfacial carbon layer had disappeared, having been replaced by a thin layer of amorphous structure (Fig. 17), as evidenced by a lack of contrast change during specimen tilting in the microscope and by the SAD pattern showing continuous halos. EDS analysis revealed the presence of oxygen and silicon peaks in this layer, which probably consists of silica.

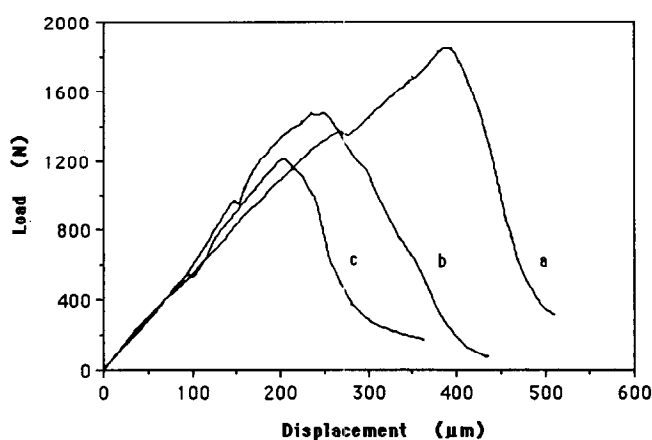
Fig. 18. Applied load vs. wedge displacement curves for SiC/SiC specimens: (a) as-received, (b) notched and heat-treated at 860°C for 50 h, (c) notched and heat-treated at 1200°C for 50 h.

It can be seen in Fig. 18 that in the notched and heat-treated specimens both the first load drop and the maximum load were considerably lower than for the as-received specimens. However, the composite still exhibited a non-catastrophic failure behaviour as indicated by the curves.
