# Microstructural Analysis of Corroded Alumina–Spinel Castable Refractories

## Abstract

*Microstructural analysis indicates that the corrosion of alumina–spinel castables by a liquid steel ladle slag involves initial reaction of CaO in the slag with alumina fines in the refractory bond. The slag becomes saturated in CaO and  $Al_2O_3$  and  $CA_2$  is precipitated from it along with other calcium aluminates. The spinel fines and grains in the refractory take up the MnO/FeO/Fe<sub>2</sub>O<sub>3</sub> from the slag, which becomes silica-rich as  $CA_2$  is precipitated and highly viscous. The thickness of the remnant slag layer on the corroded samples indicates the viscosity of the liquid slag under the test conditions. Further into the refractory  $CA_6$  is formed, firstly crystallized with a tabular morphology in dense regions and then with a similar morphology in more porous regions. Deeper still in the refractory  $CA_6$  takes a whisker/needle habit suggesting some vapour-phase reaction. MgO-rich spinel–alumina castables undergo less corrosion under these conditions as dissolution of MgO leads to a viscous MgO-rich slag which is less corrosive to the  $Al_2O_3$  components o

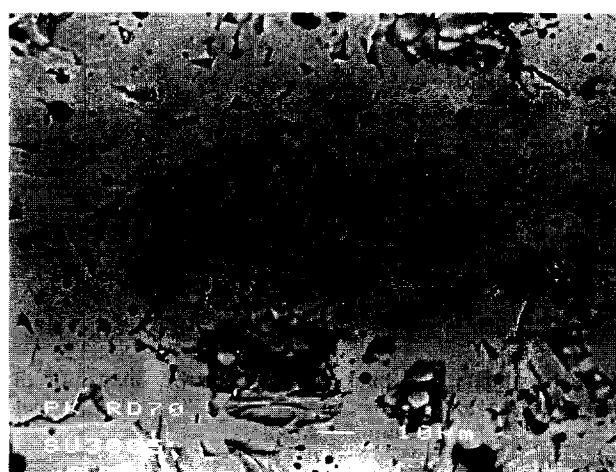
**Fig. 2.** Secondary electron SEM image of a tabular alumina grain well away from the corrosion front, showing its porous nature.

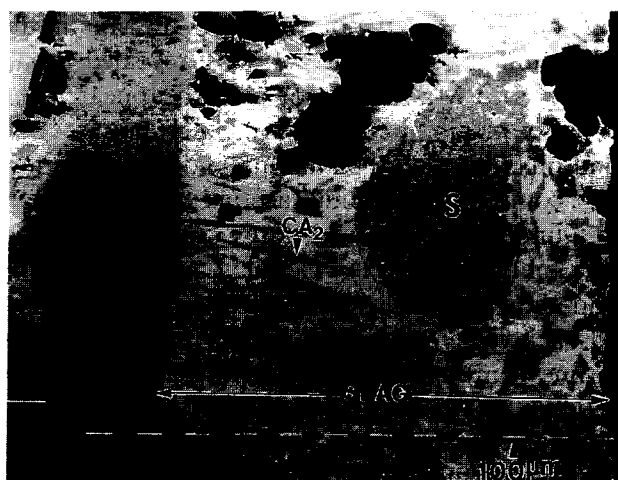
Fig. 6. Secondary electron SEM image of the attached slag/refractory interface of a 67%  $\text{Al}_2\text{O}_3$  spinel-alumina sample. S is a detached spinel grain. Note that the  $\text{CA}_2$  crystals are perpendicular to the refractory surface until about half-way across the slag layer when they become more randomly oriented.

Detailed analysis of the phases present in the penetrated refractories will now be presented. Figure 6 shows the slag layer from the 67% sample containing many phases and most of the Fe from the original slag composition. The main slag phases are revealed at higher magnification (Fig. 7) to be a dark grey angular phase and grey elongated grains in a matrix of light grey grains with white intergranular phase. EDS shows the dark grey angular phase to contain Mg, Mn, Fe, Al and O with a mole ratio of 1 ( $\text{MgO}/\text{MnO}/\text{FeO}$ ) to 2  $\text{Al}_2\text{O}_3$ , indicating it is a highly aluminous impure spinel labelled S in Fig. 7. Other grains of similar composition often occurring in penetrated 'clumps' (also labelled S in Fig. 6) are spinel grains eroded from the castable surface and gradually reacting with the slag. Note the thermal expansion cracks around the spinel clump. The lighter grey needles are a calcium aluminate with a Ca/Al

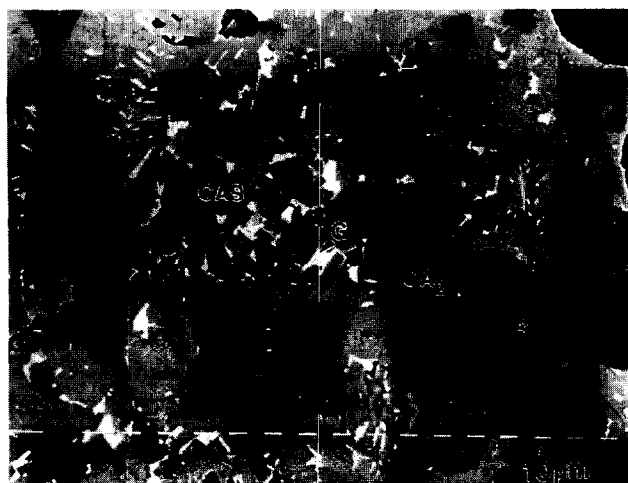
Fig. 7. Detail of the slag phases showing  $CA_2$  needles, blocky spinel (S), calcium aluminosilicate (CAS) matrix and bright phase G whose triple junction morphology suggests it is the last phase remaining after crystallization and may well be glass.

atomic ratio of 1:4:3. These are  $CaO \cdot 2Al_2O_3$  but rich in alumina (labelled  $CA_2$  in Fig. 7). The light/dark grey matrix grains are various calcium aluminosilicates with an approximate mole ratio of 6:2:4:2:4  $CaO/Al_2O_3/SiO_2$  (labelled CAS). The white phase has variable composition but is usually rich in  $CaO + Al_2O_3$  (60 wt%) and  $MnO + FeO$  (40 wt%). This phase is probably uncrystallized glass (labelled G). Note the columnar nature of the  $CA_2$  slag grains growing perpendicular to the refractory interface (Fig. 6), suggesting rapid undisturbed growth until about half way into the slag layer when more random crystal orientation occurs. The latter indicates that either (1) crystals were moving in the slag stream or (2) nucleation and growth was more random.

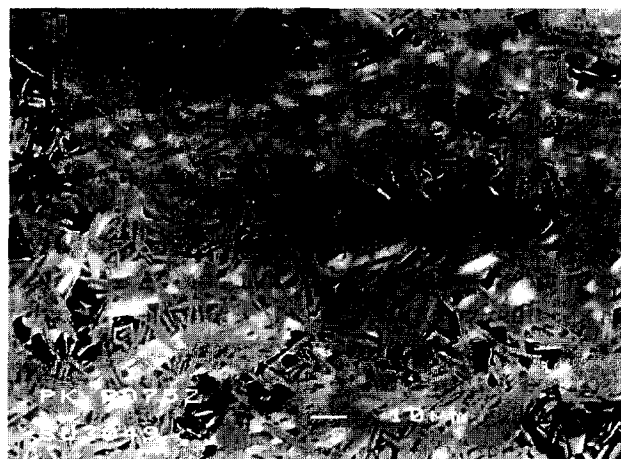
Fig. 10.  $CA_6$  crystals from the same sample as in Fig. 8 in porous region II.

$CaO \cdot 6Al_2O_3$  (labelled  $CA_6$ ) whereas region II (illustrated in Fig. 10 for 75% spinel) has similar grains but separated by angular pores. Similar faceted  $CA_6$  crystals have been observed in corroded alumina-spinel refractories.<sup>1</sup> The matrix in regions I and II contains  $CaO$ ,  $Al_2O_3$  and  $SiO_2$  (CAS) but the composition is variable. This type of matrix was never observed either in the uncorroded parts of the refractories or in uncorroded sections held for 40 h at 1650°C and its presence suggests extensive  $CaO$  and  $SiO_2$  penetration; near the slag layer  $MnO$  and  $FeO$  were detected. Region II close to the unpenetrated refractory contains a large number of needles or whiskers (illustrated in Fig. 11 for 75% spinel) suggesting vapour involvement in their deposition. The needles/whiskers are mostly alumina with some  $CaO$ , so they are also alumina-rich  $CA_6$ .
