Restoration of Hanshin Expressway after Kobe/Awaji Earthquake – challenge of 623 days before opening

Hidenao Hayashi *, Tamotsu Marui, Nobuhiko Taniguchi, Shigeru Kayano

Hanshin Expressway Public Corporation, 4-1-3 Kyutaro-machi Chuo-ku, Osaka, Japan

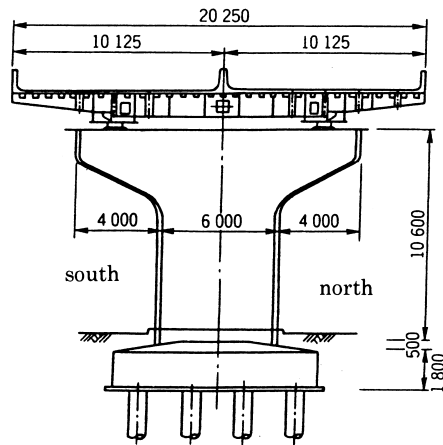
Fig. 9. Cross section of new Fukae section.

The superstructures of toppled 18 spans were rebuilt as two 9-span continuous steel box girder bridges. The representative cross section is shown in Fig. 9. Seismic

Natural period of this bridge was analyzed with an entire model of 9-span continuous base isolating bridge in order to confirm the effects of seismic isolators under earthquake loading. The results are shown in Table 2. Case 1 means a case without base isolation and case 2 means with seismic isolators. The natural period of this bridge was found to become approximately twice using seismic isolation bearings.

A dynamic analysis was carried out using the actual wave of Kobe/Awaji Earthquake and it was found that the shear deflection of isolator was 238% while the design capacity was 250% with a static horizontal force of 0.68 G.

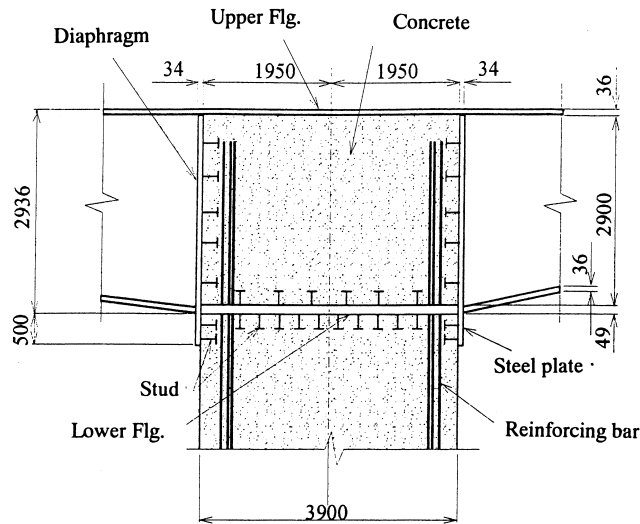
Fig. 11. Structure of connection.

The vertical main reinforcing bars for the RC column reconstructed by using the existing footing were inserted into the steel box beam and fixed by injected concrete. To composite the steel box beam and the concrete, the appropriate shear connectors were arranged on the inner surface of the steel box beam. Fig. 11 shows the structure of beam-column connection.

The connecting part of steel box beam is designed according to the method shown in the specification of steel piers. In this case, the stress delivered into the filling concrete can be neglected for safety.

Horizontal earthquake force can be transferred from beam to column by the studs installed underneath the lower flange of the steel box beam.

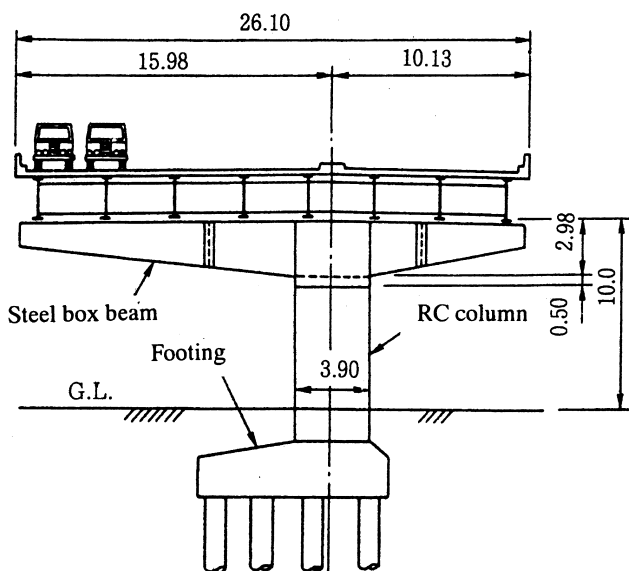
Fig. 15. General view of test pier.

In order to ascertain the safety of this structure and the design method, a loading test was carried out on three actual hybrid piers [1–4]. A general view of one of those piers is shown in Fig. 15.

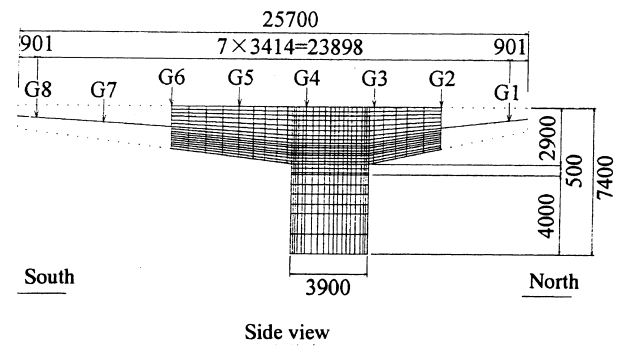
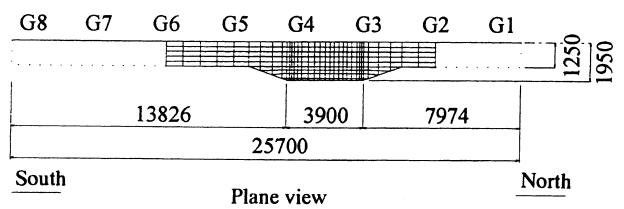
Fig. 16. Analysis model.

The behavior of the pier was analyzed with three-dimensional finite element method. The analysis model and boundary conditions are shown in Fig. 16 and Table 3, respectively. Since both edges of the beam were supposed to have less influence on transferring the stress, they were modeled in beam elements. The bottom of the column was treated as a fixed boundary. Two cases were compared, as shown in Table 3, in which different bonding conditions between the steel plate and concrete were assumed. Note, however, the concrete is fixed to the steel, under compressive state of stress in both cases.

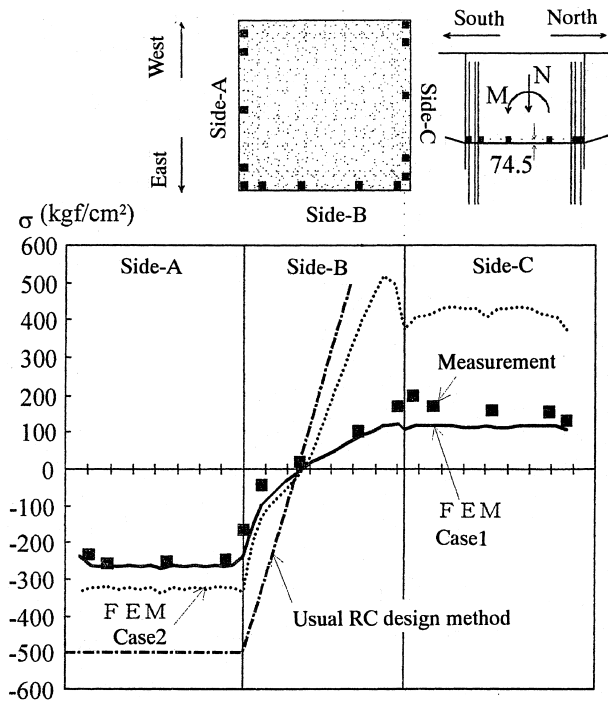
Fig 17. Distribution of axial stress in the boundary section.

The stress in the main reinforcing bars at the connection is shown in Fig. 17. And the states of the peeling of steel webs and flanges are shown in Fig. 18. The result of case 1 matches better to measured stress than case 2 and than that of the conventional RC design method. Although some cracks were expected to appear in the filling concrete before the test, they were not observed. It was supposed that few cracks would be developed due to the elastic deformation of steel beam that absorbs the tensile force on concrete.

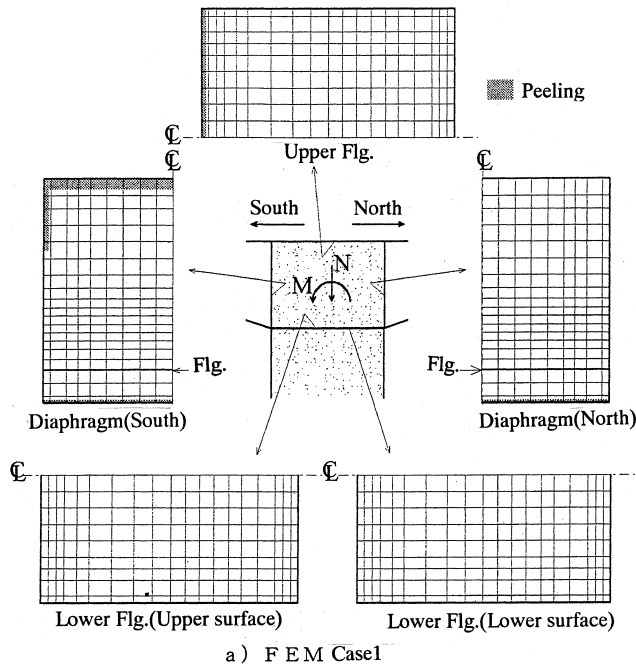
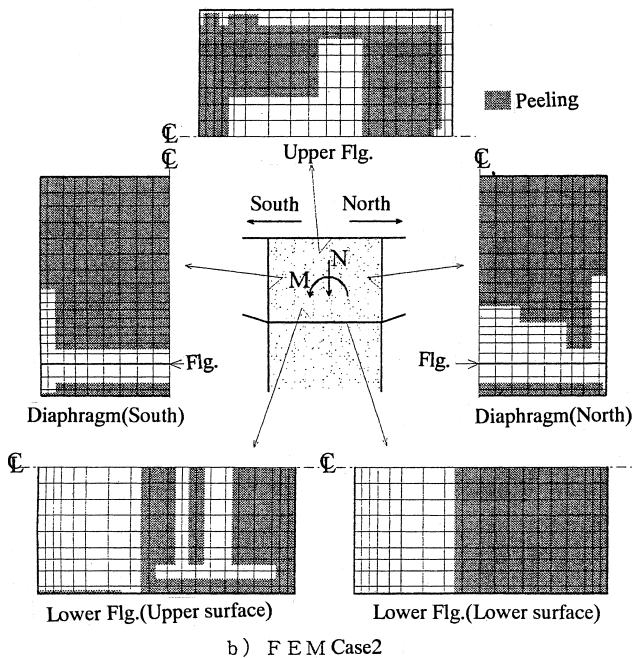
Fig 19. Boundary state of peeling between steel and concrete (analysis).

The stress of concrete and that of steel web acted almost in the same direction as shown in Fig. 19. Approximately, 80% and 20% of the shear stress in the connection part were carried by concrete and steel web, respectively. The displacement under the step 2 load is shown in Fig. 20. The deformational behavior of connection was almost the same in the analysis of Cases 1 and 2. It also matched with the measurement that was within $L/500$, the allowable standard deflection of steel box beams. Through the static load test and analysis, the adequacy of using the method shown above was confirmed.

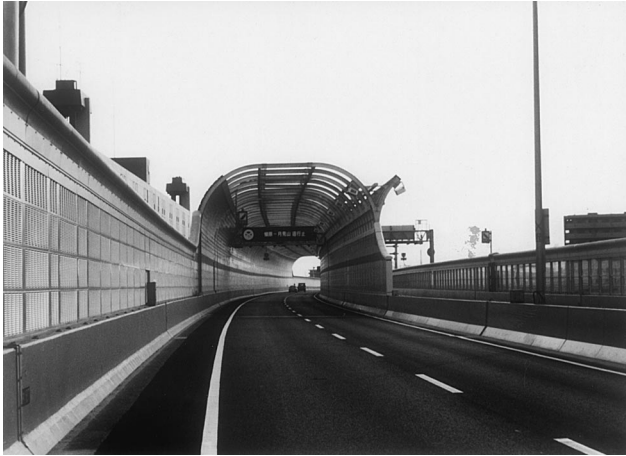
Fig 21. Tall noise barrier.

Tall noise barriers were also installed in front of tall residential buildings along the Route 3 as shown in Fig. 21. Although they are effective physically against
