Case studies of concrete deterioration in a marine environment in Portugal

António Costa ^{*}, Júlio Appleton

Departamento de Engenharia Civil, Instituto Superior Técnico, Technical University of Lisbon, Av. Rovisco Pais, 1049 001 Lisboa, Portugal

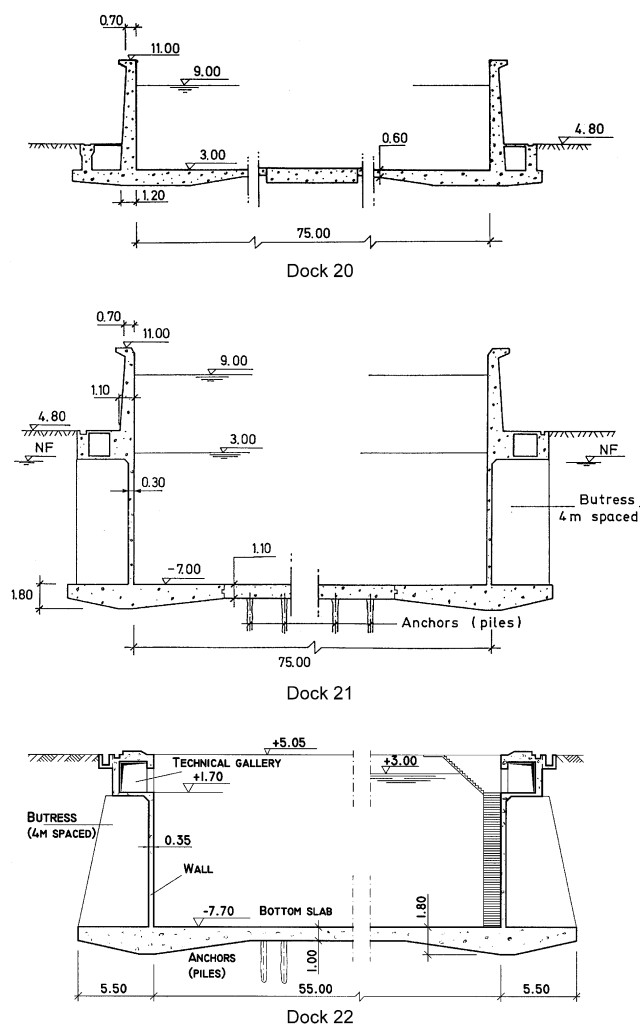
Fig. 1. Cross-section of the docks; all measurements in m.

This example describes the deterioration of the docks of a shipyard located in the estuary of River Sado, in the west coast of Portugal. The shipyard has three reinforced concrete docks (docks 20, 21 and 22) built during the 1973–1975 period. Dock 20 is a ship construction platform with plan dimensions of 420 × 75 m and 8 m high walls. Dock 21 is intended for ship repair and its dimensions in plan are 450 × 75 m with 18 m high walls. Dock 22 is also intended for ship repair and its dimensions in plan are 350 × 55 m with 12 m high walls. Fig. 1 shows the cross-sections of the three docks.
