# Thaumasite swelling in historic mortars: field observations and laboratory research

R.P.J. van Hees<sup>\*</sup>, T.J. Wijffels, L.J.A.R. van der Klugt

*TNO Building & Construction Research, P.O. Box 49, 2600 AA Delft, Netherlands*

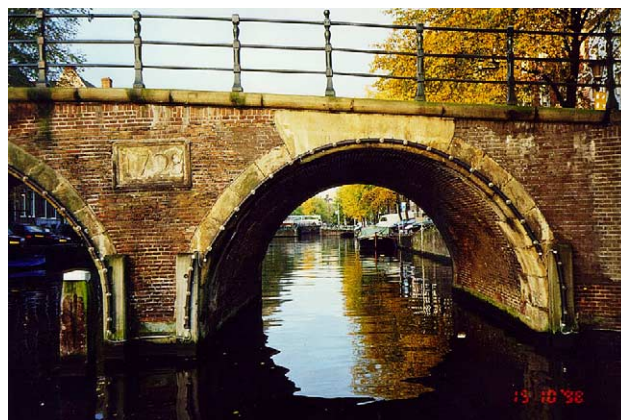
The first case is a historic canal bridge (1728) in Amsterdam, see Fig. 1. The bridge was built with clay brick (a good quality in the external 40 cm and a low strength orange-red clay brick, most probably rich in sulfate, in the internal part). The bedding mortar was a hydraulic mortar (lime–pozzolana binder).

The damage mainly occurred in the vaults, where push out of the (cement based) re-pointing and chipping of bricks occurred (Fig. 2).

Fig. 1. View of bridge 35, Amsterdam (case study 1).

As a repair measure, in the first place the ingress of water should be prevented. Further all cement based re-pointing mortar and the decayed part of the bedding mortar should be replaced. The use of cement rich in tricalcium aluminate or hydraulic lime should be avoided in the new re-pointing mortar. Blast furnace slag cement

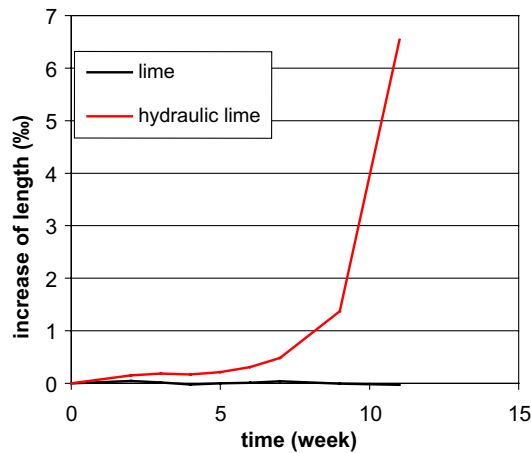
Fig. 12 gives the increase of length of the prisms over a period of 11 weeks. After 11 weeks the prisms made with hydraulic lime showed an expansion of up to 7‰. The prisms with hydrated lime and blast furnace cement did not expand.

Fig. 12. Increase of length of mortar prisms over a period of 1–11 weeks. (For interpretation of the references in colour in this figure legend, the reader is referred to the web version of this article.)

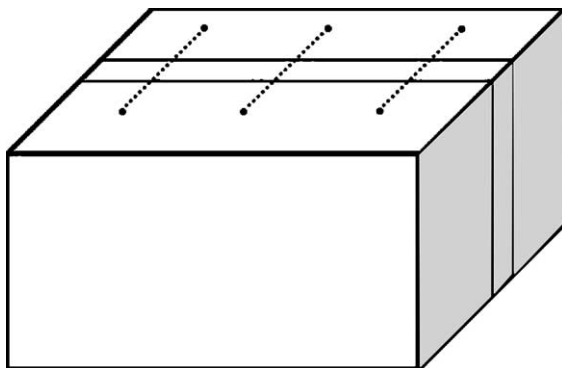
The expansion of the brick masonry sandwich was assessed by measuring the distance between  $2 \times 3$  steel points that were attached to the surface (see Fig. 14). In this case the increase was purely due to the expansion of the bedding mortar.

Fig. 14. Masonry specimen. Expansion was measured perpendicular to the joint.

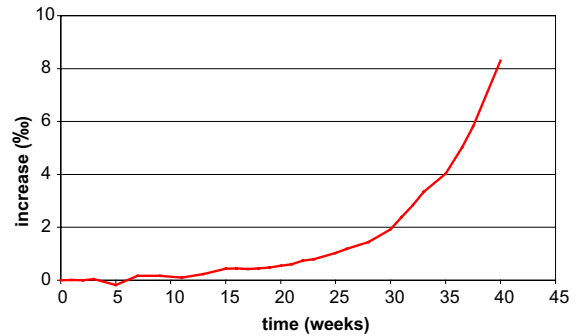
Fig. 15 gives the results of the test. The given line is the average of the three measurements. The experiment took 40 weeks. After 25 weeks the expansion of the mortar became clear. But after 40 weeks still no cracks were visible in the mortar.

Fig. 15. Swelling of mortar in masonry panel measured perpendicular to the joint and expressed as ‰ of the width of the mortar joint.

The difference in expansion is most probably due to the difference in sulfate and moisture content in the specimens. In the case of the masonry specimen, the moisture and sulfates penetrate from one side, while in the case of the mortar prisms, the moisture could penetrate from all sides.
